Mount Thorley Warkworth

2016 Annual Environmental Review

March 2017

Mount Thorley Warkworth (MTW) is an integrated operation of two open cut coal mines, Warkworth Mining Limited (WML) and Mount Thorley Operations (MTO). This Annual Review reports on the environmental performance of Mount Thorley Warkworth (MTW) for the period 1 January 2016 to 31 December 2016.

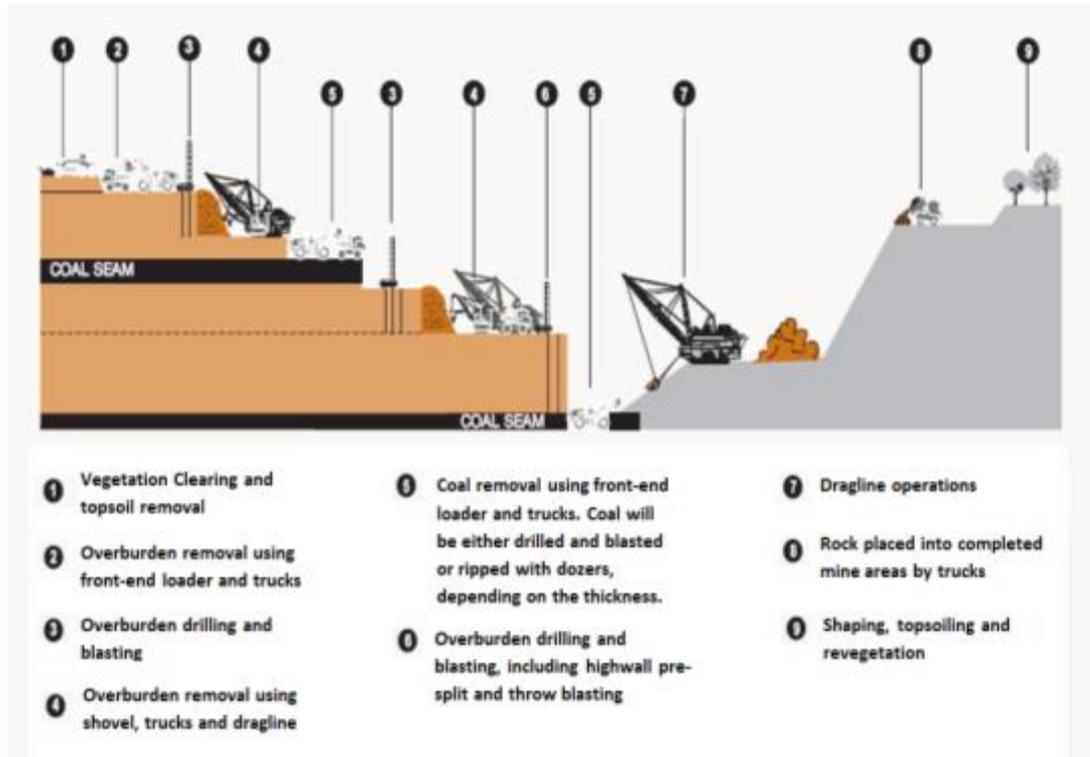
**Figure 2: Mining Process**

Areas to be mined are geologically modelled, a mine plan is formed and the relevant mining locations are surveyed prior to mining. Figure 2 illustrates the mining process. MTW have no active underground workings.

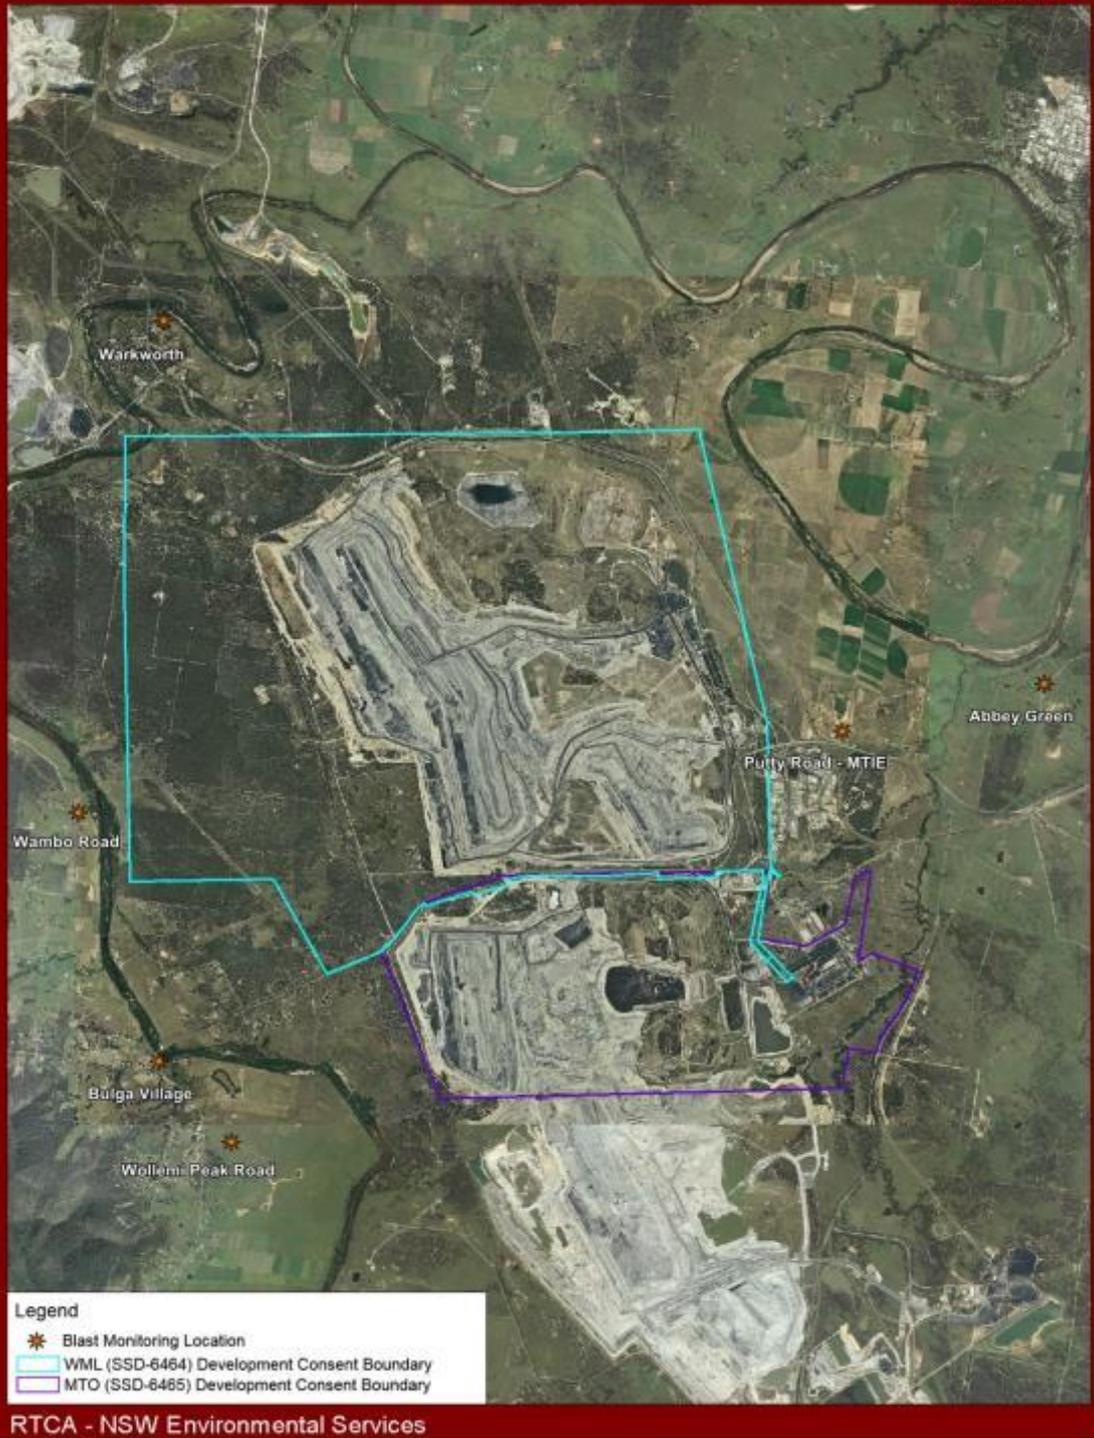
Figure 3: Blast Monitoring Locations

- Bulga Village (Wambo Road, Bulga);
- Mount Thorley Industrial Estate (known as MTIE - Putty Road, Mount Thorley)
- Wambo Road (Wambo Road, Bulga);
- Warkworth Village (former Warkworth Public School, Warkworth); and
- Wollemi Peak Road (intersection of Putty & Wollemi Peak Roads, Bulga).

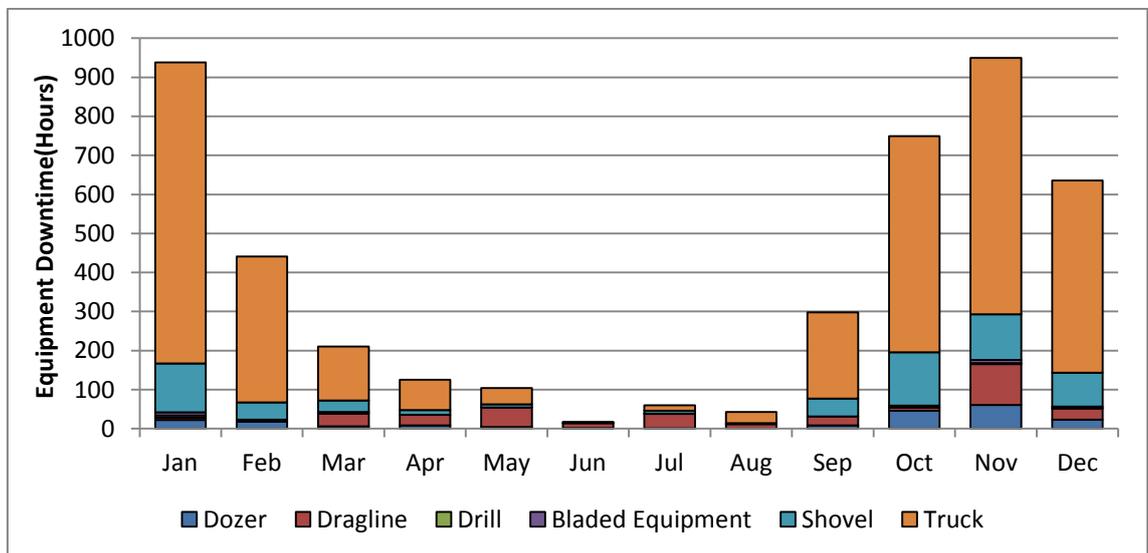
Figure 10: Equipment downtime for dust management by month

769 real-time alarms for air quality and wind conditions were received and acknowledged during 2016. In response 2,598.8 hours of equipment downtime was recorded due to air quality management. A detailed breakdown of air quality related equipment stoppages (per month, per equipment type) is presented in Figure 10.

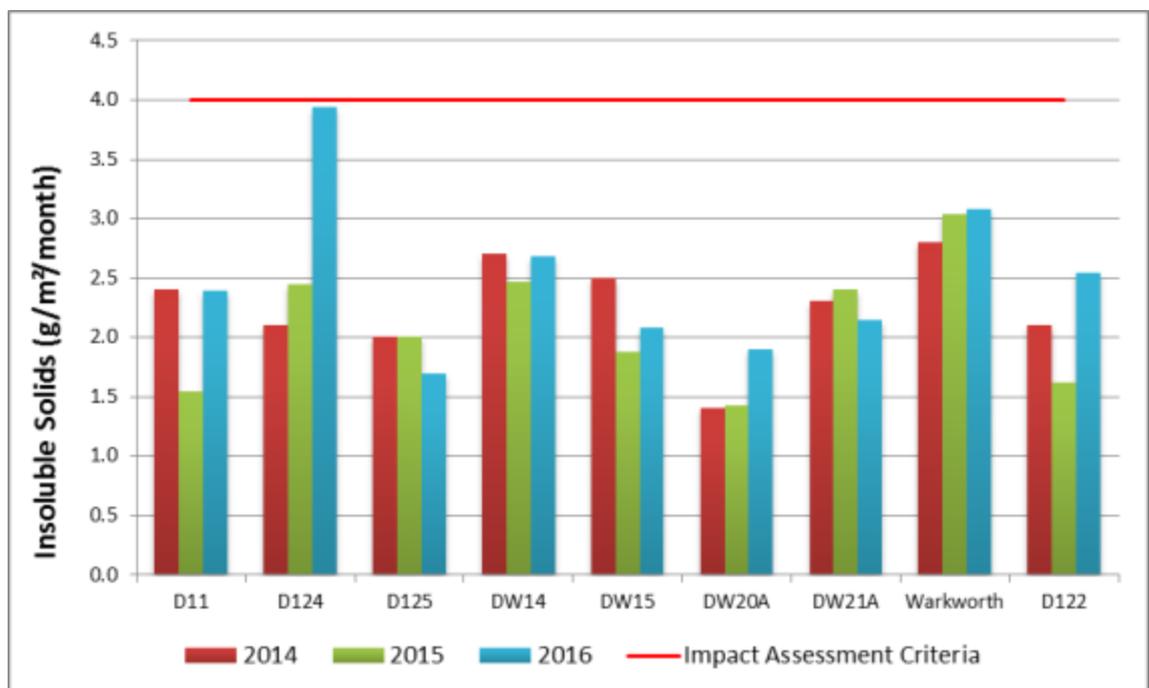
**Figure 13: 2016 Depositional Dust results compared against the impact assessment criteria and previous years' results**

There was a substantial increase (1.5 g/m<sup>2</sup>/month) in depositional dust at D124 compared to 2015 levels. Six out of the required twelve sampling results for D124 were considered to be contaminated and therefore excluded from the annual average calculation. The other six results, which were used to produce the annual average, noted the presence of additional material (insects, bird droppings and vegetation), but not enough to deem the sample contaminated. There were no operational changes at MTW that are likely to have caused an increase of this magnitude. The magnitude of the increase is inconsistent with the next nearest deposition monitor DW14 and nearby Loders Creek TSP monitor.

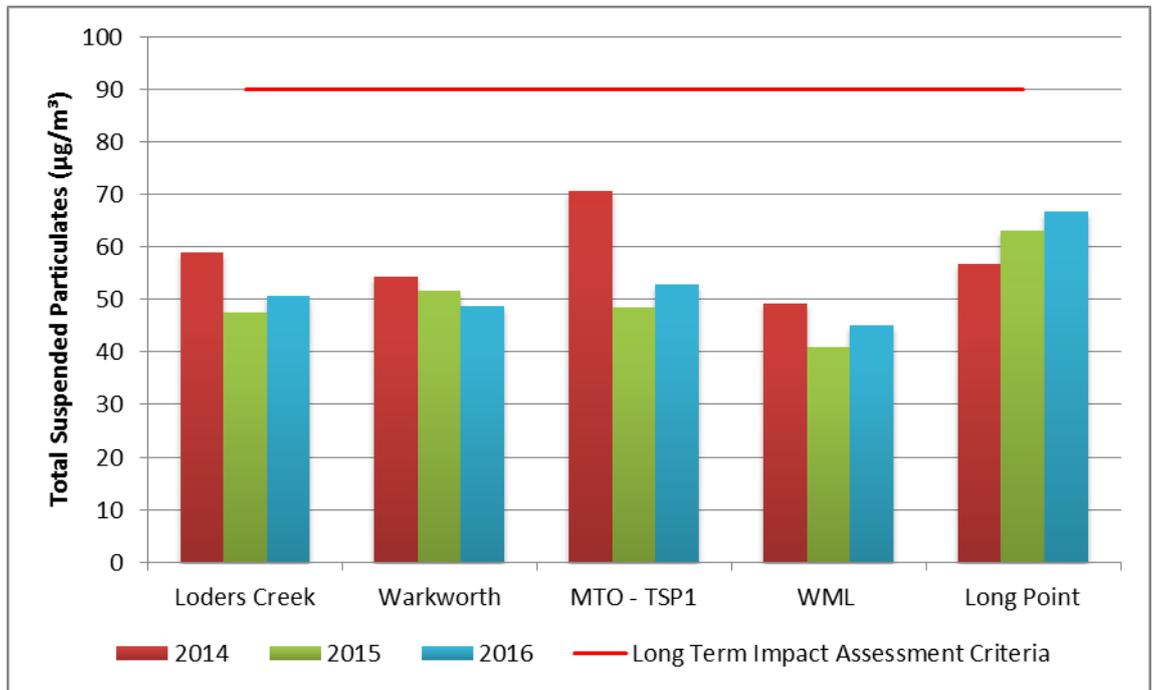
**Figure 15: 2015 TSP Annual Average compared against the impact assessment criteria and previous years' results**

The annual average TSP concentrations recorded in 2016 are generally consistent with those recorded during previous years (Figure 15).

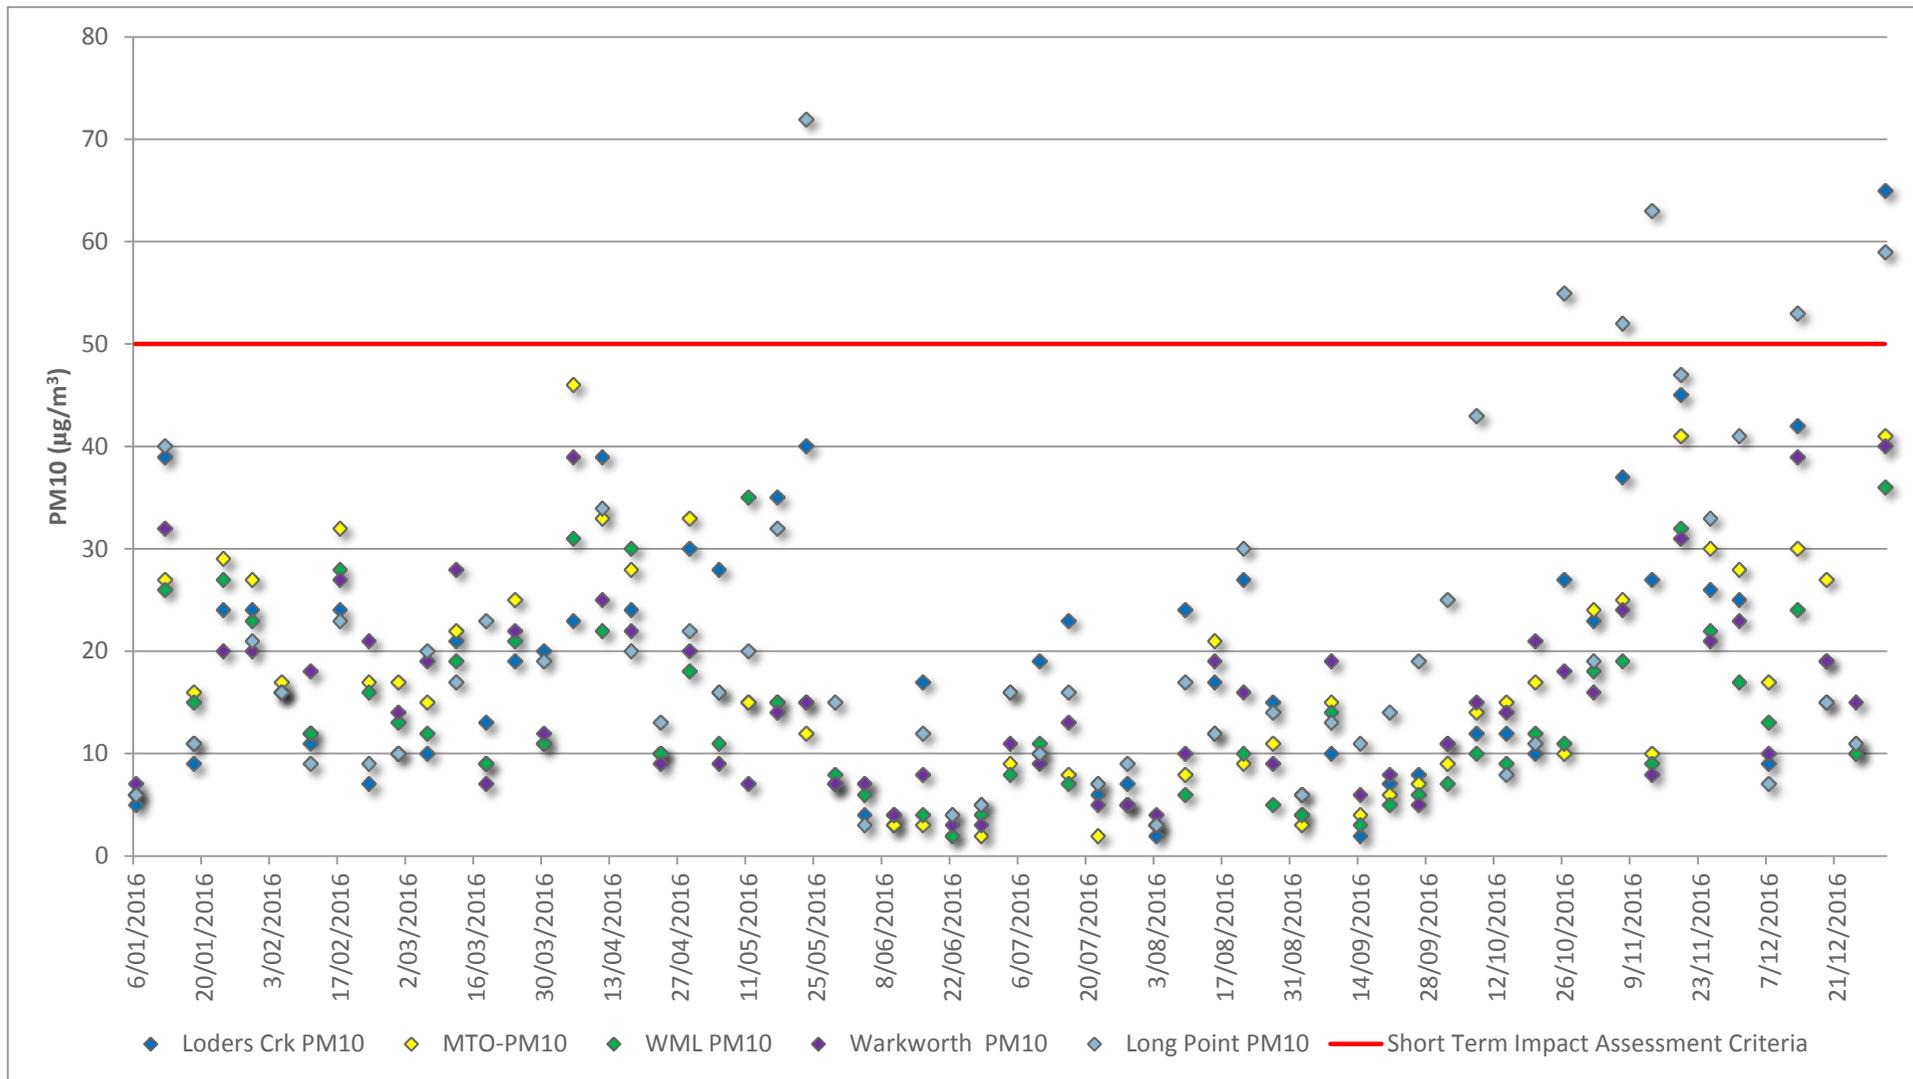
**Figure 16: PM<sub>10</sub> 24hr monitoring results (measured by MTW PM<sub>10</sub> HVAS network)**

Monitoring results for PM<sub>10</sub> (24 hour) collected through the High Volume Air Sampler monitoring network are compared against the short term impact assessment criteria (Figure 16). All 24hr average results recorded by MTW's surrounding network of TEOM monitors are presented on a quarterly basis in Figure 17 to Figure 20.

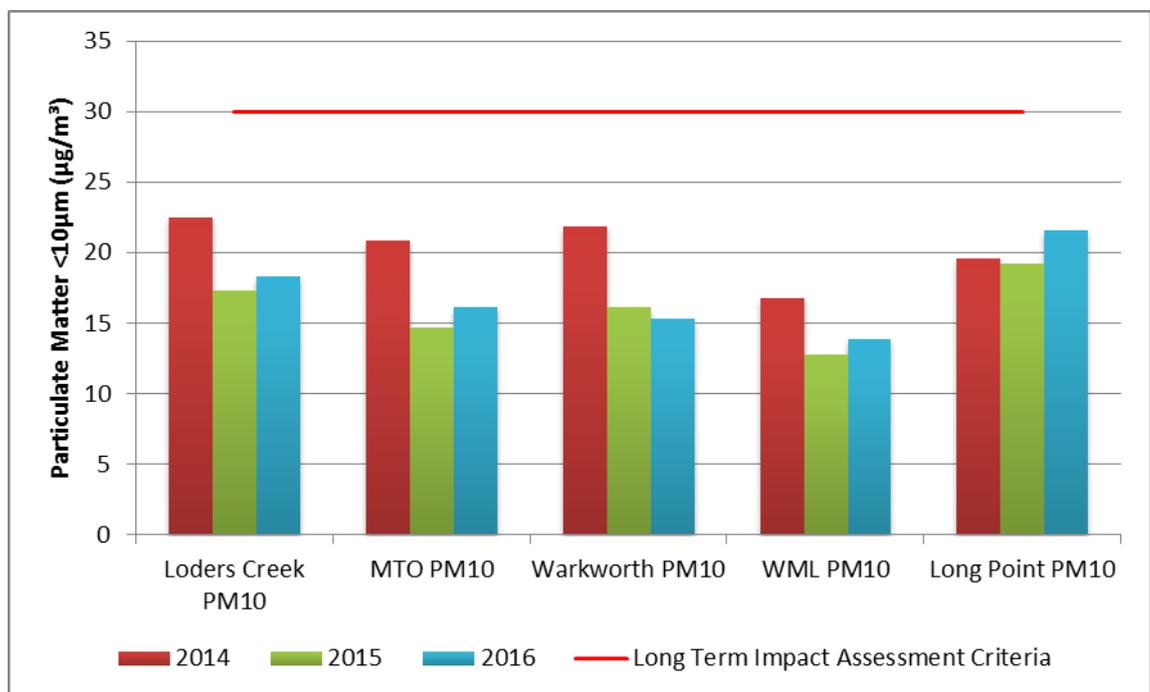
Figure 21: Annual average HVAS PM<sub>10</sub> results 2014 to 2016

Annual average PM<sub>10</sub> concentrations have been compared with the long term PM<sub>10</sub> impact assessment criterion and previous years' data (Figure 21). All annual average PM<sub>10</sub> concentrations recorded on privately owned land were compliant with the assessment criterion. All monitoring locations except Warkworth recorded minor increases in PM<sub>10</sub> compared to 2015. This is likely attributable to decrease in rainfall in comparison to 2015.

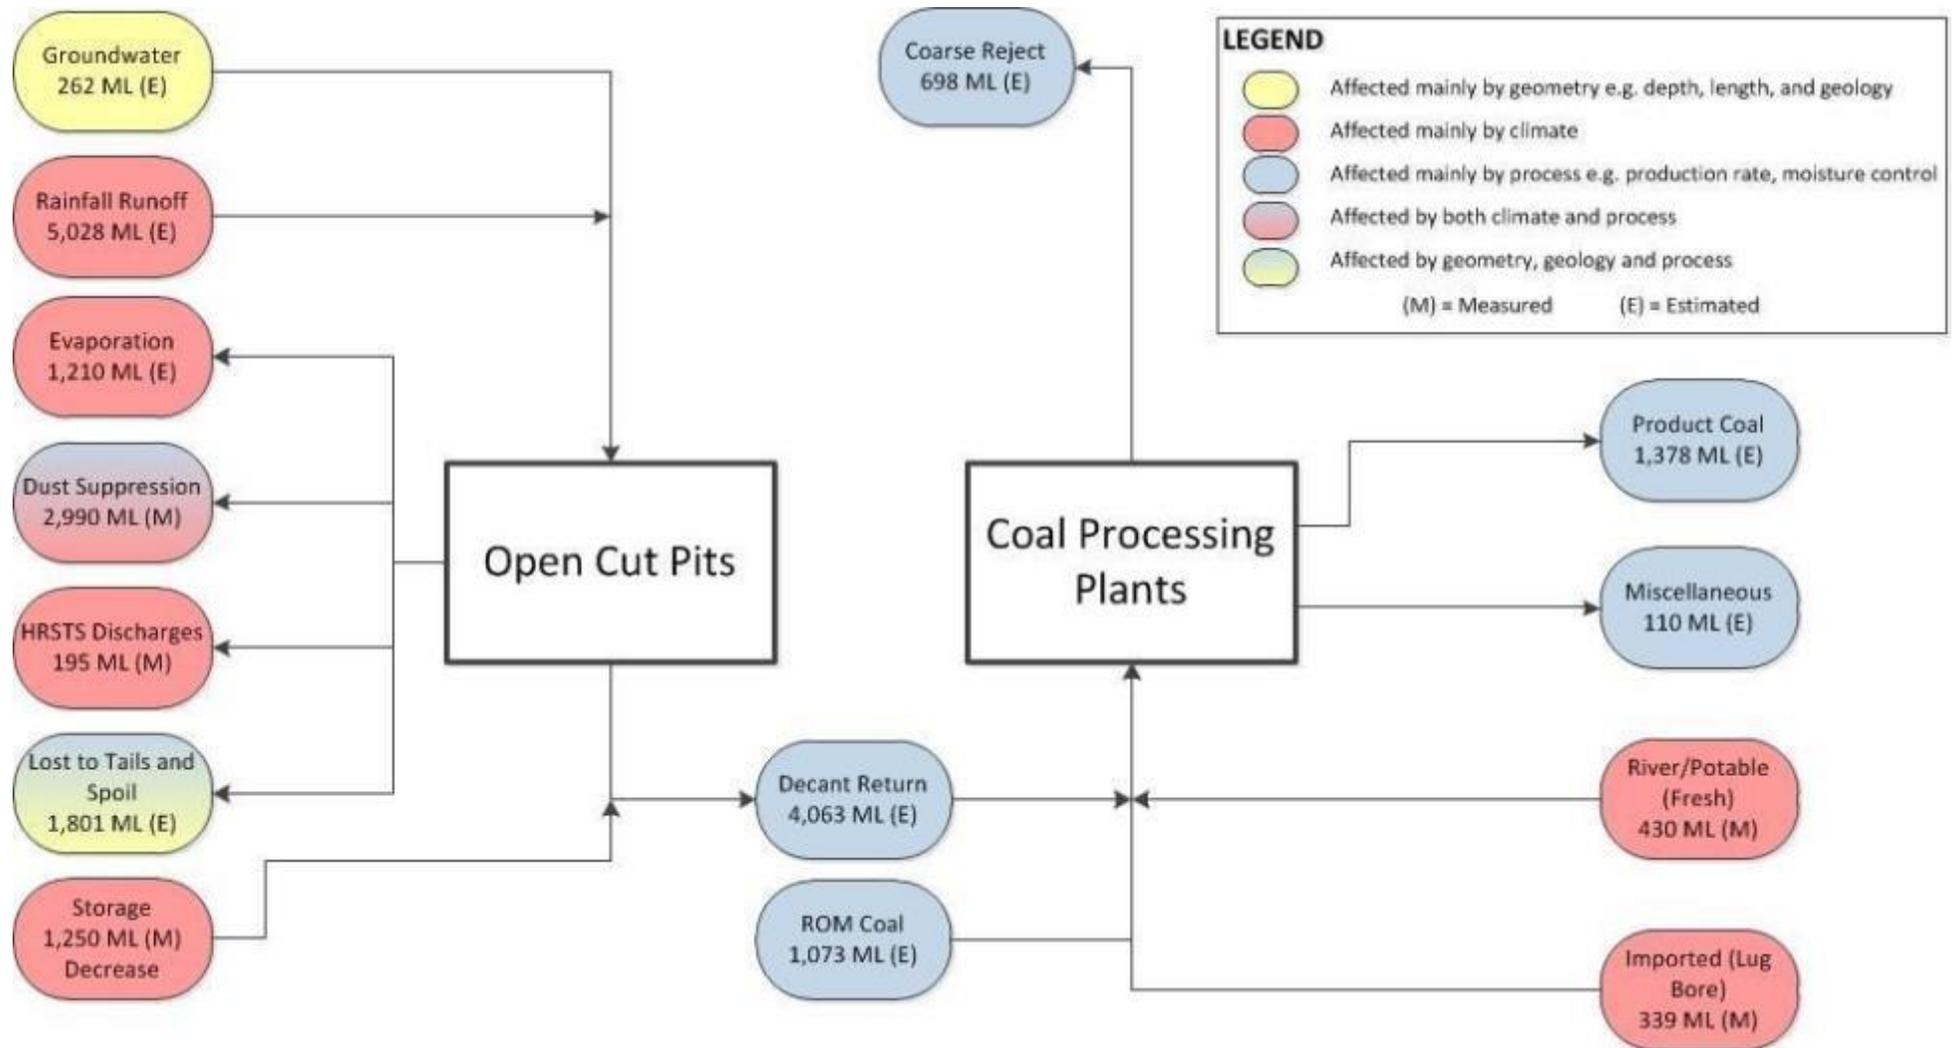
Figure 23: Schematic Diagram MTW Water Flux

Water Stream	Volume (ML) (% Total)
<b>Inputs</b>	
Rainfall Runoff	5,028 (70%)
Hunter River (MTJV supply scheme)	407 (6%)
Potable (Singleton Shire Council / trucked)	23 (<1%)
Groundwater	262 (4%)
Recycled to CHPP from tailings (not included in total)	4,063
Imported (LUG bore)	339 (5%)
Water from ROM Coal	1,073 (15%)
<b>Total Inputs</b>	<b>7,132</b>
<b>Outputs</b>	
Dust Suppression	2,990 (36%)
Evaporation – mine water dams	1,210 (15%)
Entrained in process waste	1,801 (22%)
Discharged (HRSTS)	195 (2%)
Water in coarse reject	698 (8%)
Water in product coal	1,378 (16%)
Miscellaneous use (wash-down etc.)	110 (1%)
<b>Total Outputs</b>	<b>8,382</b>
<b>Change in storage (decreased)</b>	<b>1250</b>

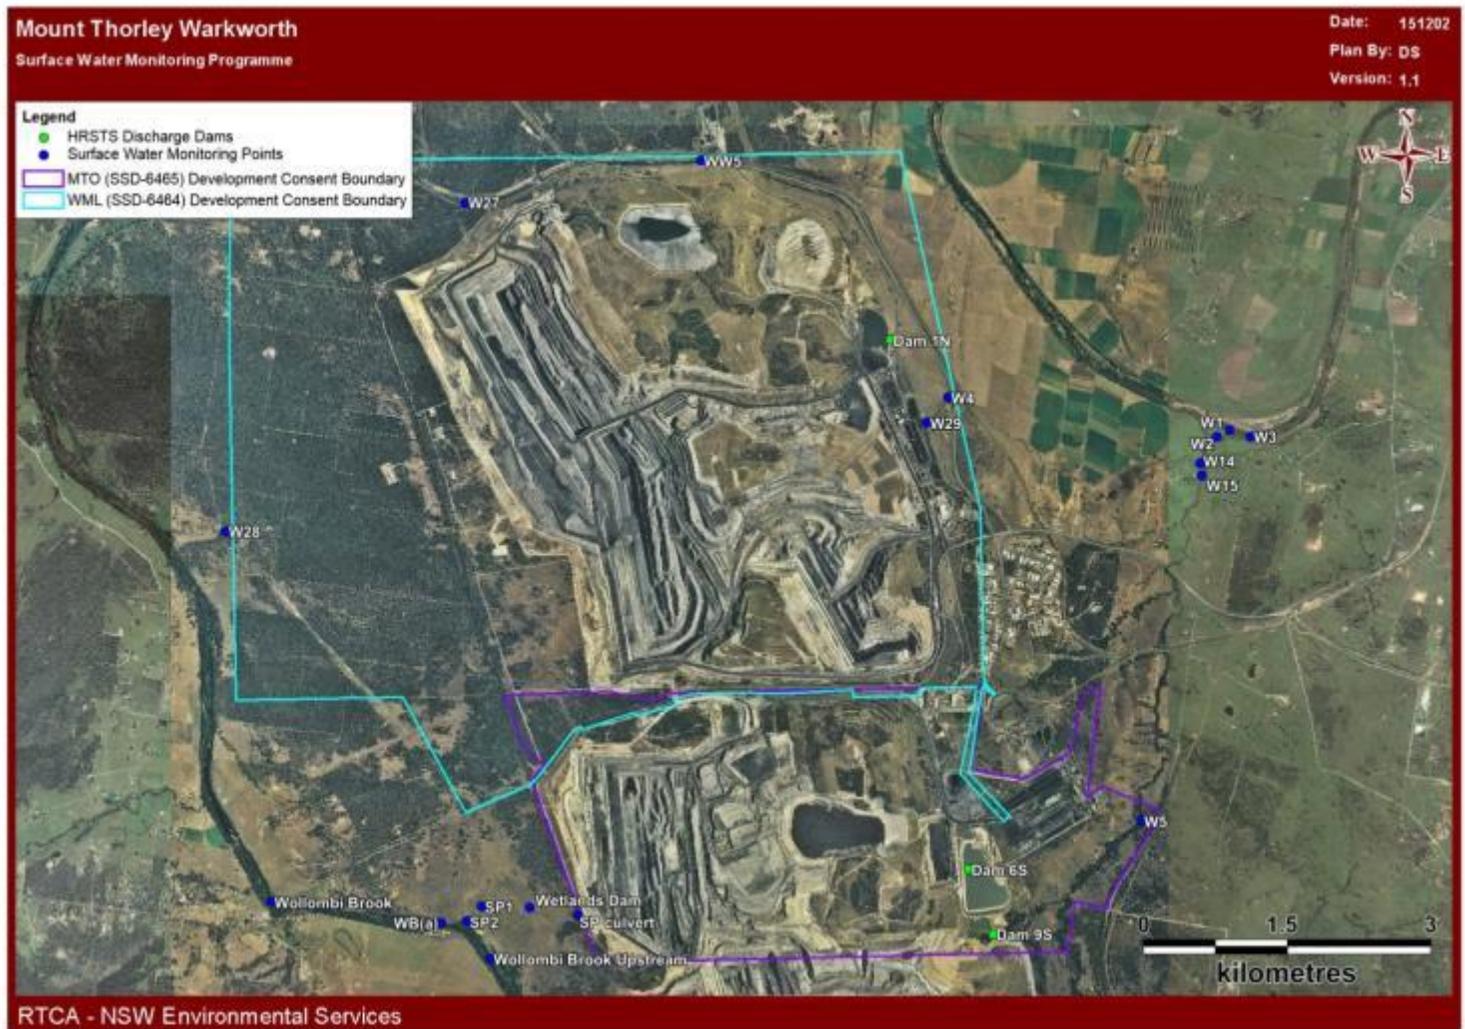
Figure 25: Surface Water Monitoring Points

Surface water monitoring data review involves a comparison of measured pH, EC and TSS results against internal trigger values which have been derived from the historical data set. The response to measured excursions outside the trigger limits is detailed in the MTW Water Management Plan.

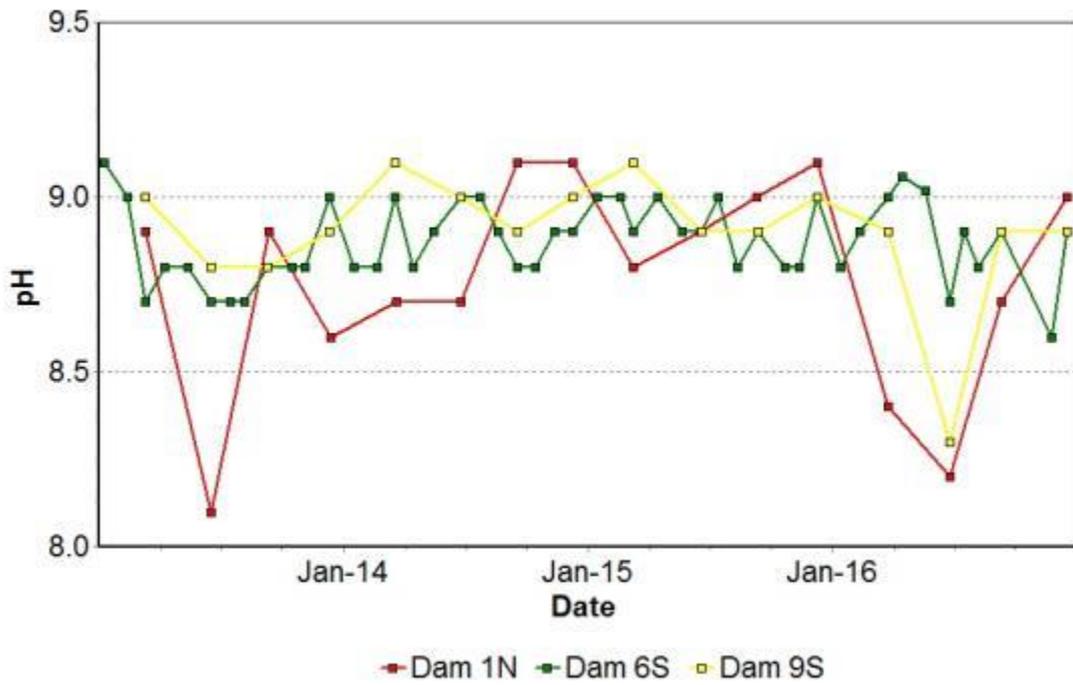
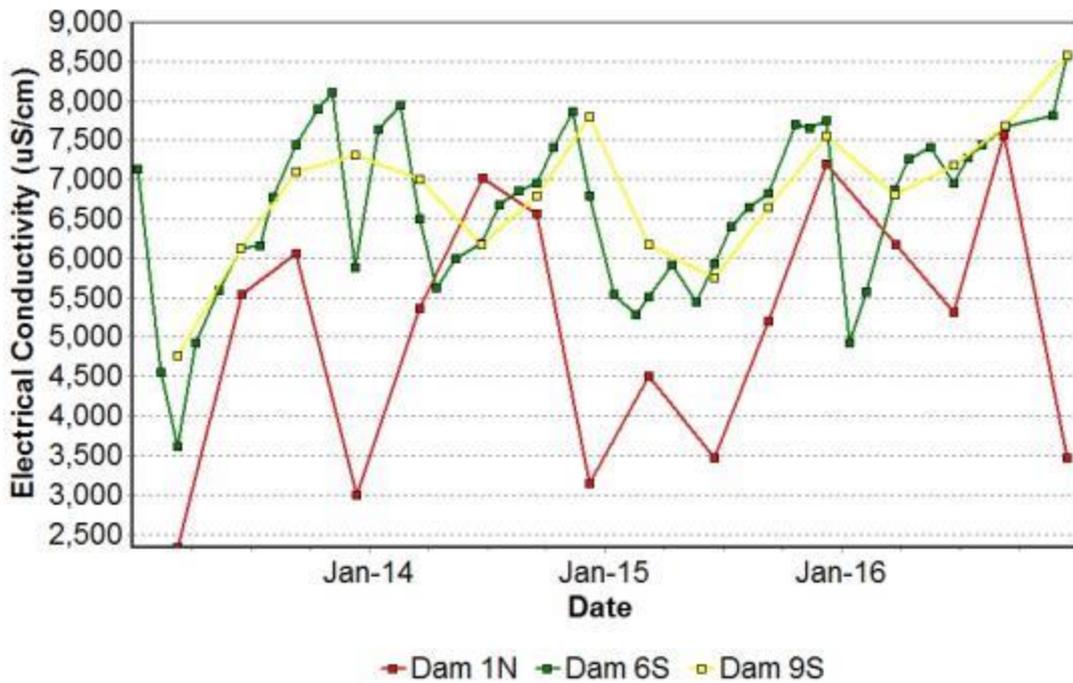
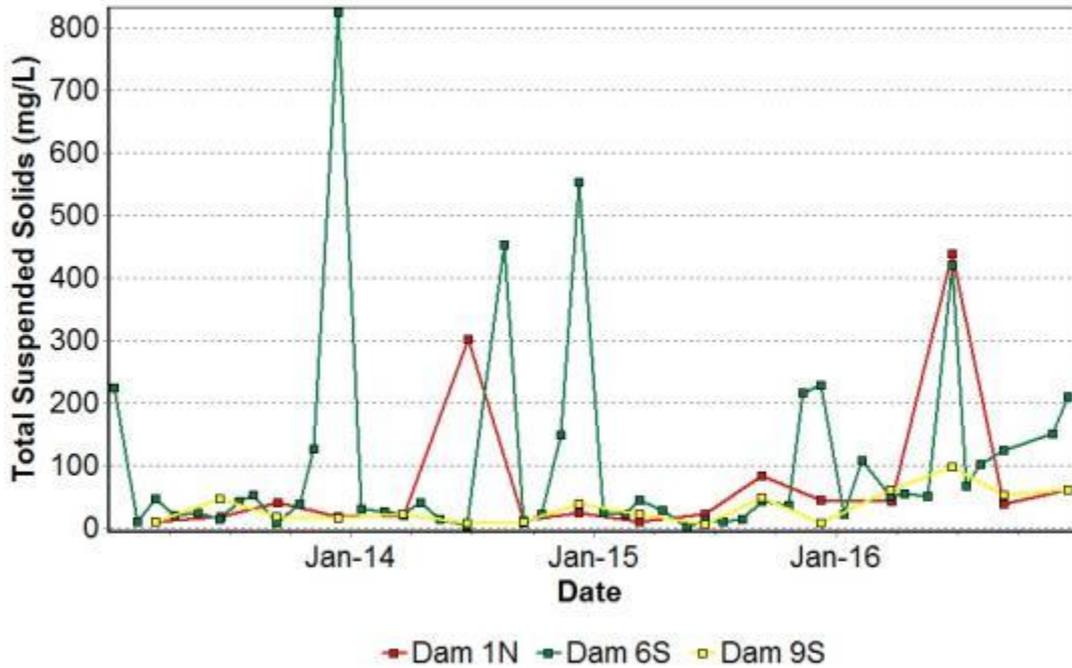
Figure 26 to Figure 31 show long term water quality trends for the Hunter River, Wollombi Brook, other surrounding tributaries and site dams. Measurements of EC and pH were generally stable during the reporting period and consistent with historical seasonal trends. Electrical conductivity shows an increasing trend during 2016 in site Dams 6S and 9S; drier weather conditions resulted in evapo-concentration of salts in mine water, combined with reduced fresh-water inputs from rainfall runoff.

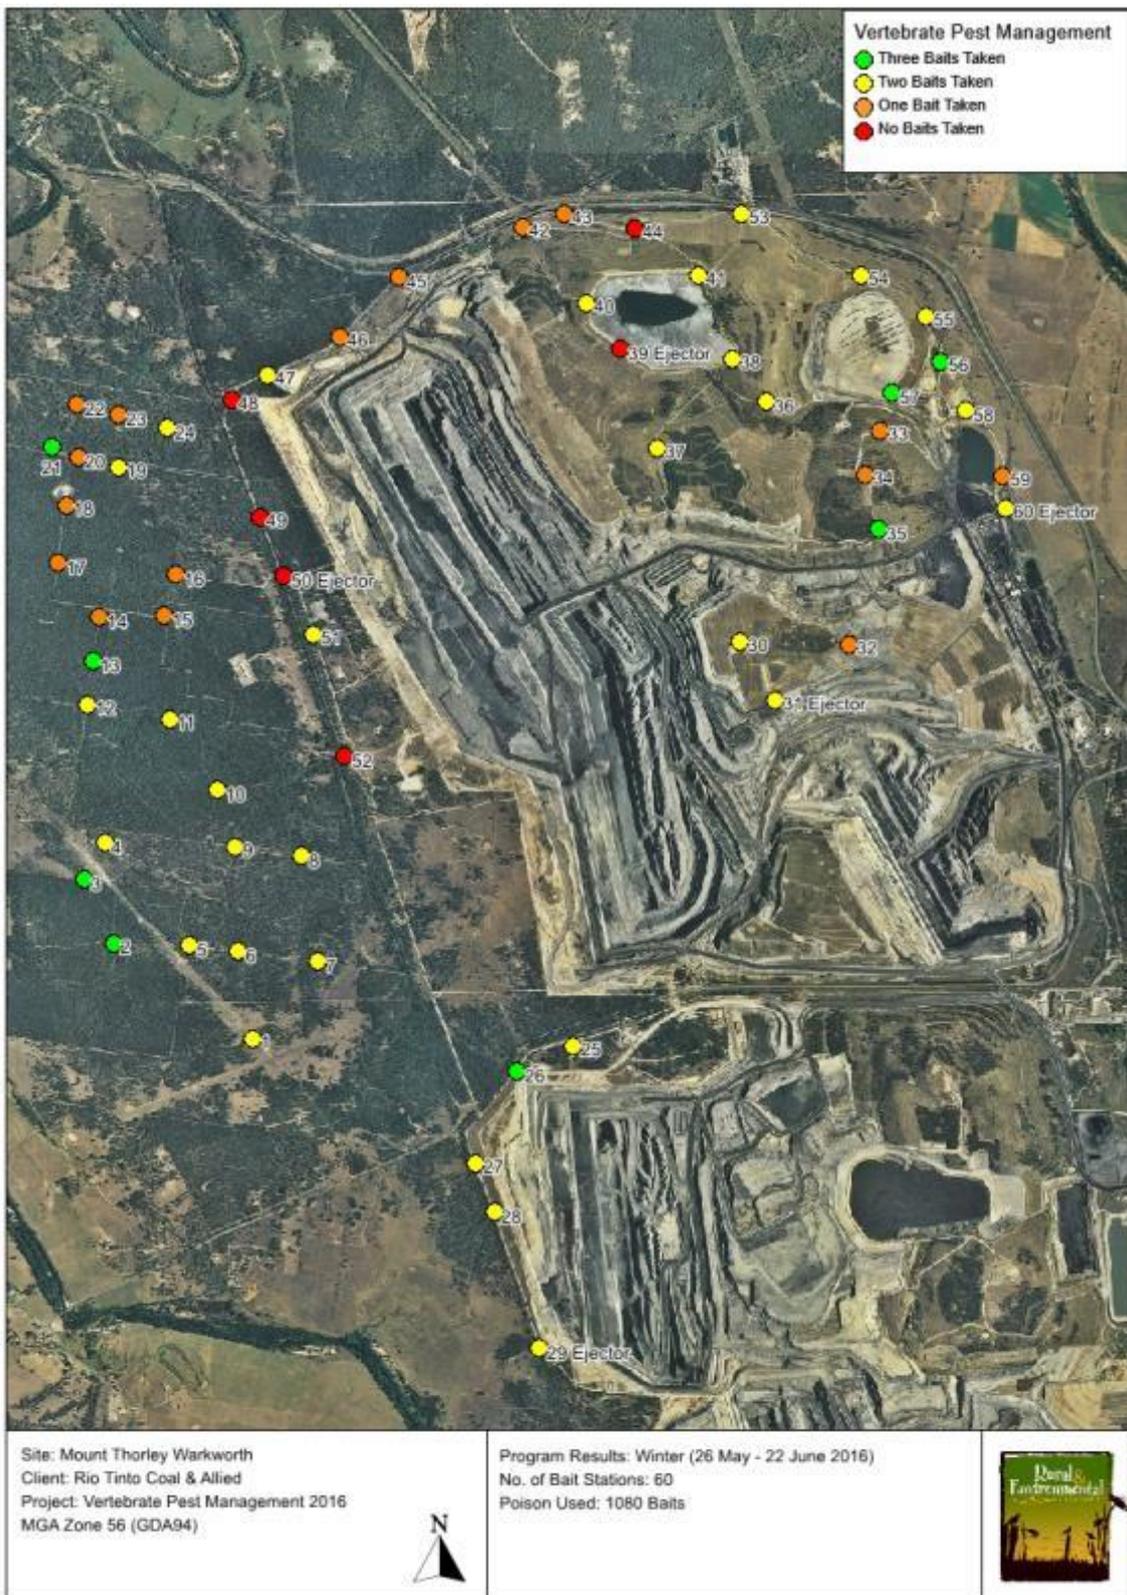
**Figure 78: Baiting Station Locations and Results at MTW during the Winter 2016 Vertebrate Pest Management Programme**

Table 38 summarises the results from the 1080 ground baiting programmes and opportunistic shooting carried out at MTW during 2016. The baiting locations and results for the programmes are illustrated in Figure 77.

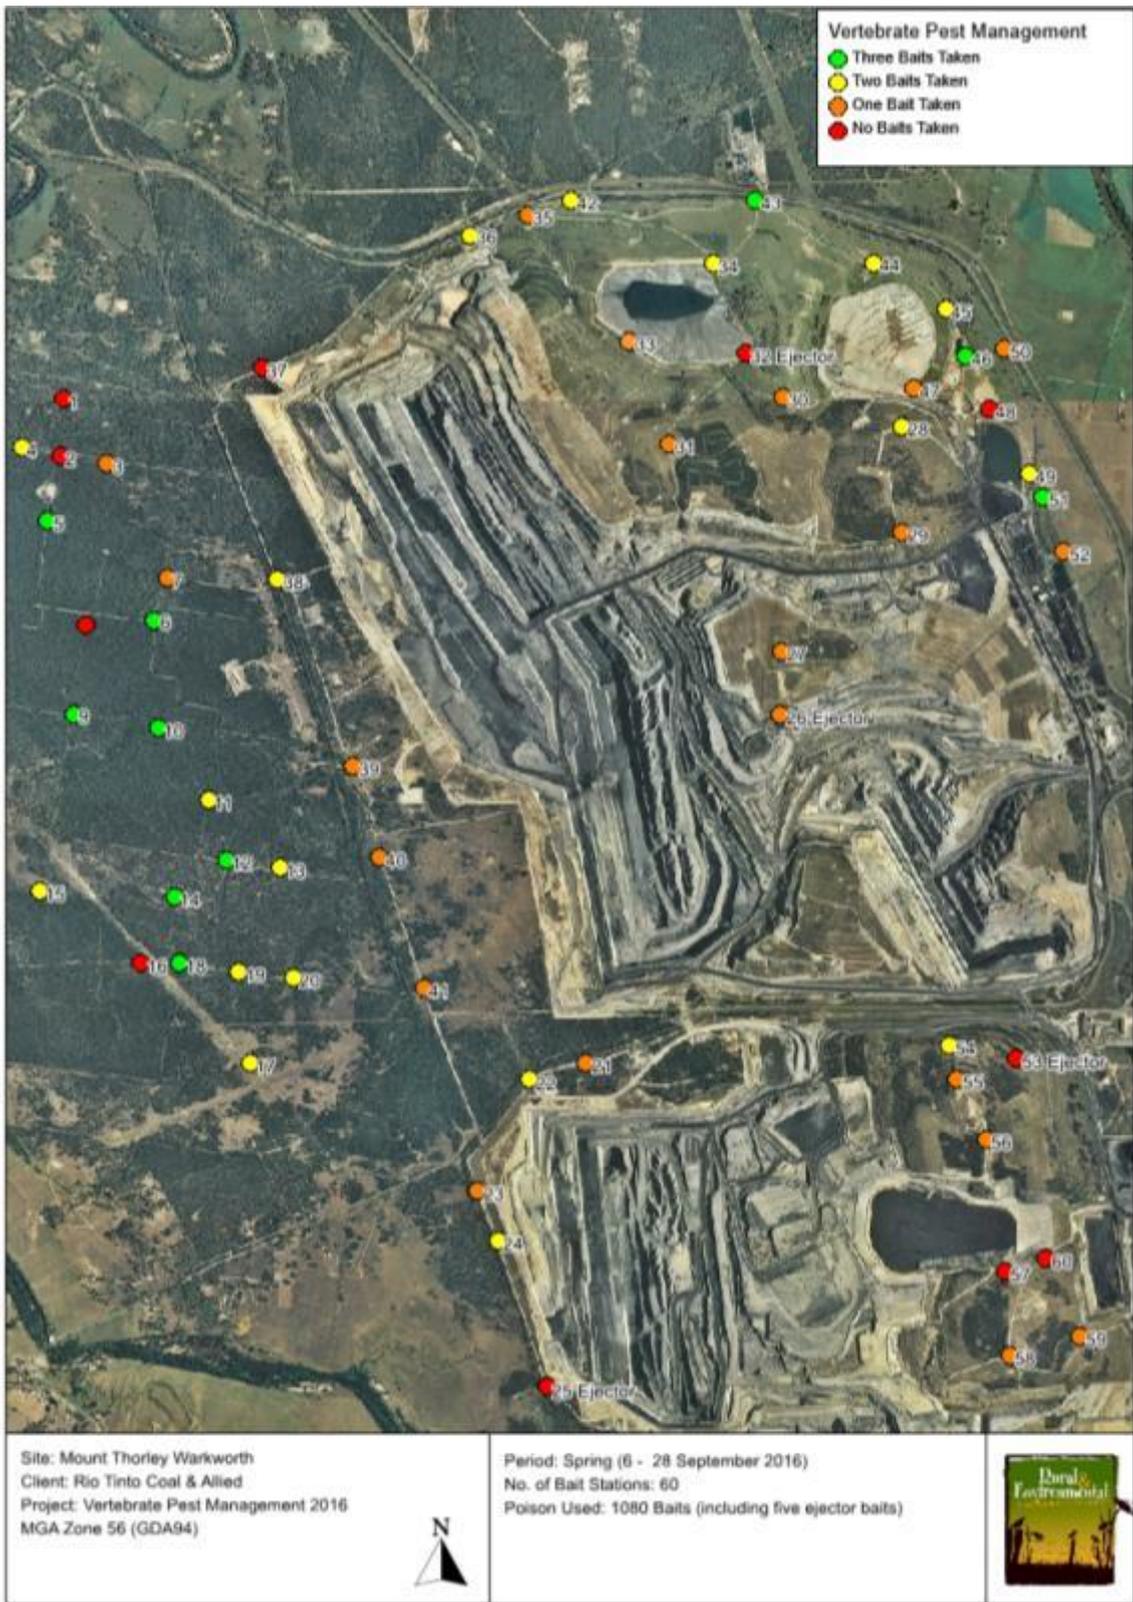
**Figure 79: Baiting Station Locations and Results at MTW during the Spring 2016 Vertebrate Pest Management Programme**

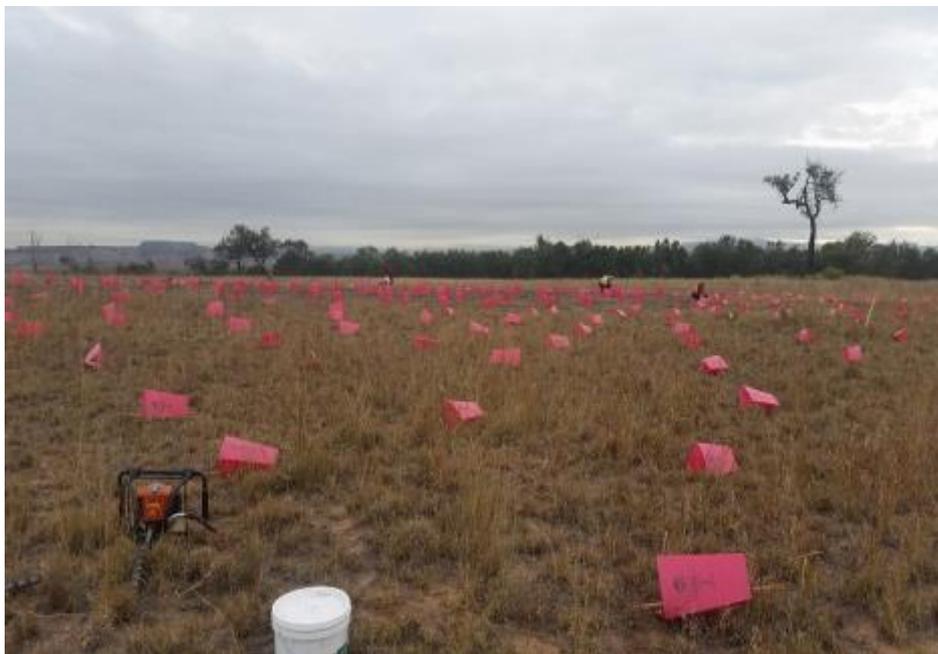
**Figure 80: Installation of tube stock at one of the plots in the Northern Biodiversity Area by Toolijooa Environmental Restoration.**

MTW has committed to restoring the Endangered Ecological Communities of Warkworth Sands Woodland and Central Hunter Grey Box – Ironbark Woodland in the Southern and Northern Biodiversity Areas. Work commenced in 2014 to restore over 80 hectares of Warkworth Sands Woodland, this involved the planting of seedlings and the relocation of sand salvaged ahead of mining activities. In 2016, planting works continued in the Northern Biodiversity Area, with over 8,000 seedlings planted between May and July. The team dug holes for each seedling, either by hand or auger, into 50x50m patches. All plants were watered, fertilised and protected with a tree guard. In total there were 20 patches established, half of these received the addition of topsoil from ahead of mining operations at MTW prior to planting and half received only weed control, to observe if the addition of topsoil improves survival. Within these patches the seedlings are planted at a close spacing to create “stepping stones” between existing remnant vegetation. When these patches grow they will create shelter to support natural regeneration in surrounding areas and over time all of these areas will connect together and create a better habitat for native plants and animals. Restoration activities also commenced in a small area of Ironbark Woodland in the Southern Biodiversity Area, with over 2,000 seedlings planted in July. The site preparation for this site included ripping by tractor and weed control. The team planted the seedlings into rip lines. To mimic nature the tree species were planted at a spacing of 5 -10m and shrubs species planted in clumps as commonly found with understory species within this

vegetation type. All plants were watered, fertilised and protected with a tree guard. The next round of planting is planned for Autumn 2017. Overall there is more than 500 hectares of grassland area to be planted and managed over 15 years to restore these Endangered Ecological Communities.

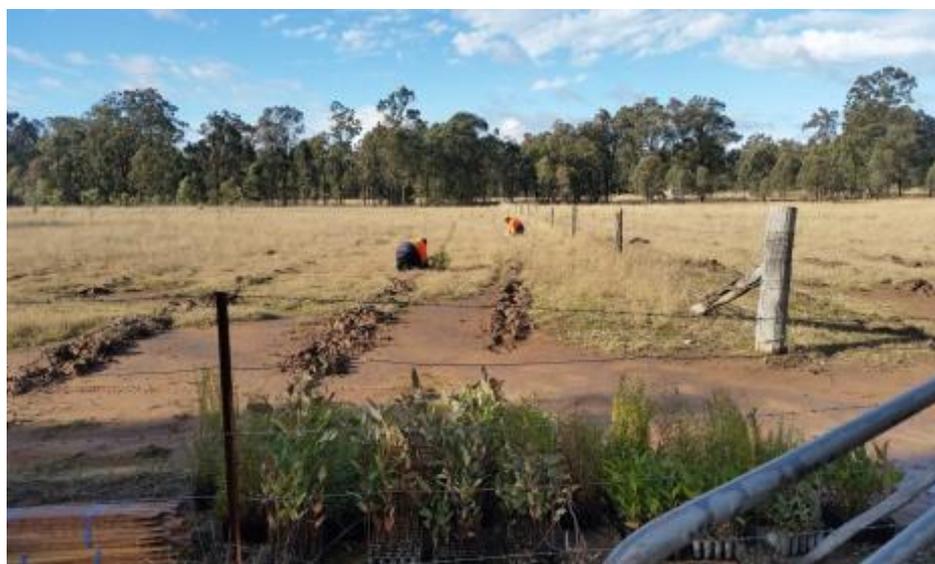
**Figure 81: Installation of tube stock at the Southern Biodiversity Area Toolijooa Environmental Restoration.**
