Monthly Environmental Monitoring Report

Yancoal Mount Thorley Warkworth

March 2023

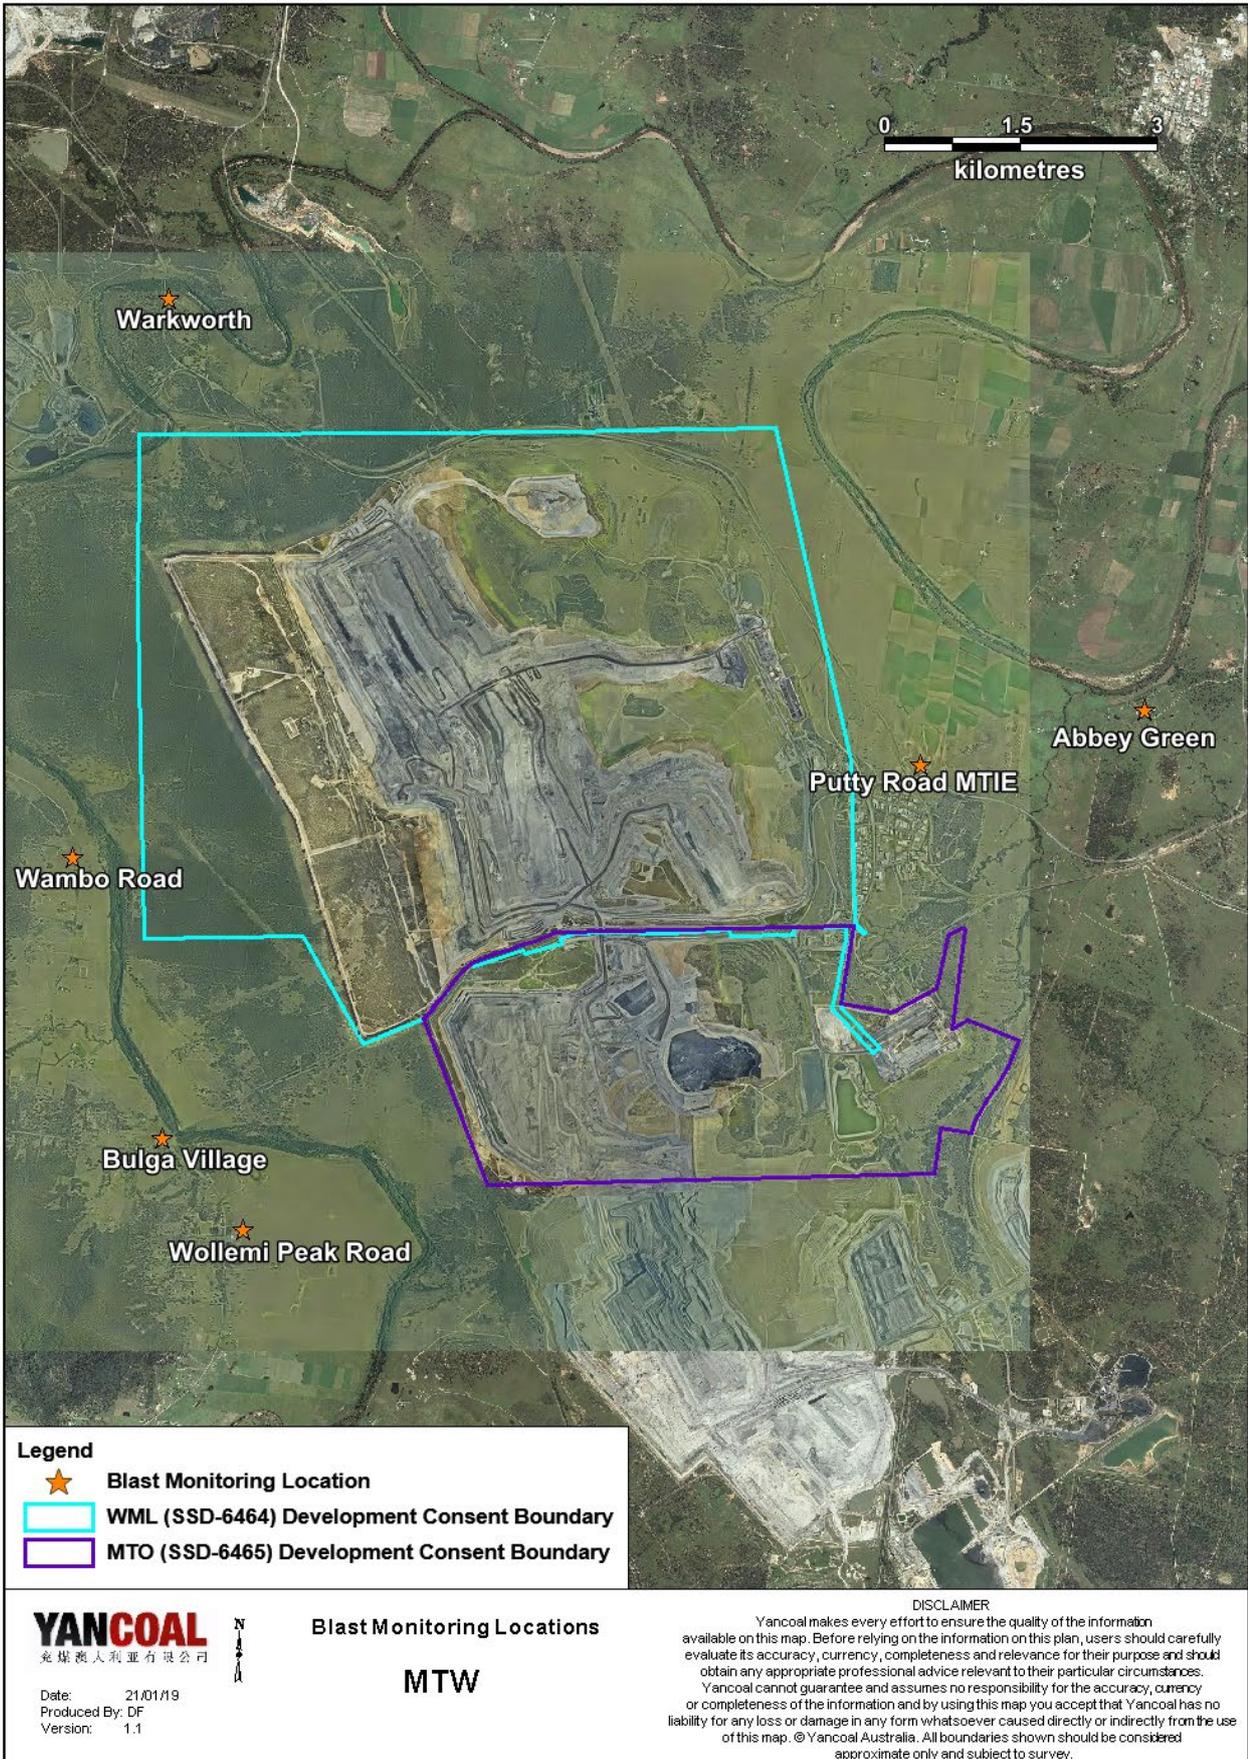
Figure 72: MTW Blast Monitoring Location Plan

MTW have a network of six blast monitoring units. These are located at nearby privately owned residences and function as regulatory compliance monitors.

The location of these monitors can be found in **Figure 72**.
