Monthly Environmental Monitoring Report

Yancoal Mt Thorley Warkworth

December 2020

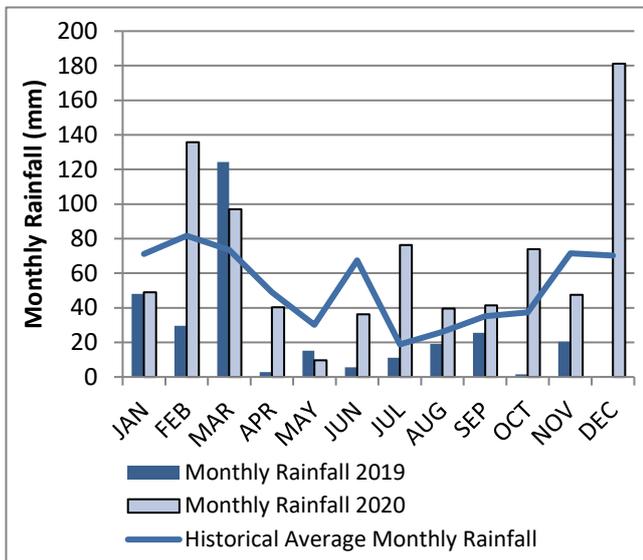
Rainfall for the period is summarised in **Table 1**, the year-to-date trend and historical trend are shown in **Figure 1**.

Note: The historical average monthly rainfall is calculated from 2007 to 2019 monthly totals

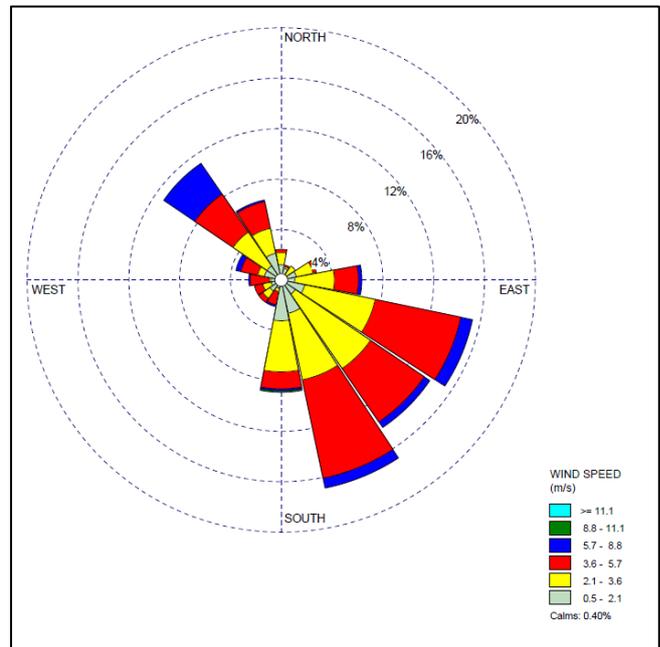
Figure 2: Charlton Ridge Wind Rose – December 2020

Winds from the south east were dominant throughout the reporting period as shown in **Figure 2**.

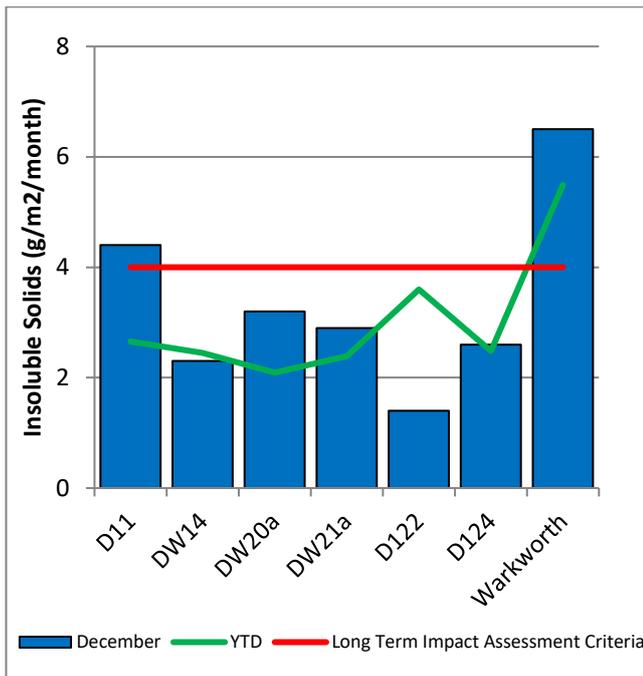
Figure 4: Depositional Dust - December 2020

Figure 4 displays insoluble solids results from depositional dust gauges during the reporting period compared against the year-to-date average and the annual impact assessment criteria.

During the reporting period the D11 and Warkworth monitors recorded monthly results above the long-term impact assessment criteria of 4.0 g/m² per month. There is no evidence to suggest that the D11 or Warkworth results are contaminated. Accordingly, the results will be included in the annual average calculation.

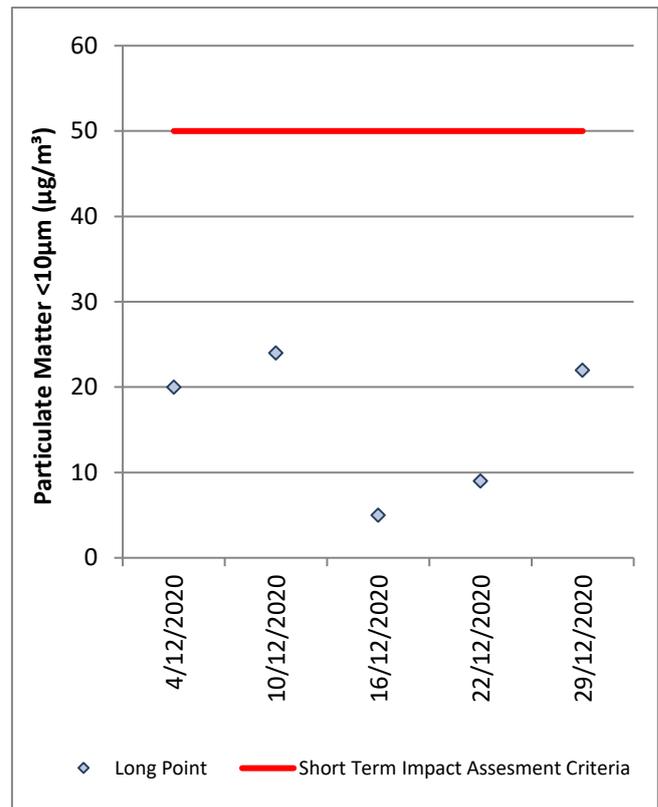
Figure 5: Individual PM₁₀ Results – December 2020

Figure 5 shows the individual PM₁₀ results at the monitoring station against the short-term impact assessment criteria of 50µg/m³.

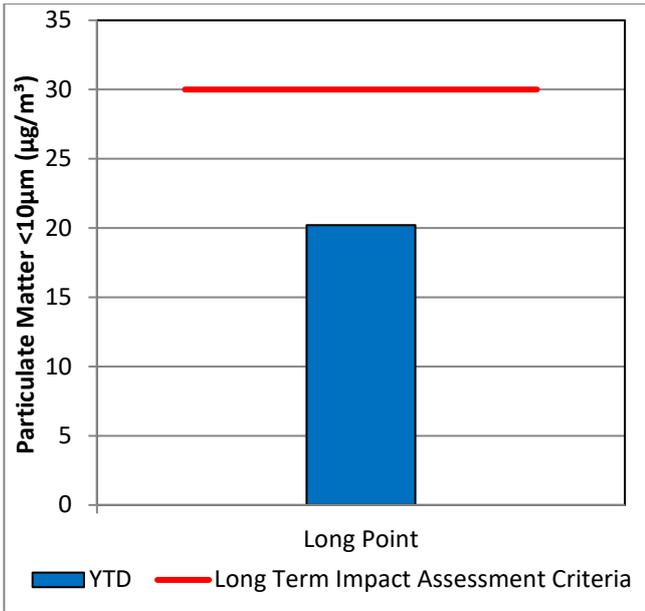
Figure 6: Annual Average PM₁₀ – December 2020

Figure 6 shows the annual average PM₁₀ results against the long-term impact assessment criteria.

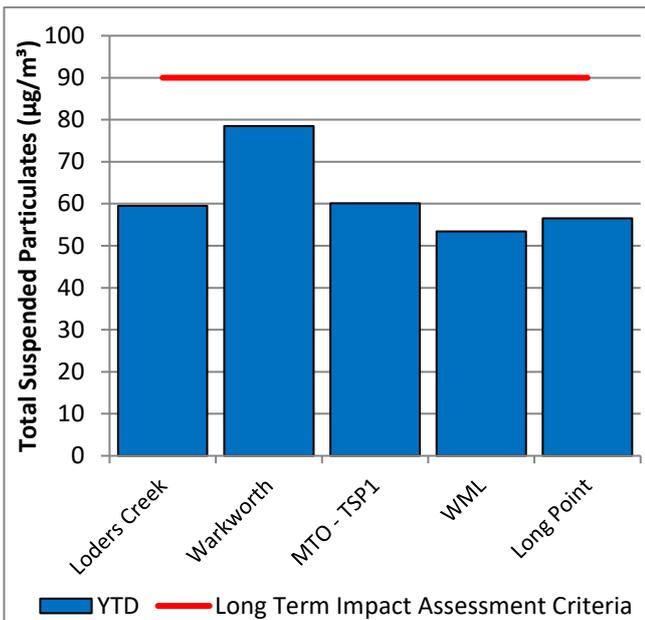
Figure 7: Annual Average Total Suspended Particulates – December 2020

Figure 7 shows the annual average TSP results compared against the long-term impact assessment criteria of 90µg/m³.

Data was not available on 4 December 2020 from the Warkworth HVAS likely due to a power outage.

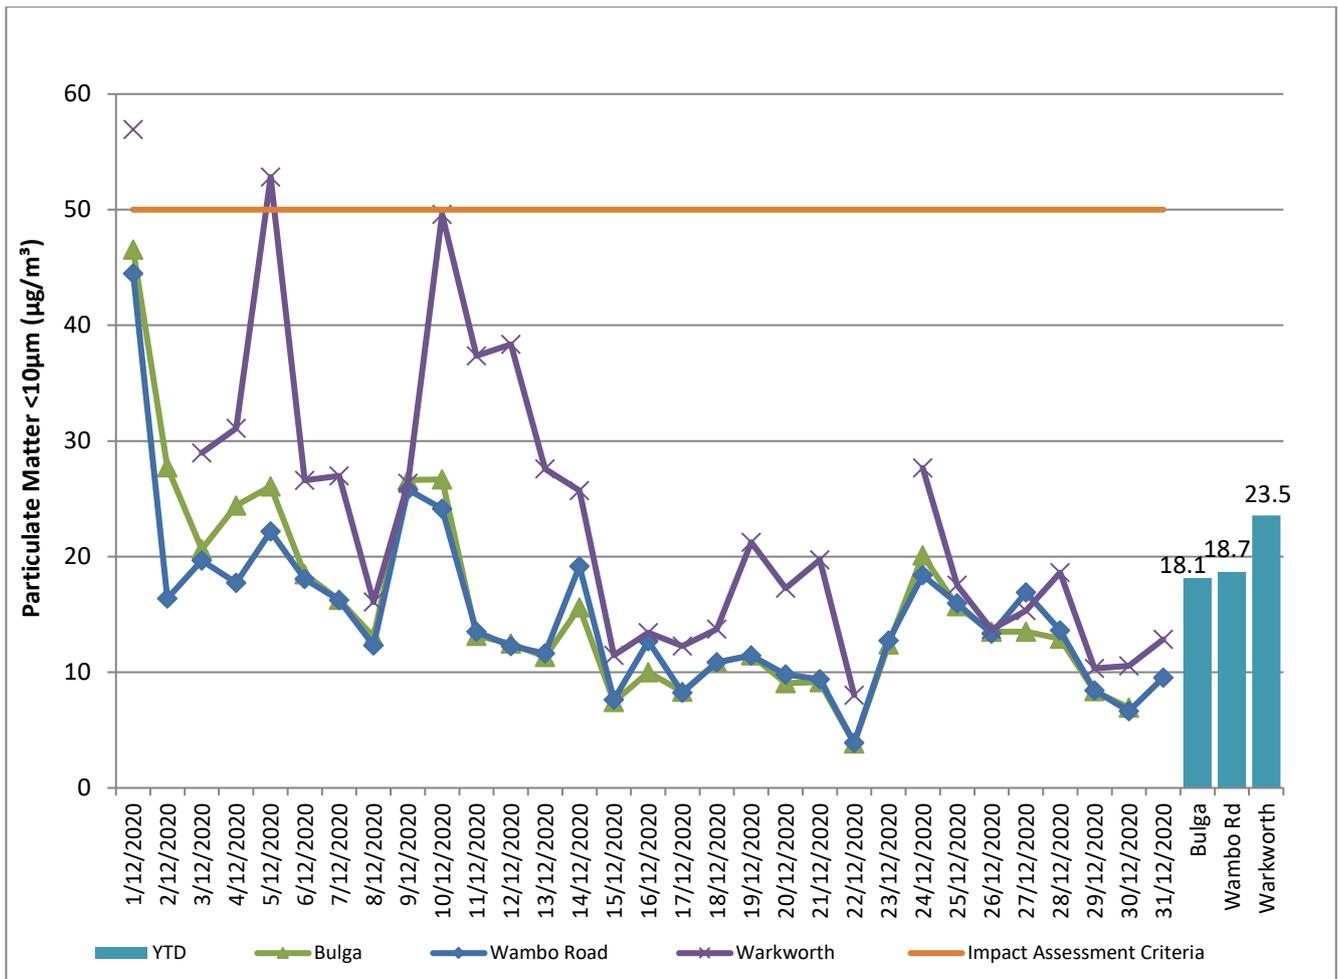
Figure 8: Real Time PM10 24hr average and Year-to-date average – December 2020

Results for real time dust sampling are shown in Figure 8, including the daily 24-hour average PM₁₀ result and the annual PM₁₀ average.

On 1 December 2020, the Warkworth TEOM (56.9µg/m³) exceeded the short term (24hr) criteria. The measurement was assessed for MTW’s potential contribution based on meteorological conditions on this day resulting in a maximum estimated contribution of ~29.5µg/m³, less than a 52% contribution to the result. Accordingly, no further action is required (as per approved Air Quality Monitoring Programme).

On 5 December 2020, the Warkworth TEOM (52.8µg/m³) exceeded the short term (24hr) criteria. The measurement was assessed for MTW’s potential contribution based on meteorological conditions and background PM₁₀ levels on this day resulting in a maximum estimated contribution of 26.8µg/m³, less than a 51% contribution to the result. Accordingly, no further action is required (as per approved Air Quality Monitoring Programme).

Data was not available on 2 or 23 December 2020 from the Warkworth TEOM due to equipment issues.

Note: The Year to Date (YTD) PM10 average result for the Wambo Road monitoring location has been calculated using data from the Wallaby Scrub Road TEOM location for January 2020 and from the Wambo Road TEOM from February 2020 onwards.

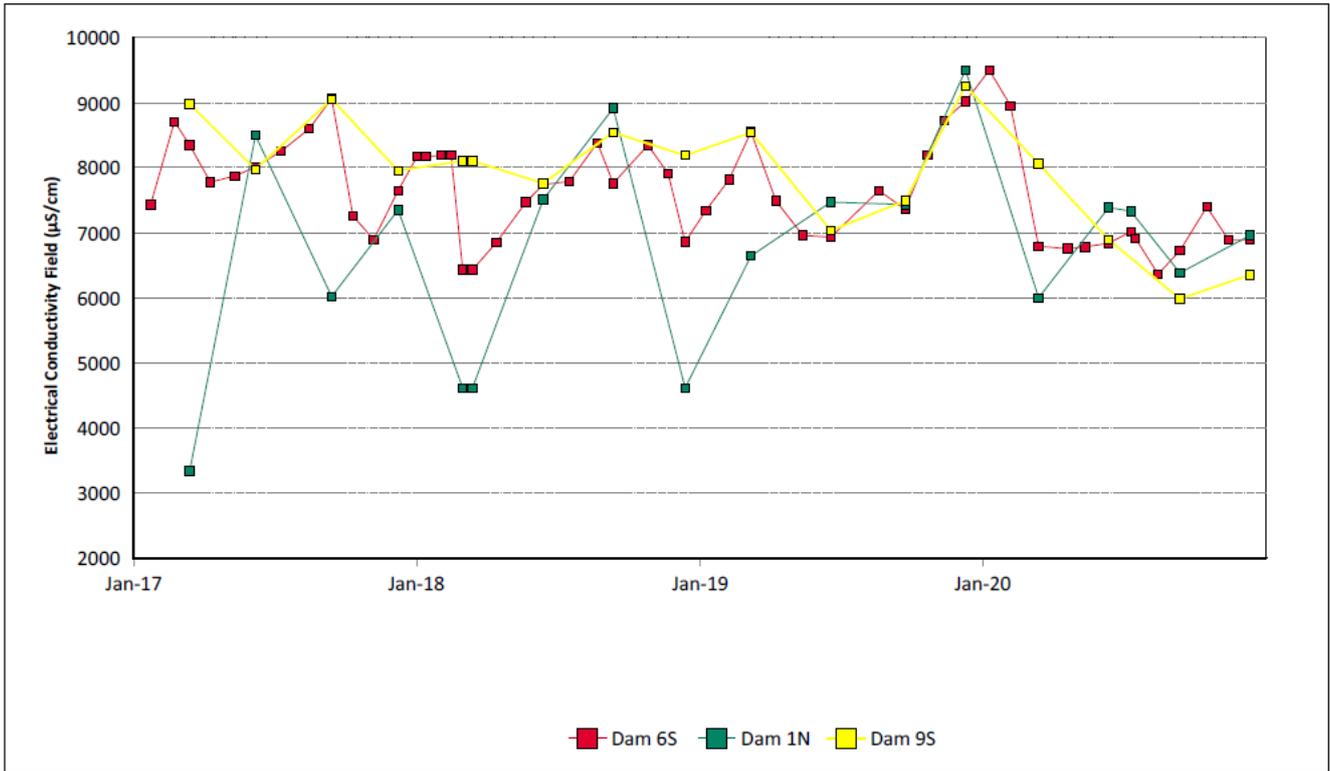
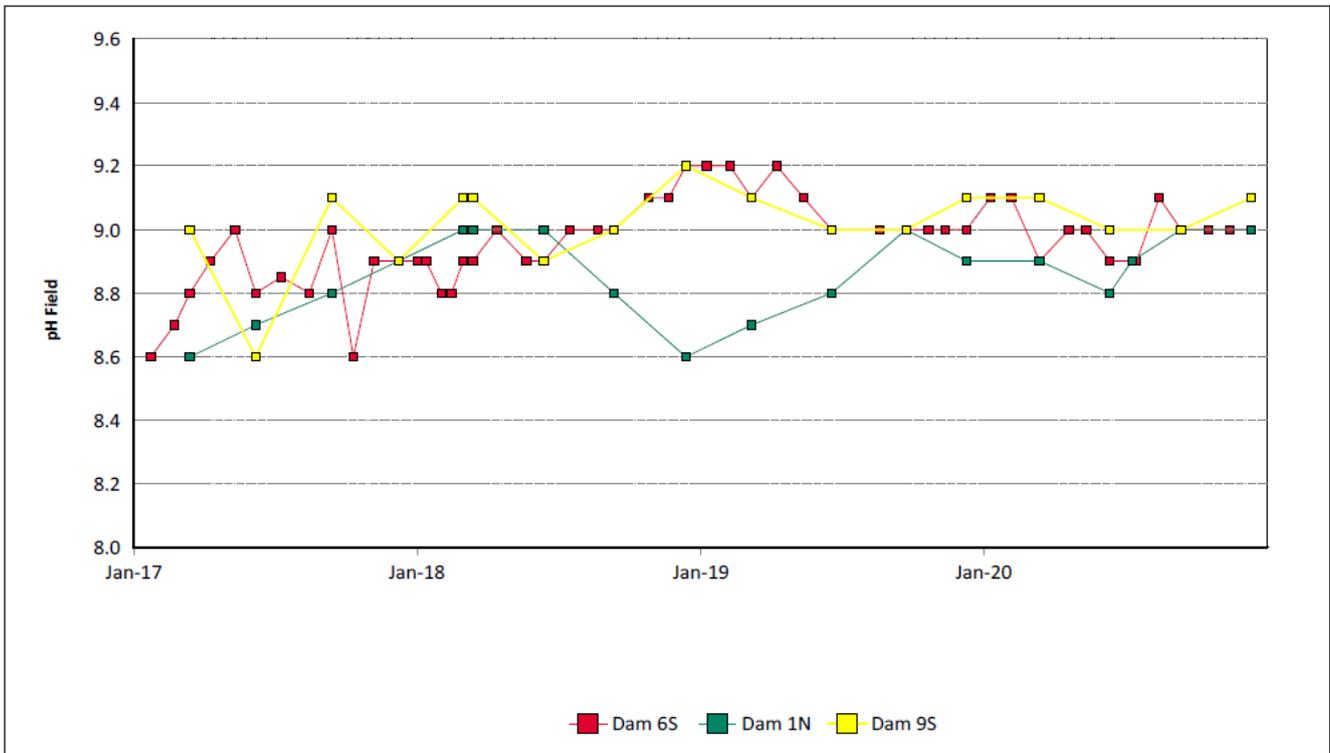
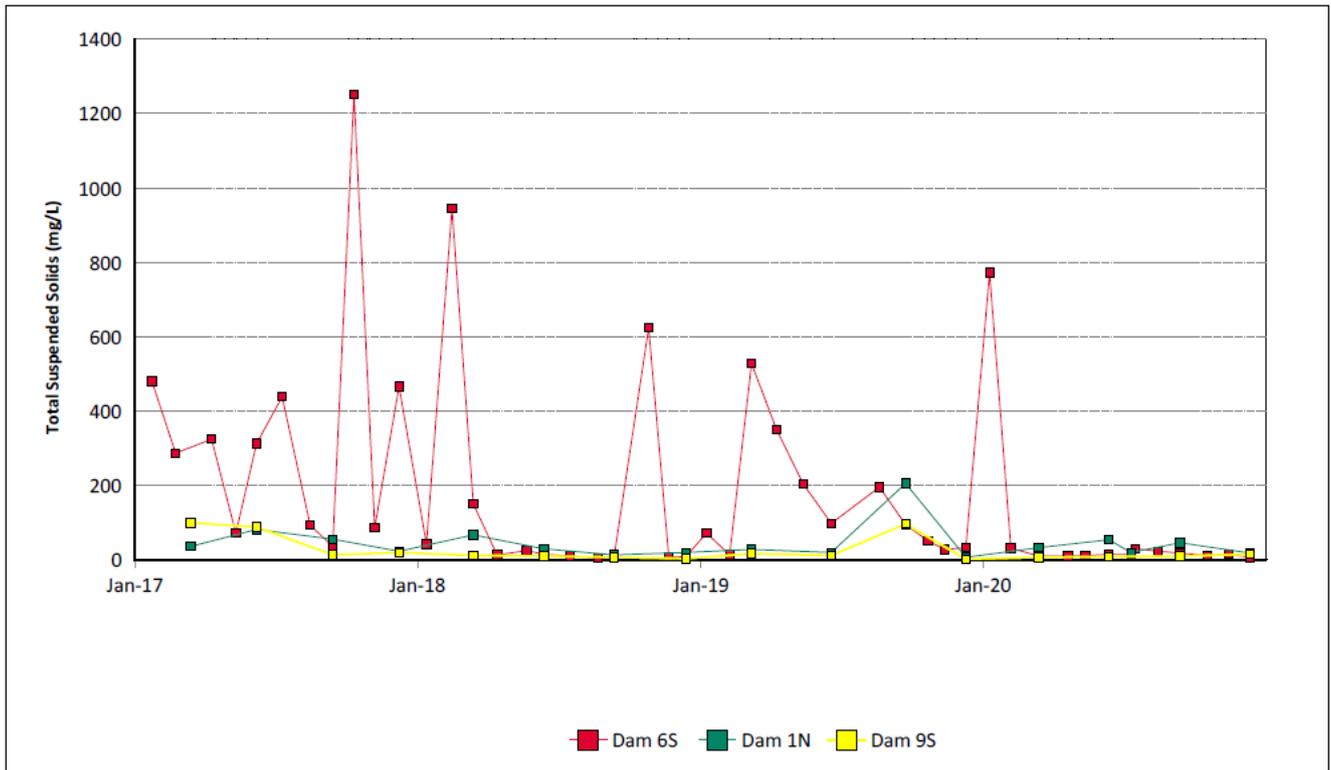
Figure 9 to Figure 11 show the long-term surface water trend (2017 – current) within MTW mine dams. Figure 12 to Figure 14 show the long-term surface water trend (2017 - current) in surrounding watercourses.

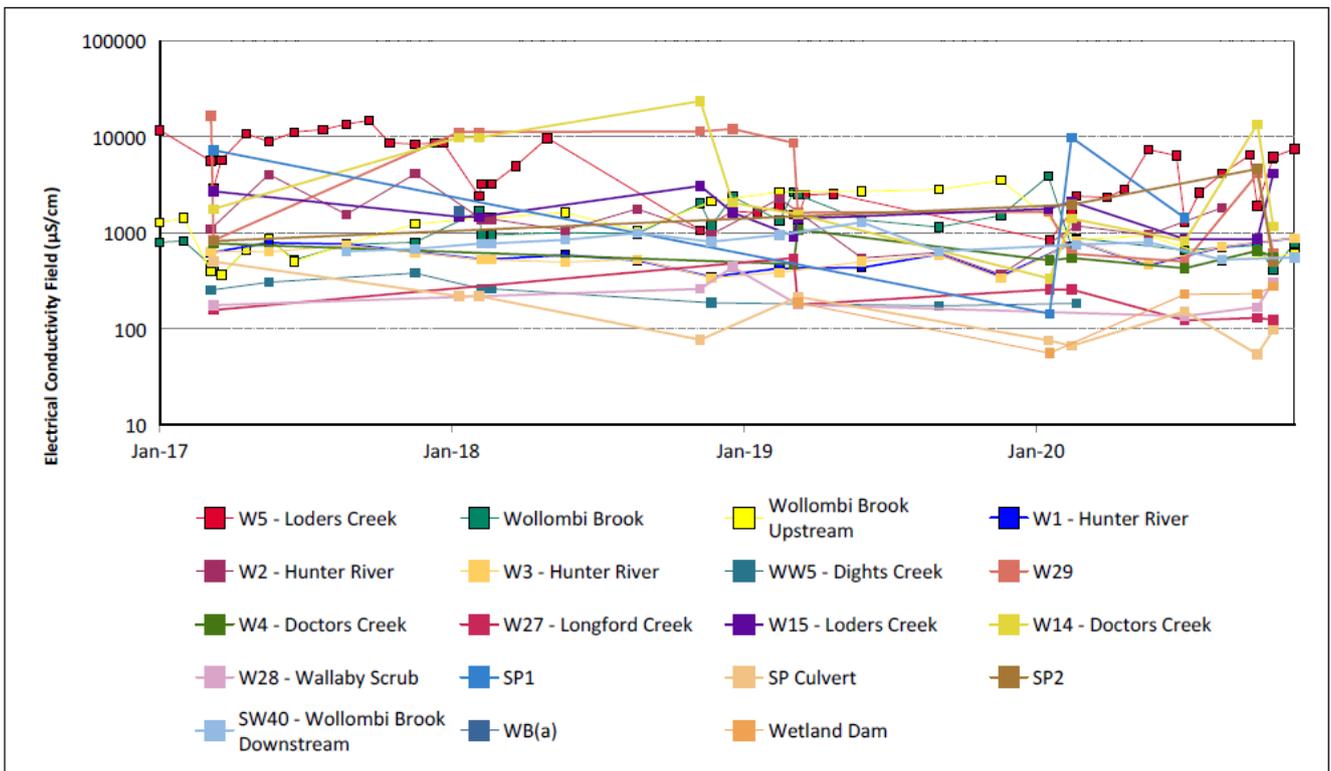
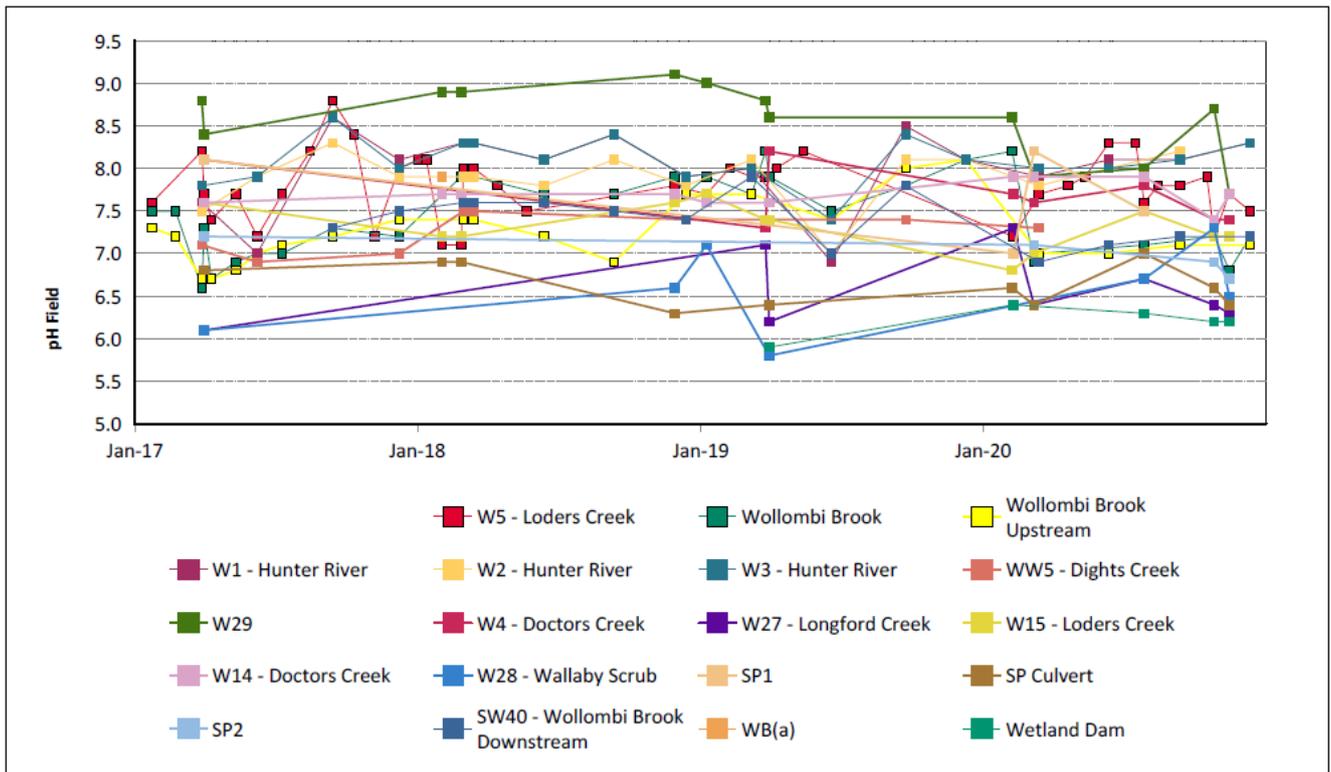
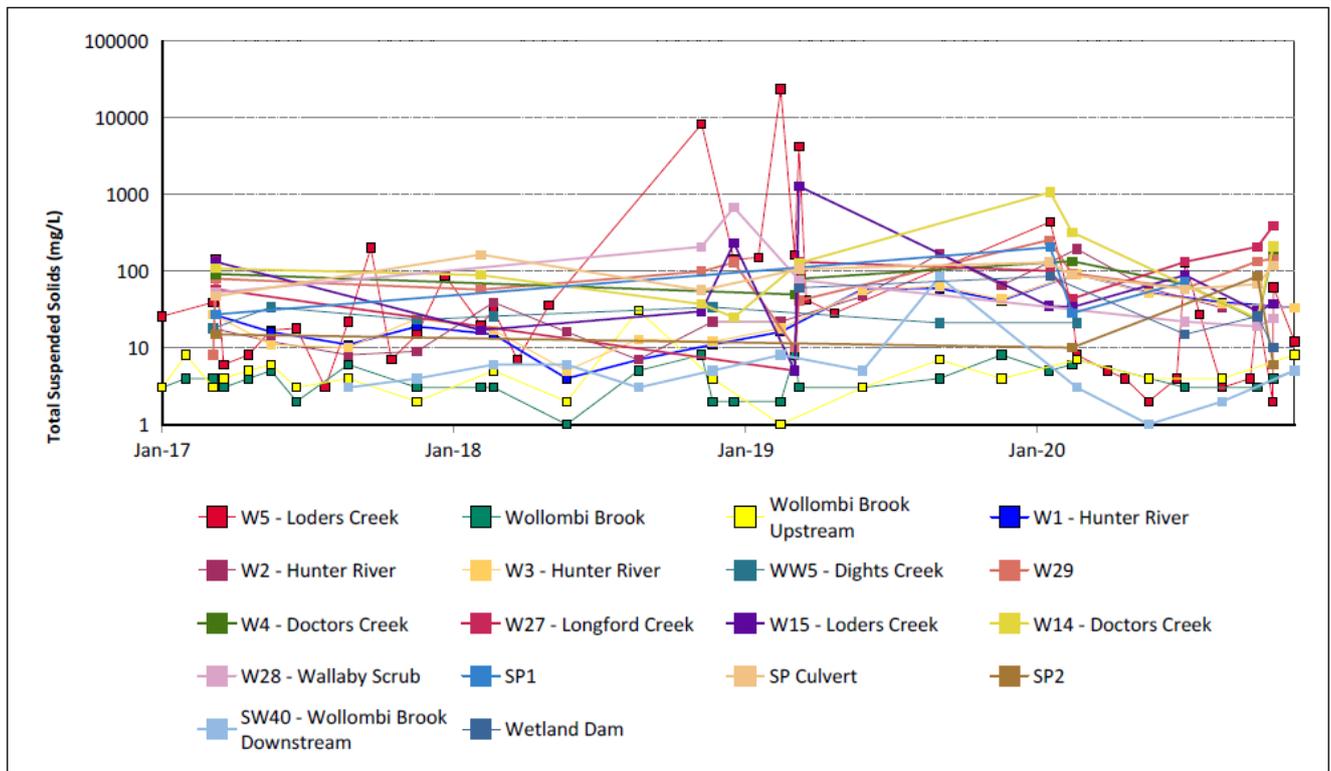
Note: Missing data indicates that there was insufficient water to take a sample, or that there was no safe access.

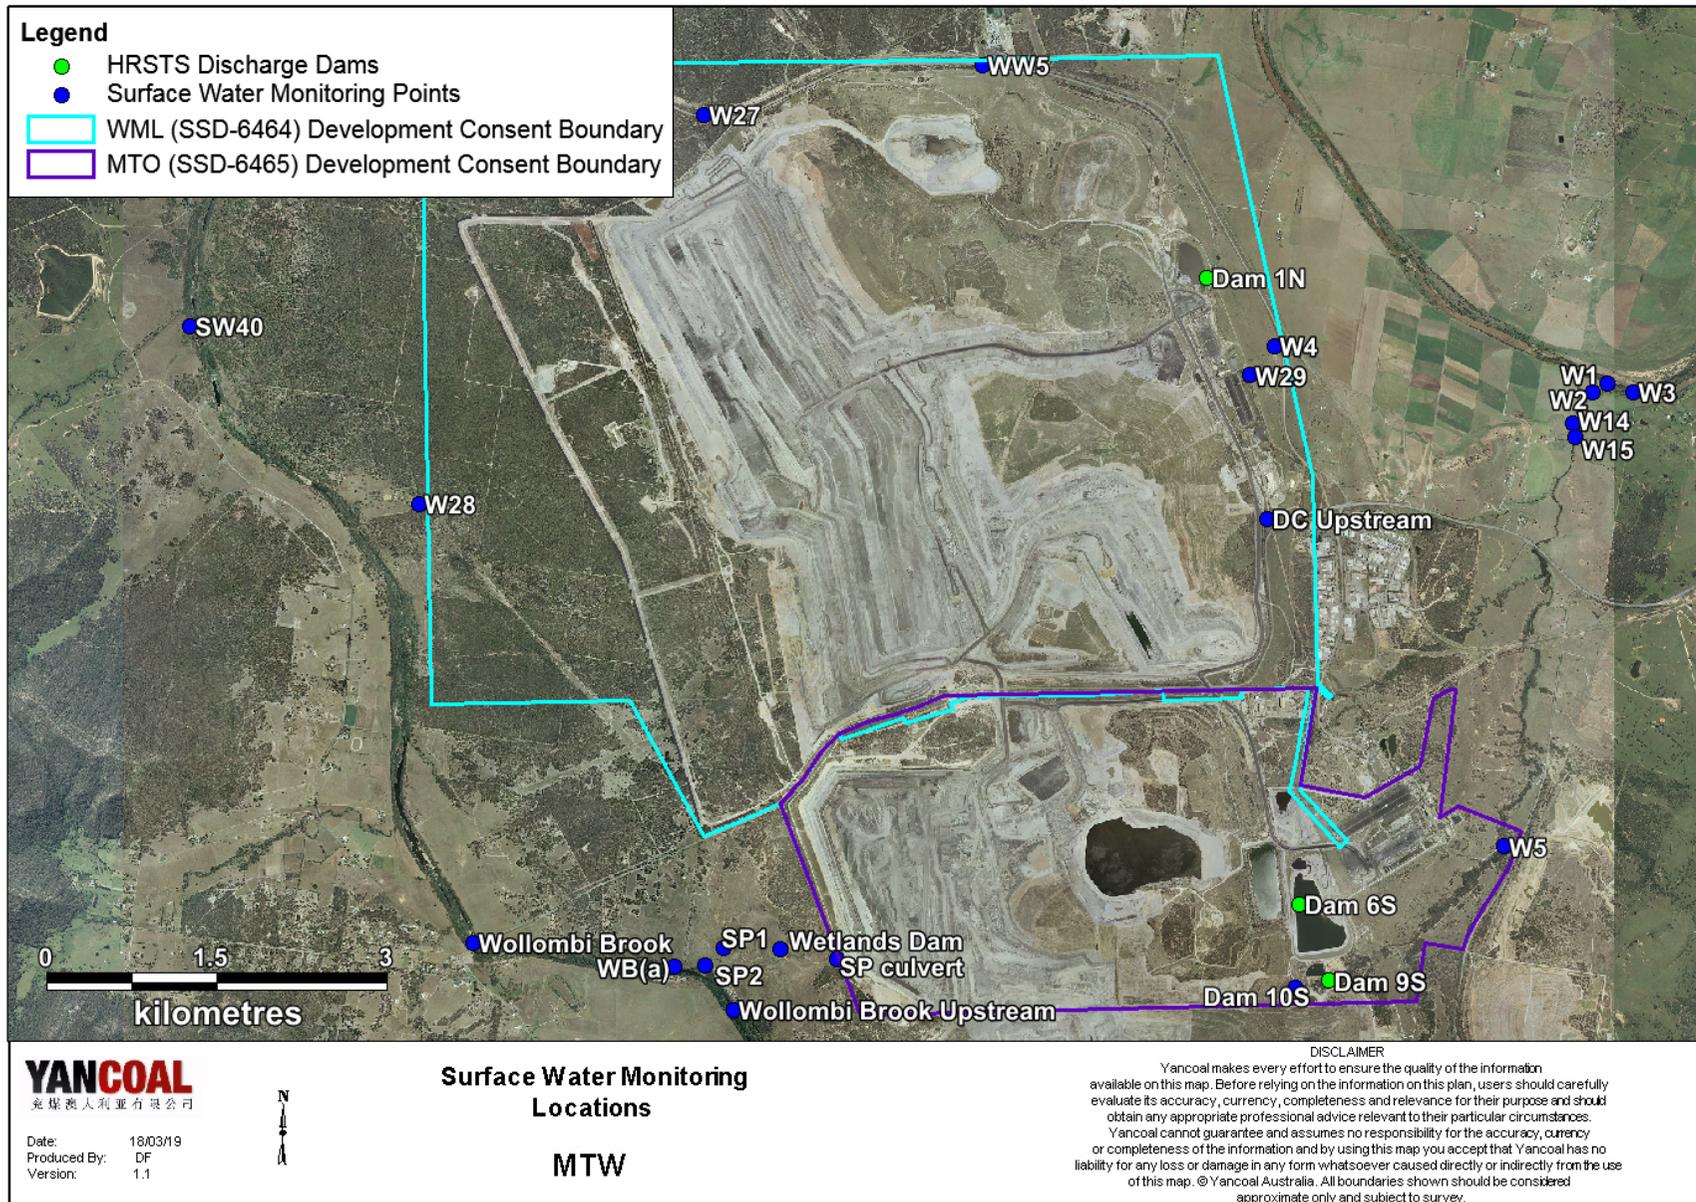
Figure 15: Surface Water Monitoring Location Plan

Monitoring is conducted at mine site dams and surrounding natural watercourses. The surface water monitoring locations are outlined in Figure 15.

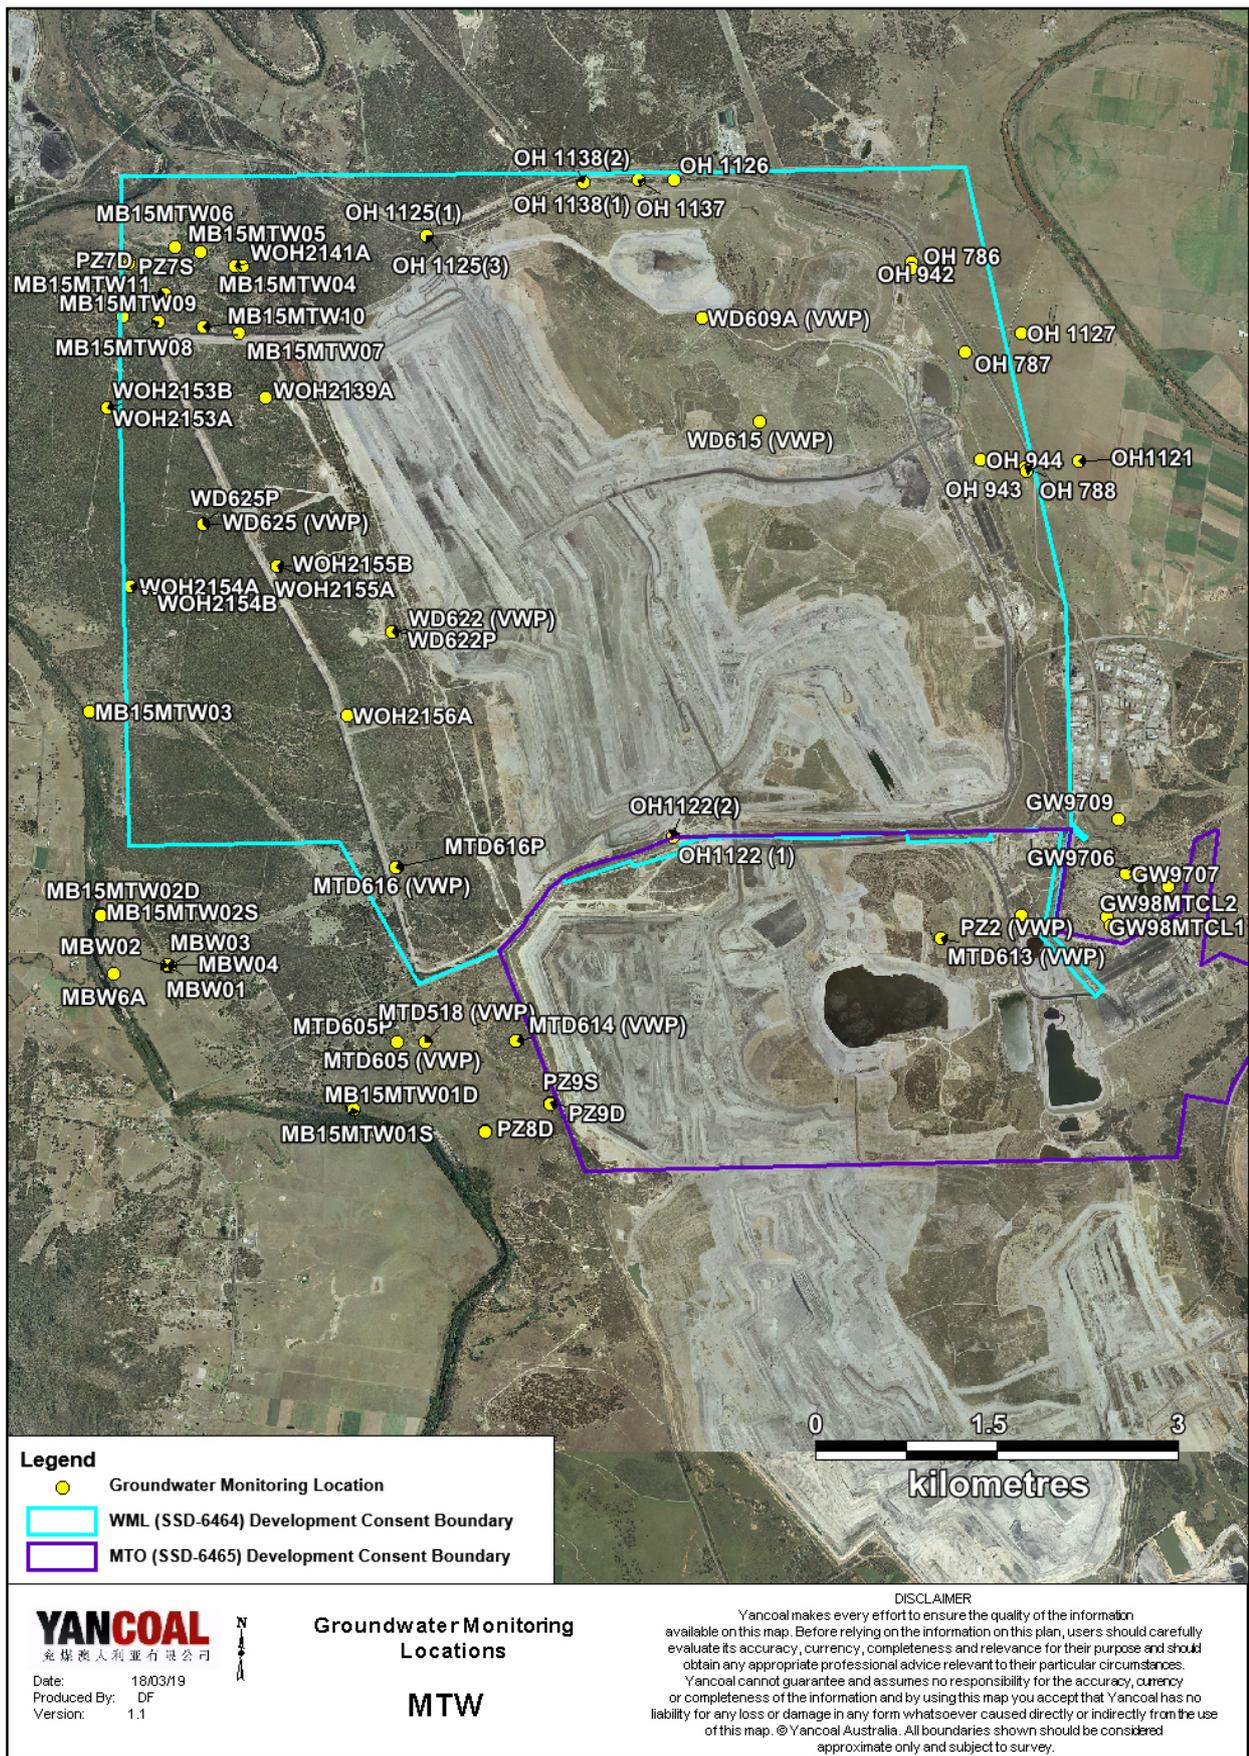
Figure 62: Groundwater Monitoring Location Plan

Internal trigger limits have been developed to assess monitoring data on an on-going basis, and to highlight potentially adverse groundwater impacts. The process for evaluating monitoring results against the internal triggers and subsequent responses are outlined in the MTW Water Management Plan. Locations of groundwater bores are shown in **Figure 62**.

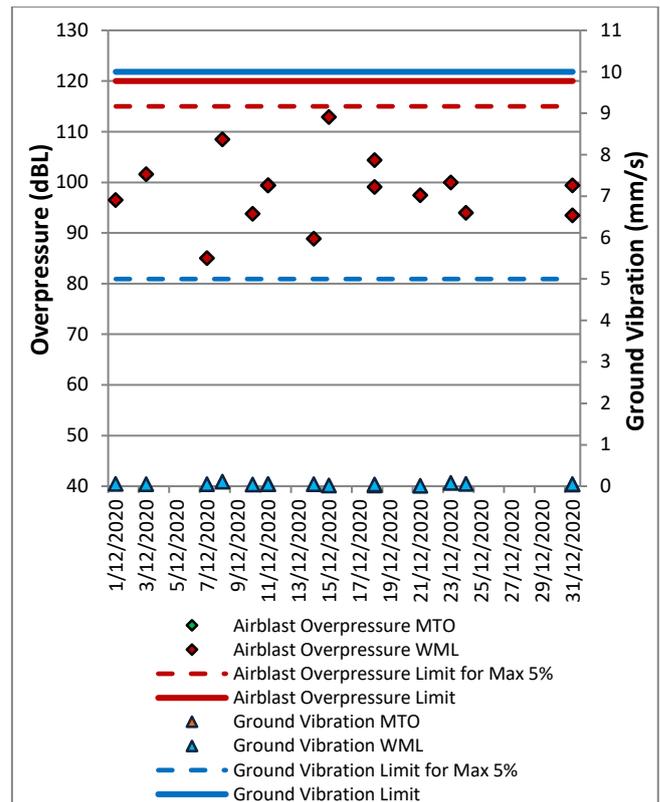
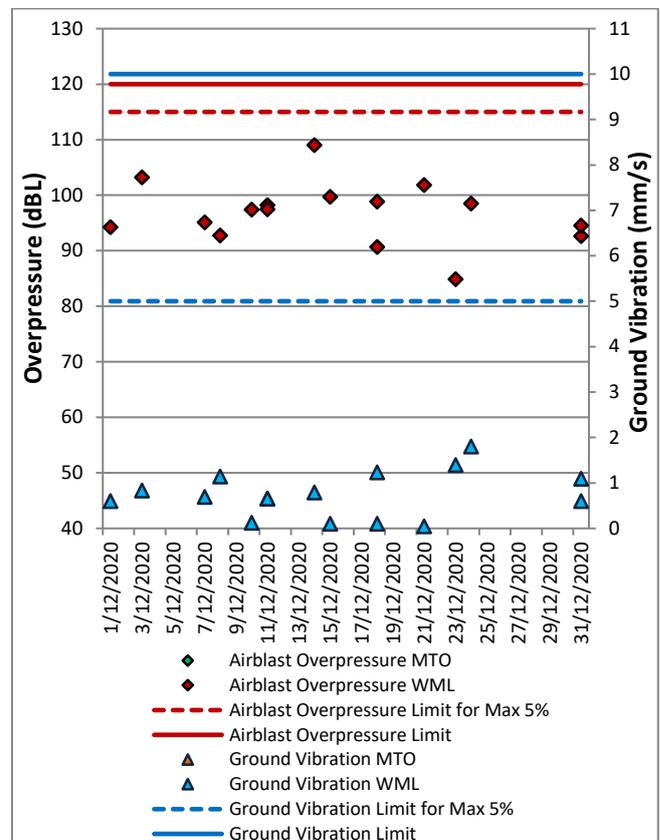
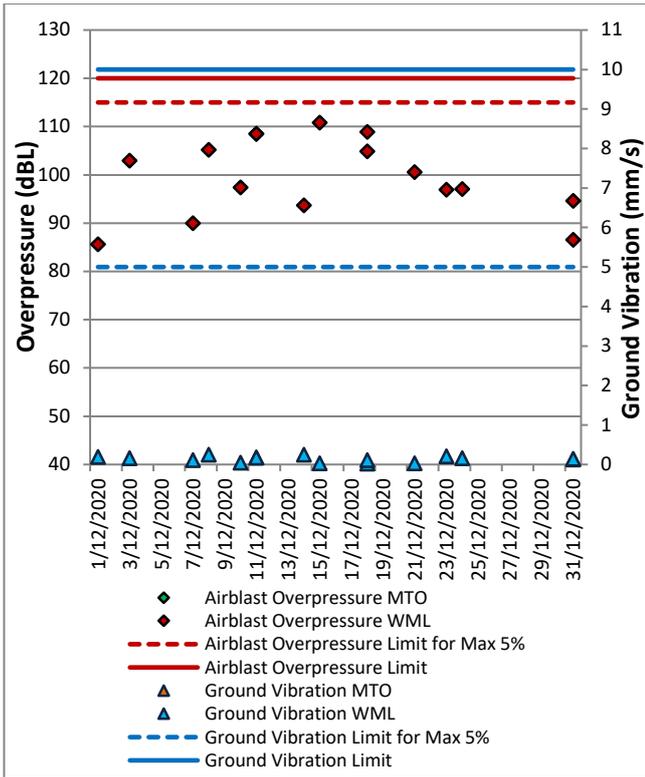
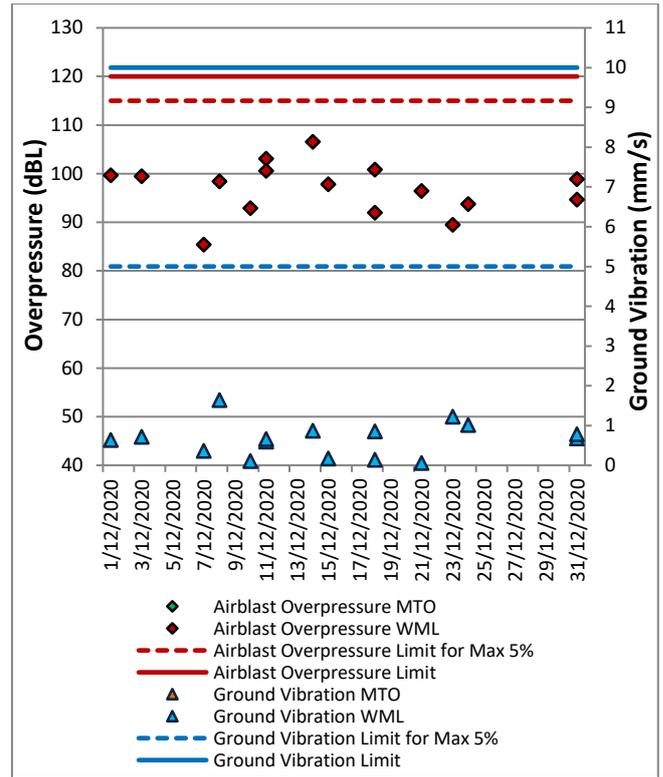
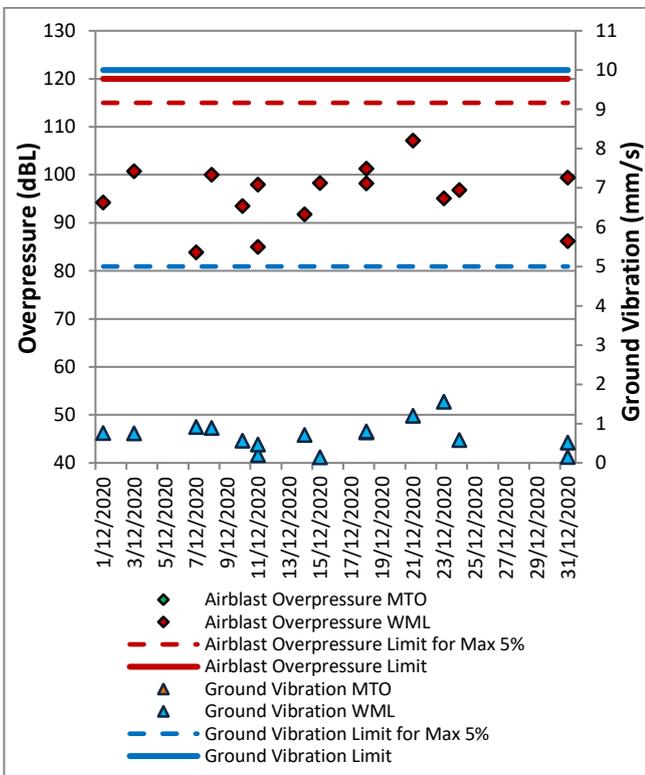
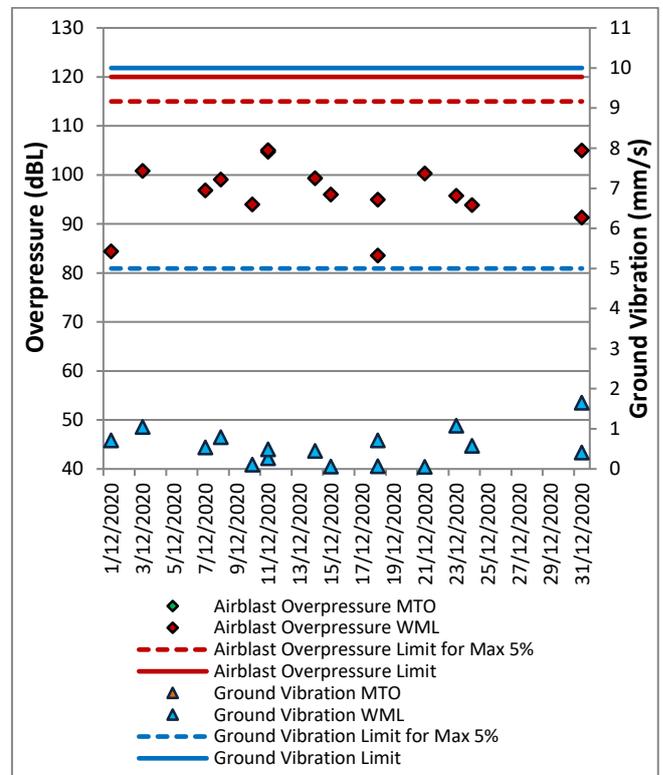
Figure 63 to Figure 68 show the blast monitoring results for the reporting period against the impact assessment criteria. The criteria are summarised in **Table 4**.

During the reporting period no blasts exceeded the 115 dB(L) 5% threshold for airblast overpressure or 5mm/s 5% threshold for ground vibration.

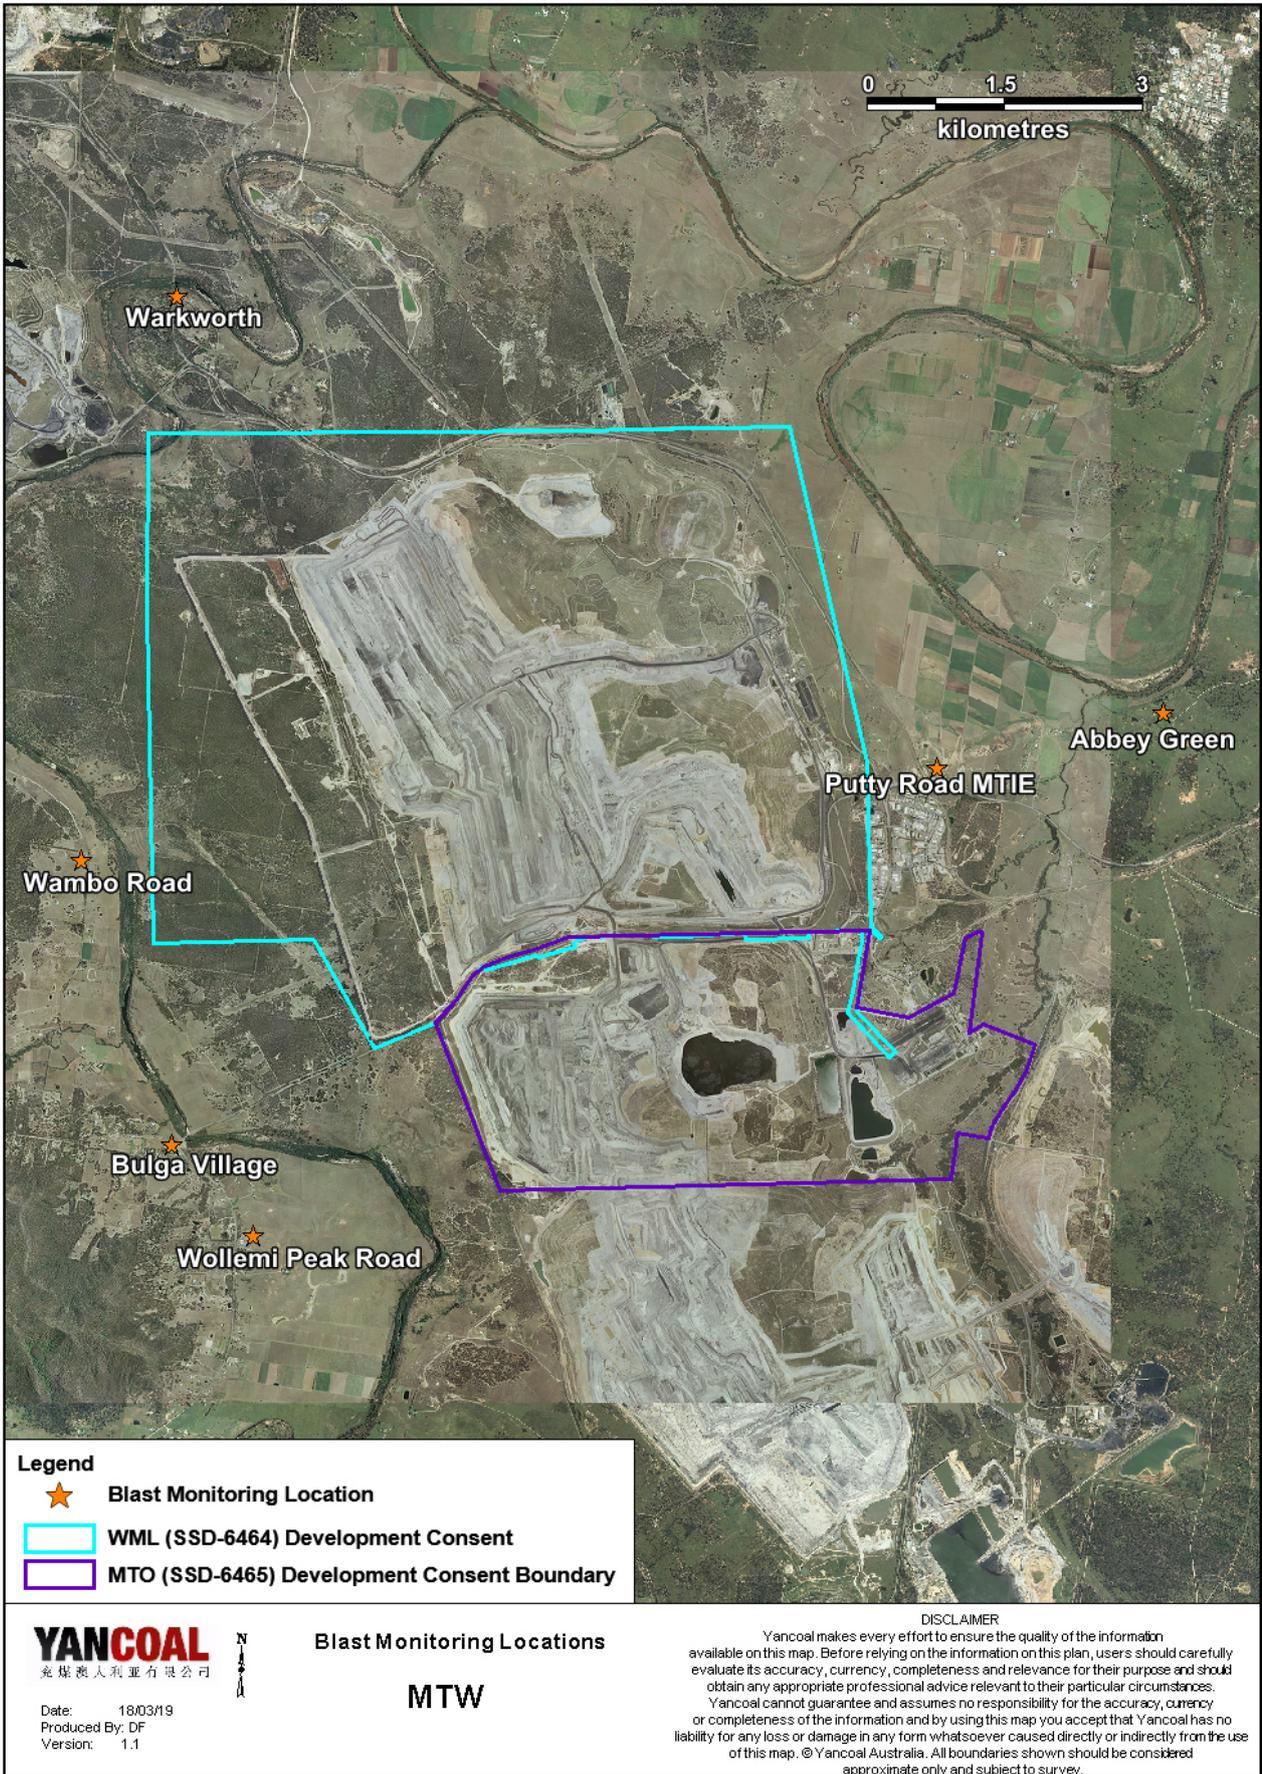
Figure 69: Blast and Vibration Monitoring Location Plan

MTW have a network of six blast monitoring units. These are located at nearby privately-owned residences and function as regulatory compliance monitors.

The location of these monitors can be found in **Figure 69**.

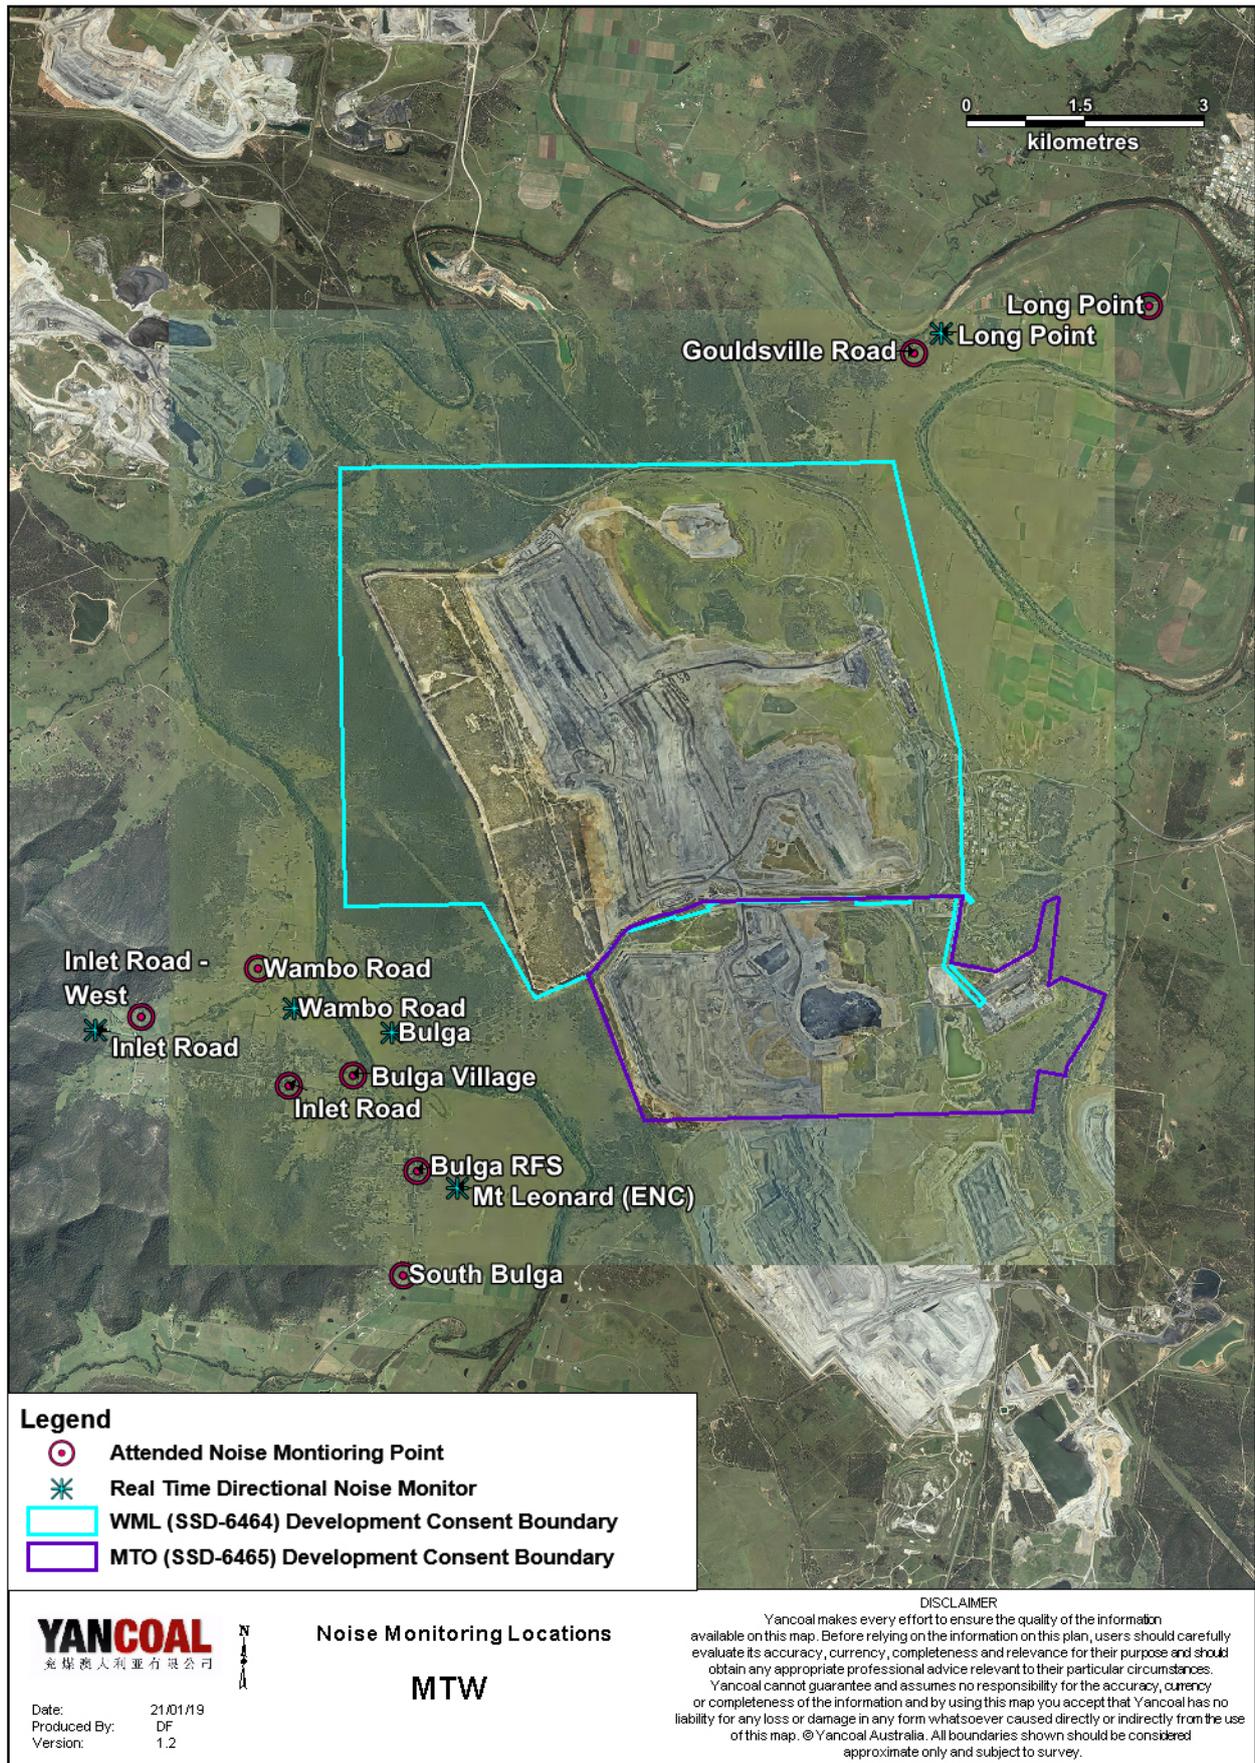
Figure 70: Noise Monitoring Location Plan

Routine attended noise monitoring is carried out in accordance with the MTW Noise Management Plan. A review against EIS predictions will be reported in the Annual Review Report. The purpose of the noise surveys is to quantify and describe the acoustic environment around the site and compare results with specified limits. Unattended monitoring (real time noise monitoring) also occurs at five sites surrounding MTW. The attended noise monitoring locations are displayed in **Figure 70**.
