Stratford Mining Complex Annual Review

ANNUAL REVIEW 2021

Reporting Period: 1st January 2021 to 31st December 2021

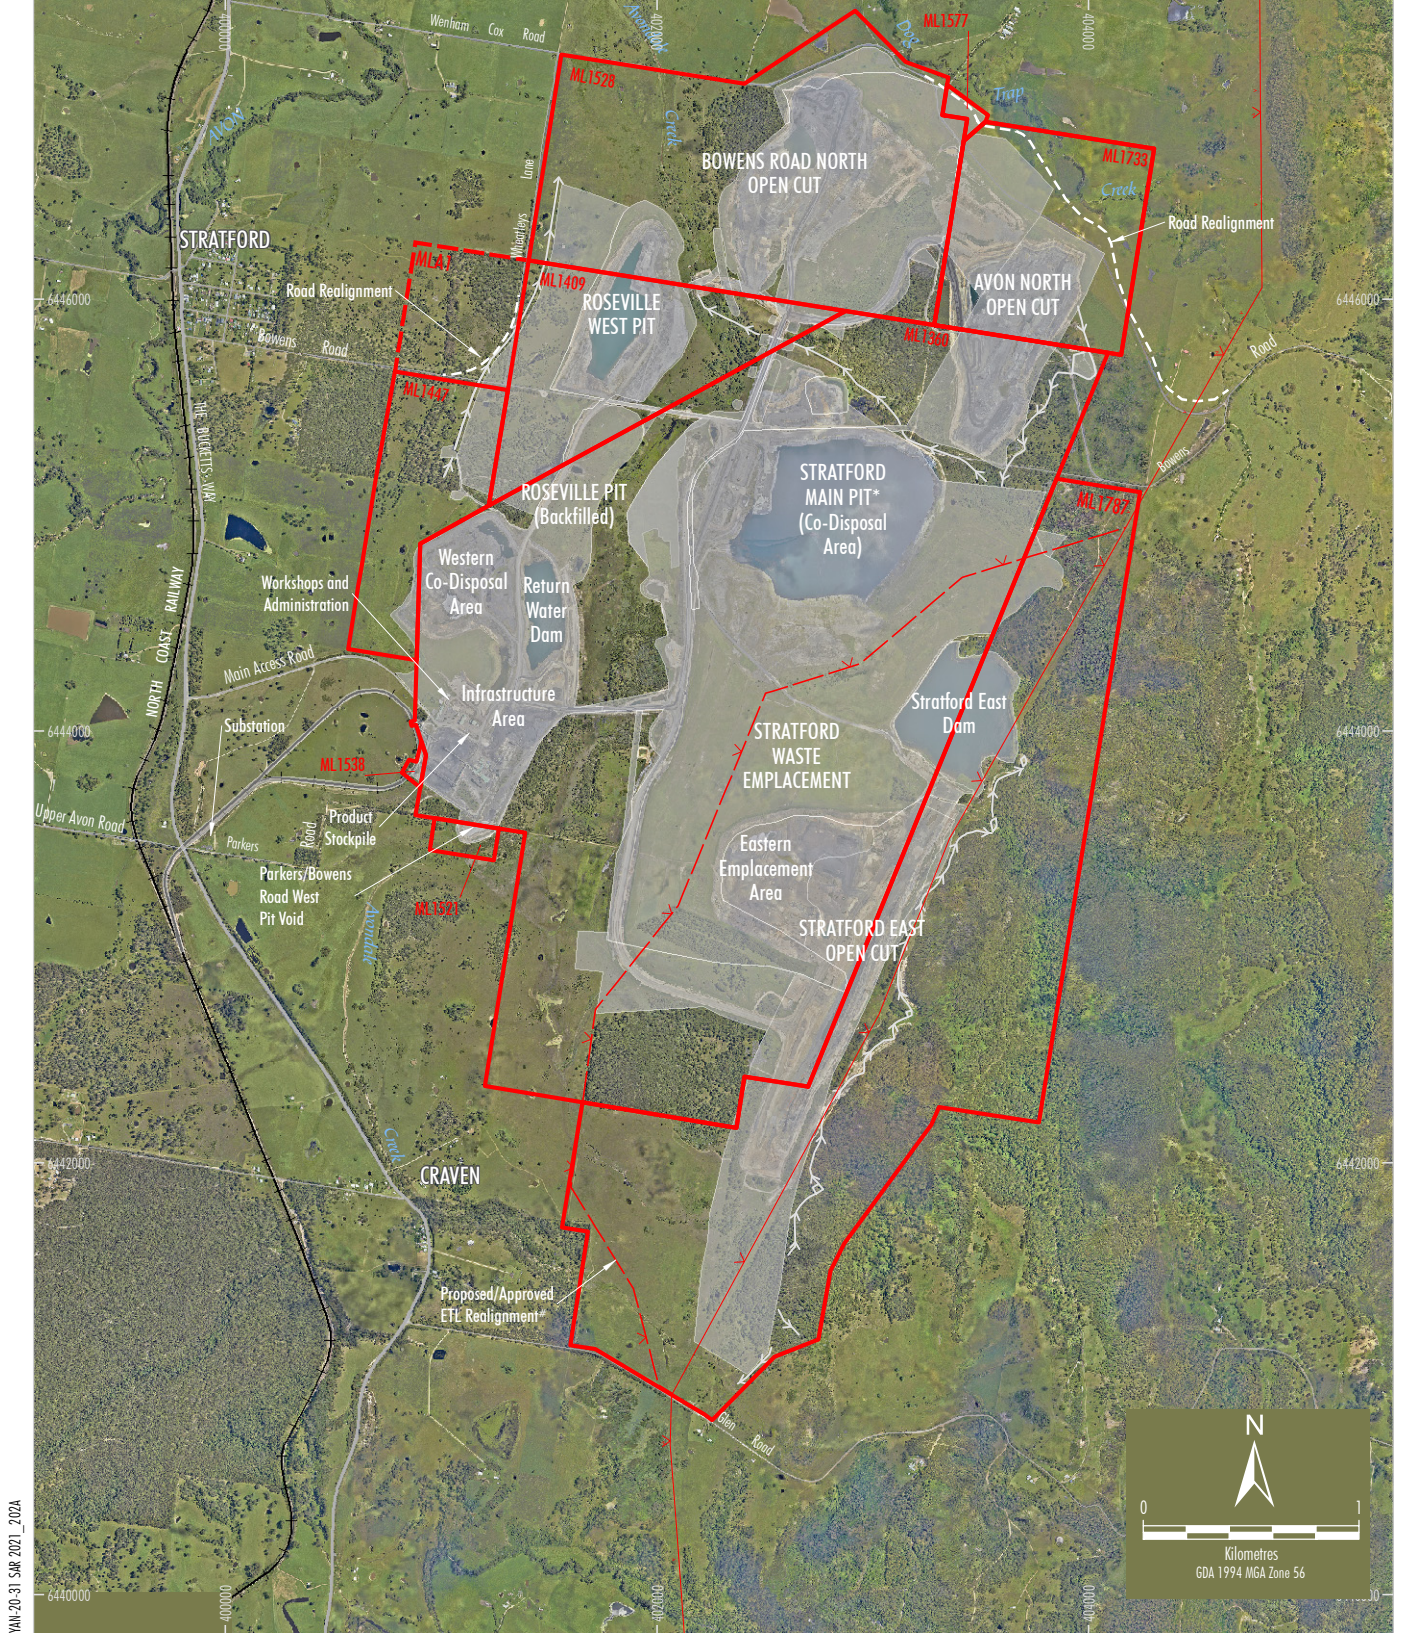
Figure 1

YAN-20-31 SAR 2021_202A

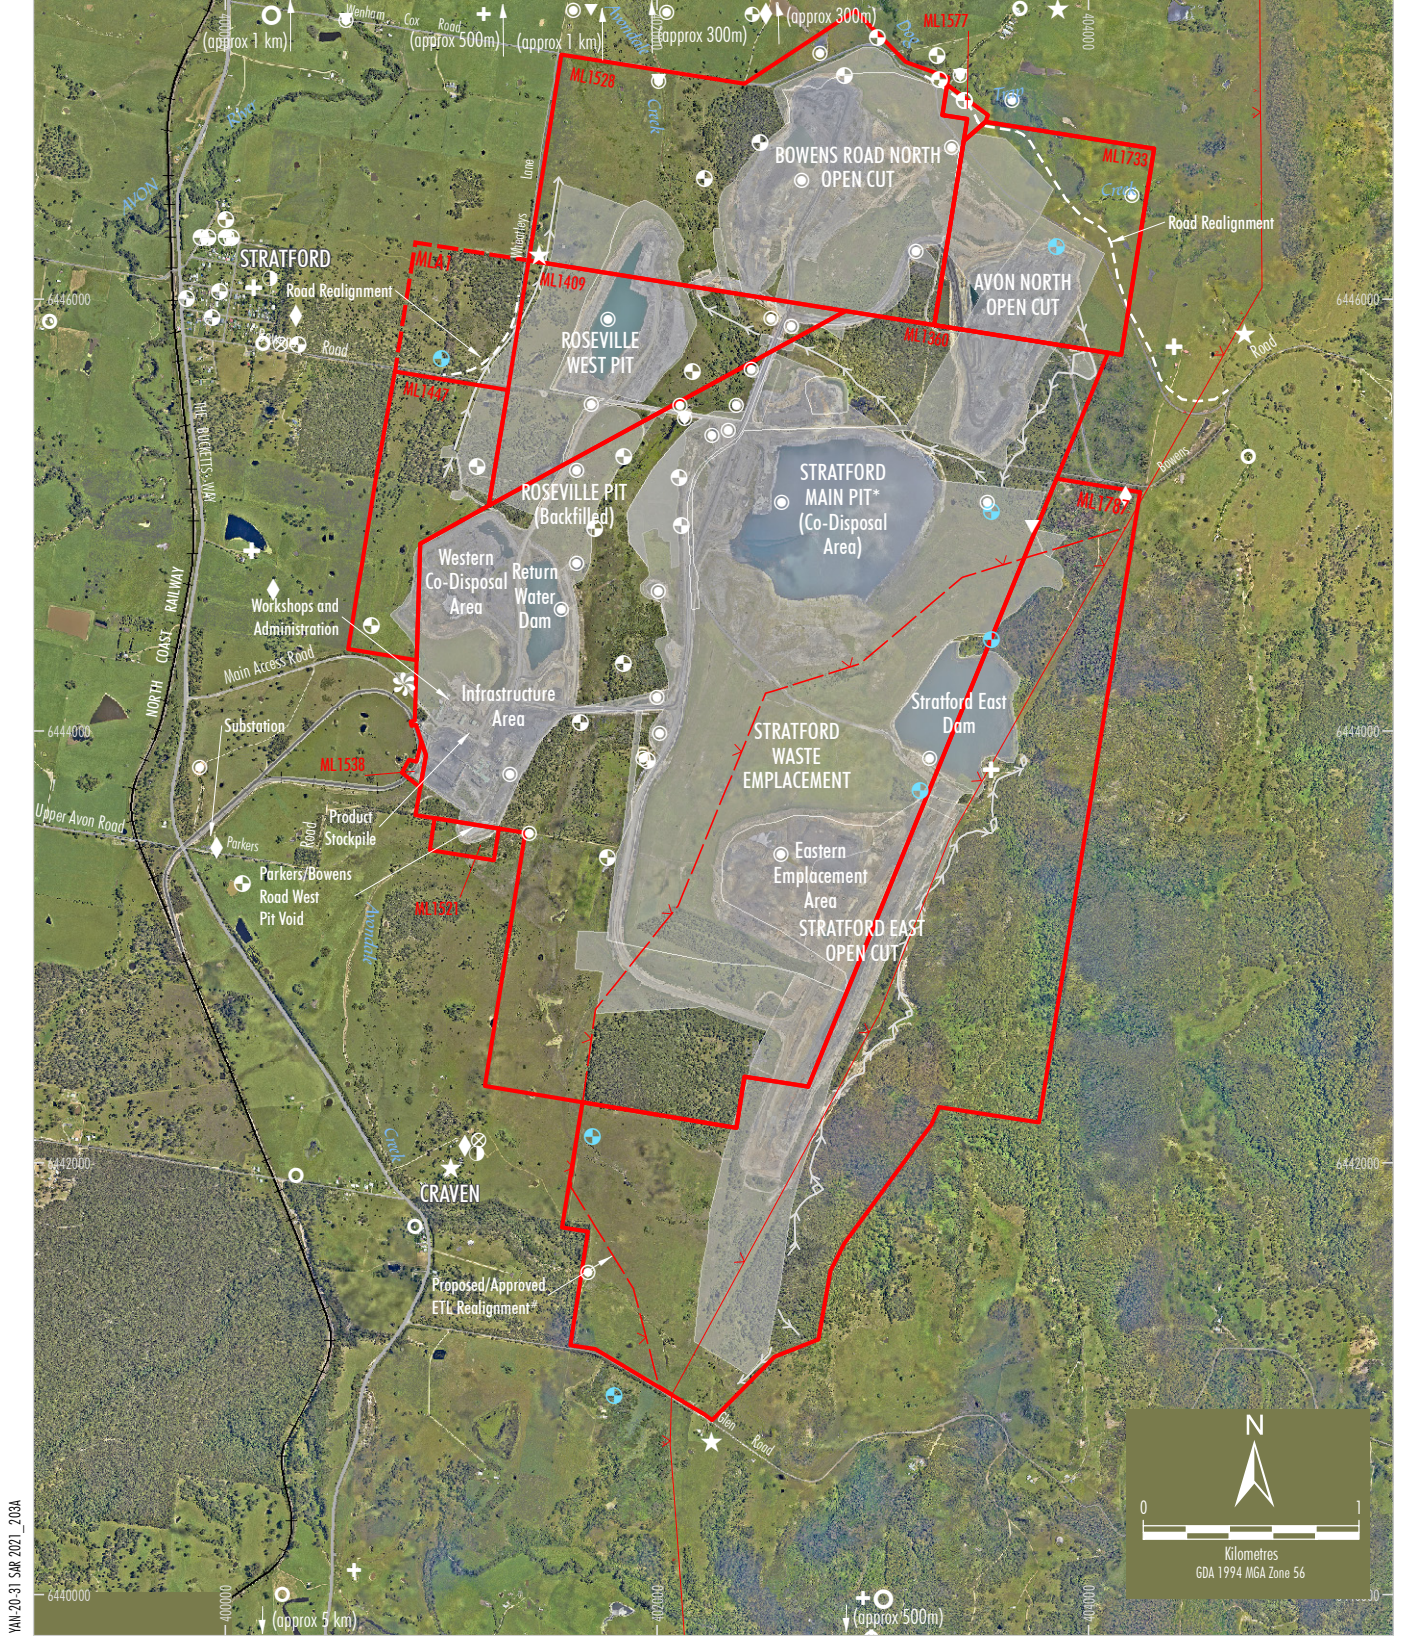
Figure 2

STRATFORD MINING COMPLEX 2021 ANNUAL REVIEW
Approved General Arrangement

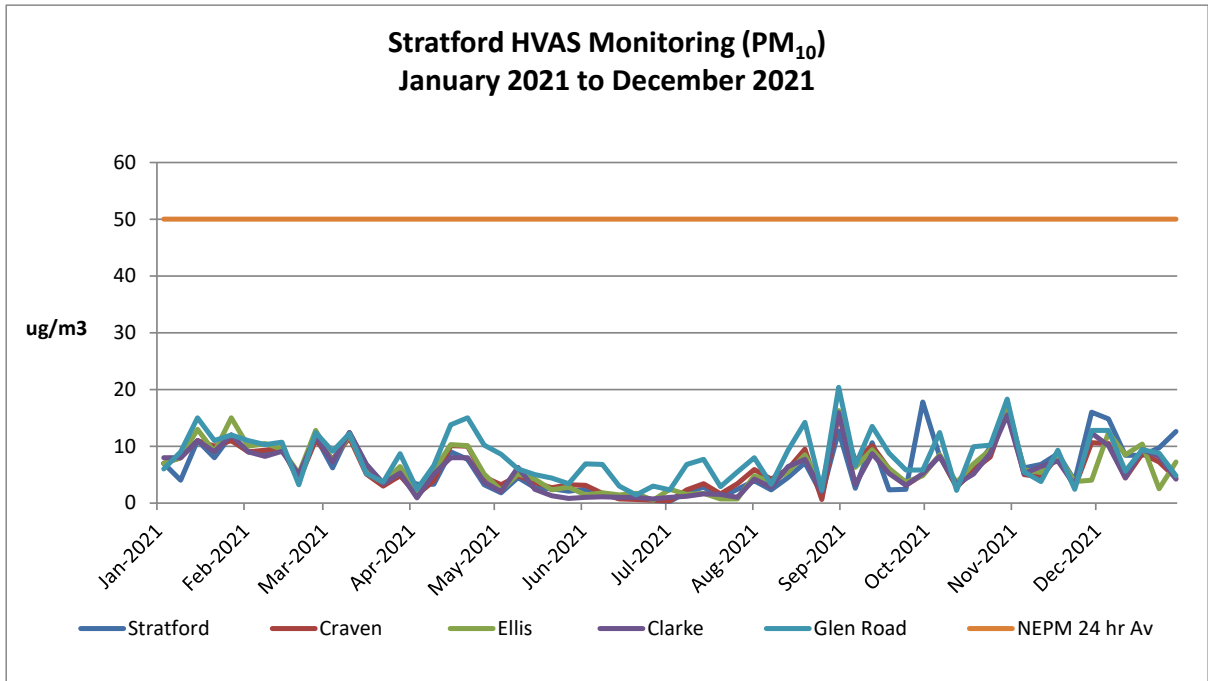
Figure 3-3: High Volume Air Sampler (HVAS) PM₁₀ Results

- One HVAS sampling event failed to run on 23 December 2022, resulting in less than required PM10 monitoring undertaken as per EPL 5161 - M2.2 Air Monitoring Requirements at HVAS unit-Point 13.

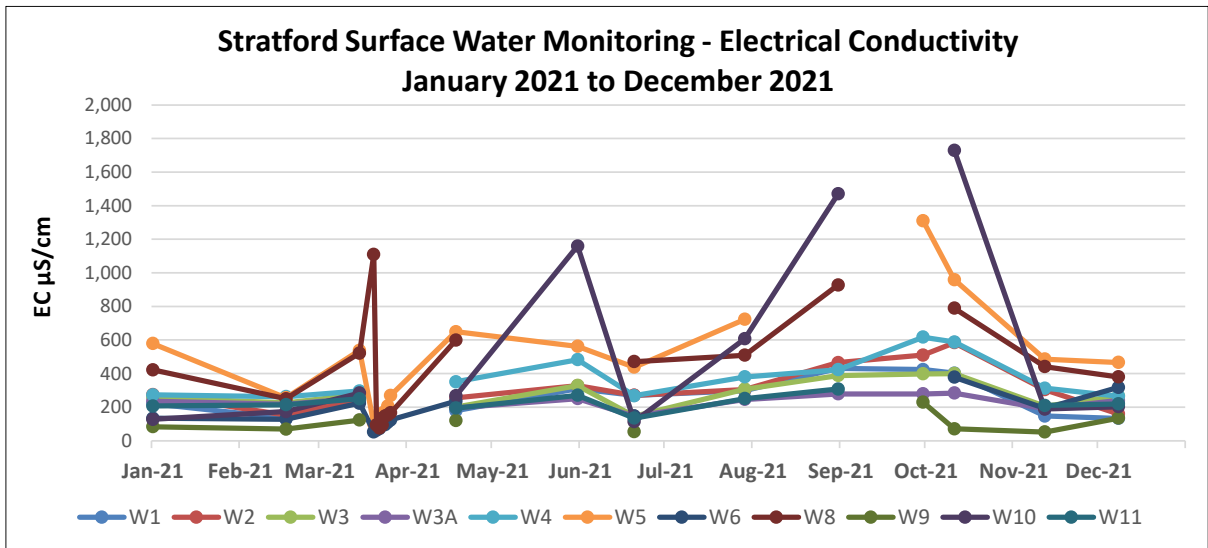
Figure 5-2: Surface Water Monitoring Results - Electrical Conductivity

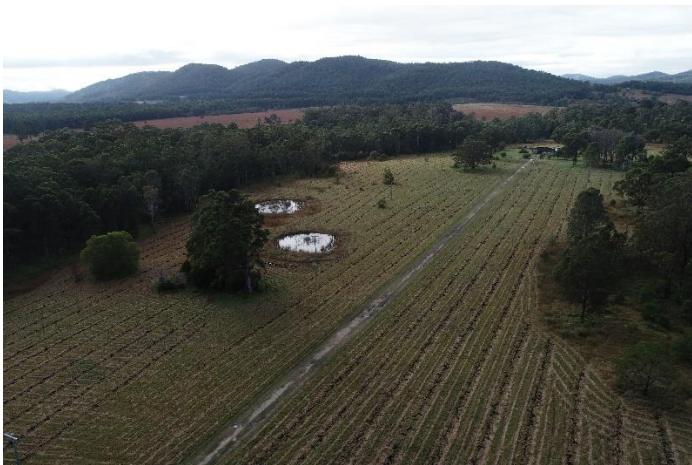
Plate 1: Ground preparation of Offset Area 3 – Colinda Property 2021.

Ground preparation work was undertaken prior to tubestock planting and involved slashing by tractor to reduce the biomass and then deep ripped to break the soil surface and provide a soil bed for easier tubestock installation. The total number of plants installed were 10,088 consisting of 4297 canopy plants across 11 different species and 5791 midstorey and shrub plants across 29 species. A summary of the revegetation work undertaken during 2021 is included in Appendix D (*2021 Stratford Biodiversity Offsets Planting Program Report, Kleinfelder 2022*).

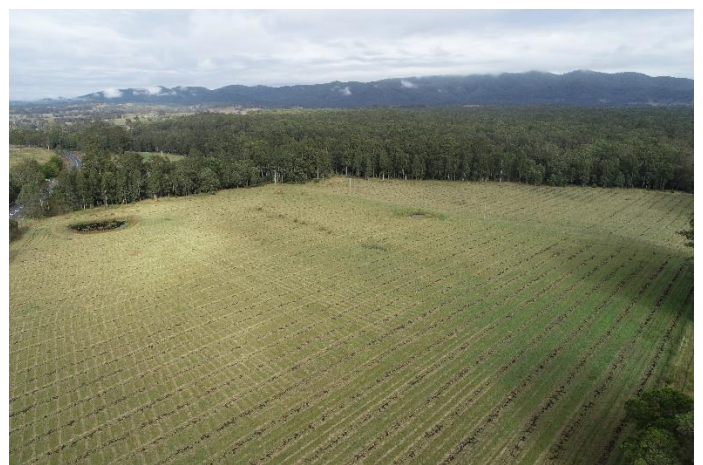
Plate 2: Ground preparation of Offset Area 4 – Rodgeron 2021.

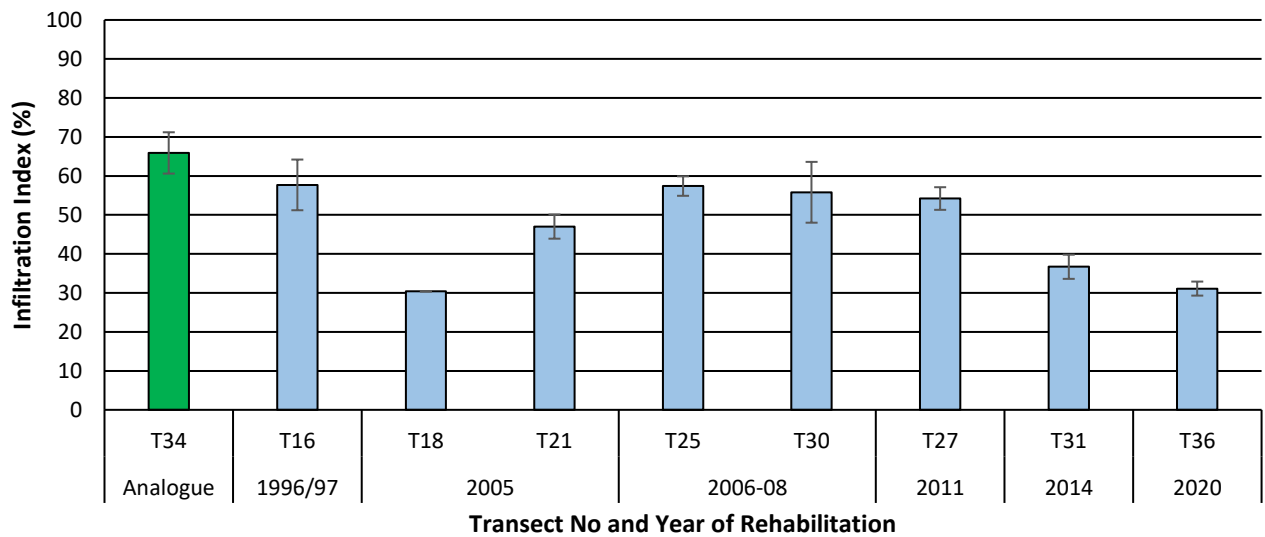
Figure 3: Results of the Landscape Functional Analysis monitoring for the 2021 monitoring of the Stratford Mining Complex native flora rehabilitation transects. Stability Index (top), Infiltration Index (middle) and Nutrient Cycling Index (bottom).

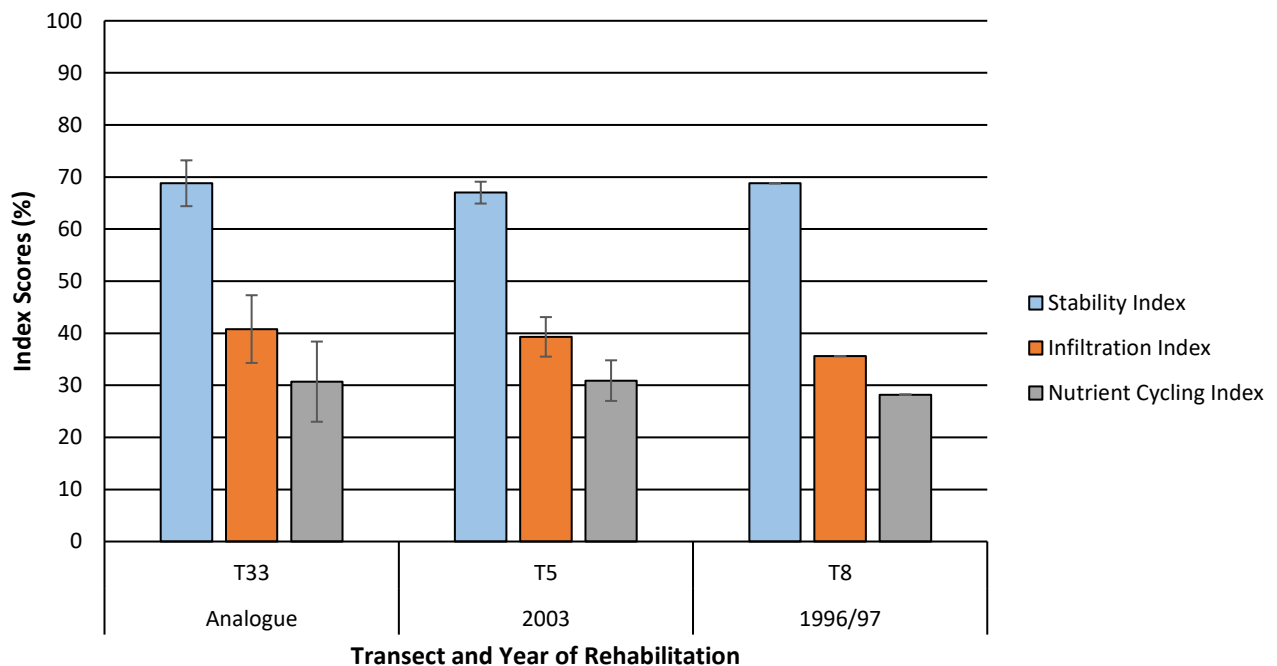
Figure 4: Results of the Landscape Functional Analysis for the 2021 monitoring of the Stratford Mining Complex pasture rehabilitation transects.

LFA results for the pasture rehabilitation transects for the 2021 survey are shown in **Figure 4**. The analogue transect (T33) recorded index scores of 68.8 ± 4.4 (Stability Index), 40.8 ± 6.5 (Infiltration Index) and 30.7 ± 7.7 (Nutrient Cycling Index). These index scores are equivalent to the previous year's monitoring results, with only minor improvements in the Infiltration and Nutrient Cycling Index scores. The two ages of pasture rehabilitation recorded similar Stability Index scores compared last year's monitoring – 67.0 ± 2.1 for T5 and 68.6 ± 0.0 for T8, but improved index scores for Infiltration Index and Nutrient Cycling Indices. Transect T5 (2003 rehabilitation) recorded Infiltration and Nutrient Cycling Index scores of 39.3 ± 3.8 and 30.9 ± 3.9 respectively. Transect T8 (1996/97 rehabilitation) recorded Infiltration and Nutrient Cycling Index scores of 35.6 ± 0.0 and 28.2 ± 0.0 respectively.

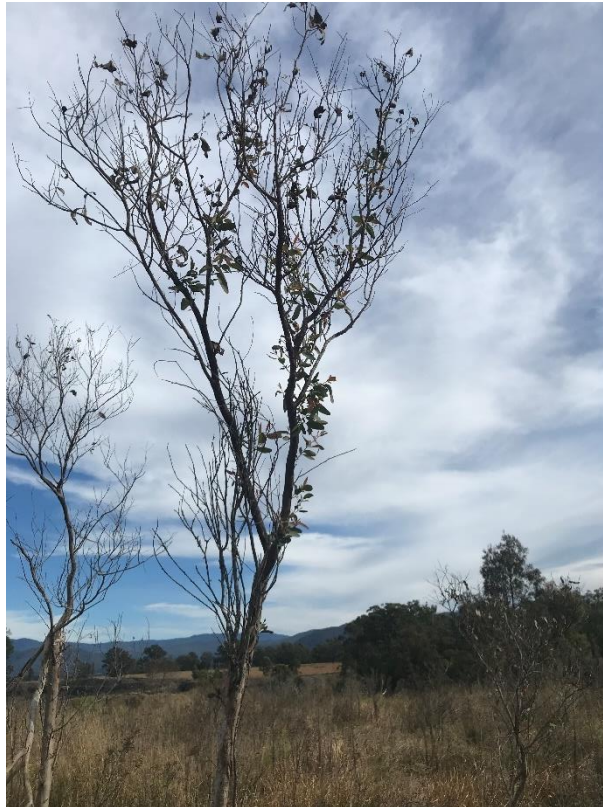
The area monitored by T18 is located on the flat of the southern emplacement and consists of sparse native overstorey and midstorey/shrub species with groundcover consisting of exotic and native grasses and forbs (**Plate 5**). The current Eucalypt density is within the target range for open woodland, with 74 stems/ha, while the combined midstorey and shrub layers are below the equivalent analogue densities. The Eucalypts were observed to be suffering from dieback, with almost all individuals showing signs of stress (**Plate 1**). Many were displaying some re-growth, but the effect of the stress has hindered the revegetation effort with no fruit or seed observed on any of the Eucalypt trees.

Plate 1: Eucalypts displaying dieback on Roseville Waste Emplacement (south), T18

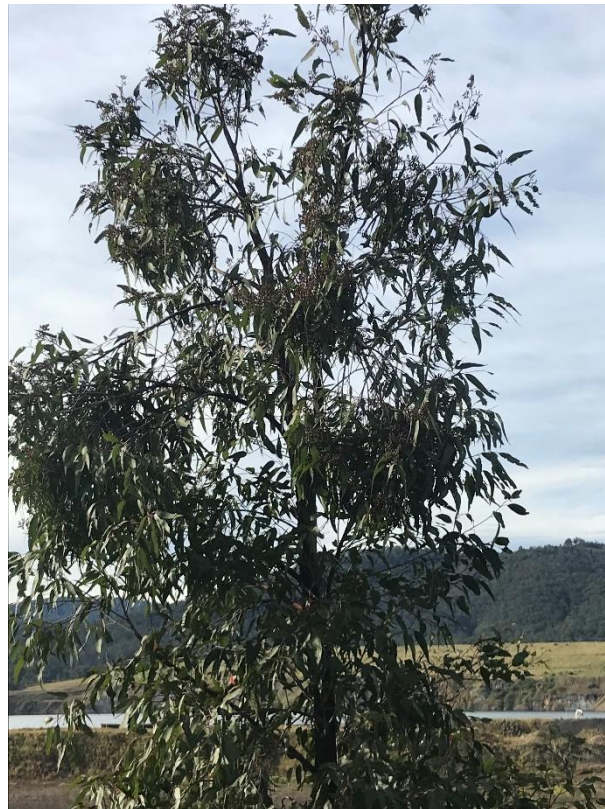
The LFA indices show that the soil surface stability is quite good, and the infiltration and nutrient cycling indices are higher than the southern emplacement, they are still lower than other, younger rehabilitation areas at the SMC. As with the above transect, the indices have decreased from the previous time this area was surveyed. This suggest that the issues identified above are not limited to the southern emplacement, but inherent to the RWE. These may include shallow topsoil and low rates of litter accumulation that result in low moisture retention. The observation of the native vegetation on this emplacement is that it is sparse, and did not suffer from dieback, and indeed many Eucalypts were observed to have fruit (**Plate 2**).

Plate 2: Example of healthy Eucalypt with fruit at the Roseville Waste Emplacement, T21

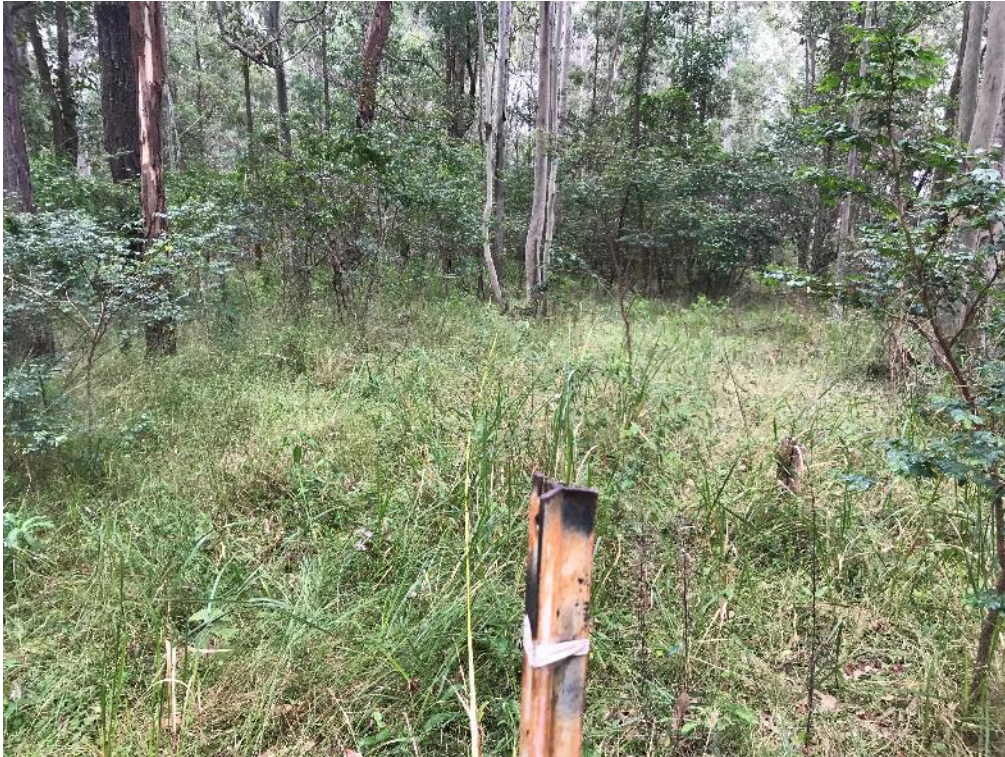
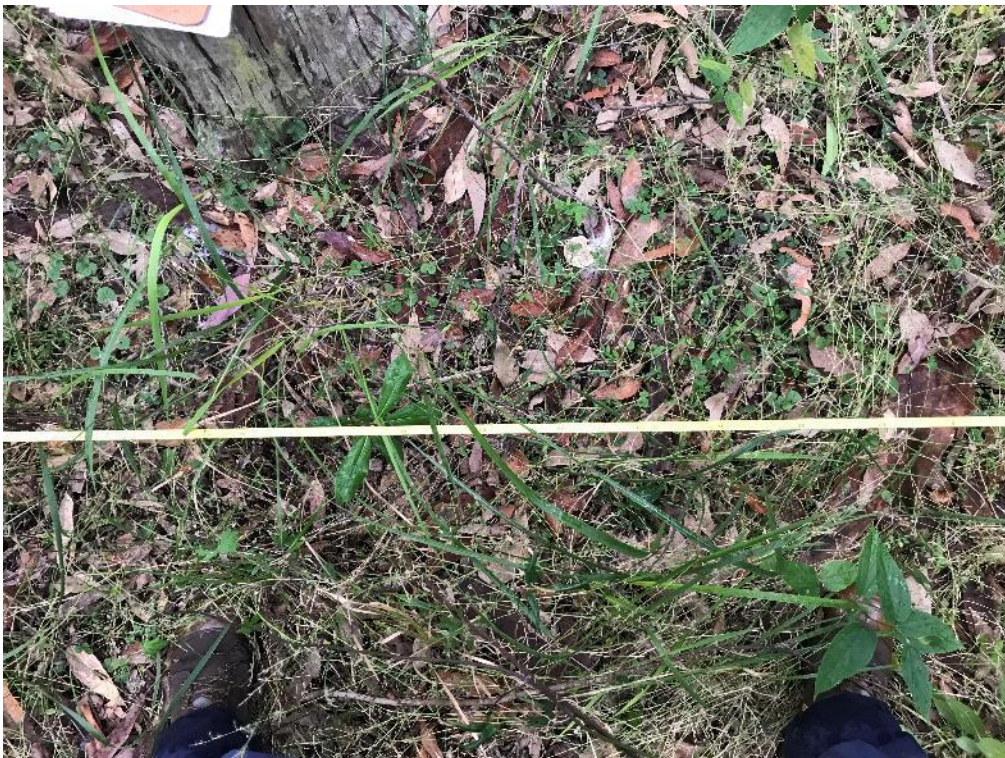
Plate 3: Native Flora Rehabilitation Analogue Transect T34 showing LFA transect (top) and example of grassy litter groundcover typical of this transect

The woodland analogue was reduced to a single transect/area this survey (T34) which has had the effect of increasing the analogue LFA values slightly, but the index scores are similar to last year's survey (**Figure 8**). This indicates that any changes to index scores observed in the rehabilitation areas can be attributed to changes in transect as outlined in the methods or to the properties of the rehabilitation area. A noticeable change in the analogue transect area was a large increase in the density of the shrub layer (**Plate 3** and **Figure 10**). The 2020 survey recorded 918 shrubs/ha while this survey recorded 5, 827 shrubs/ha. Examination of the survey data (not shown) shows that this year, in addition to the *Breynia oblongifolia* (Coffee Bush) that dominated the shrub layer in 2020, a number of additional species that were not recorded previously have germinated and increased the density of this layer substantially. These included *Trema tomentosa* (Native Peach) (the majority of the new shrubs) with *Ozothamnus diosmifolius* (White Dogwood) and *Plectranthus parviflorus* (Cockspur Flower) also recorded. This is mentioned to foreshadow that with time, the *T. tomentosa* will grow to become a midstory layer. There were no substantial changes to the overstorey or midstory layers this survey.

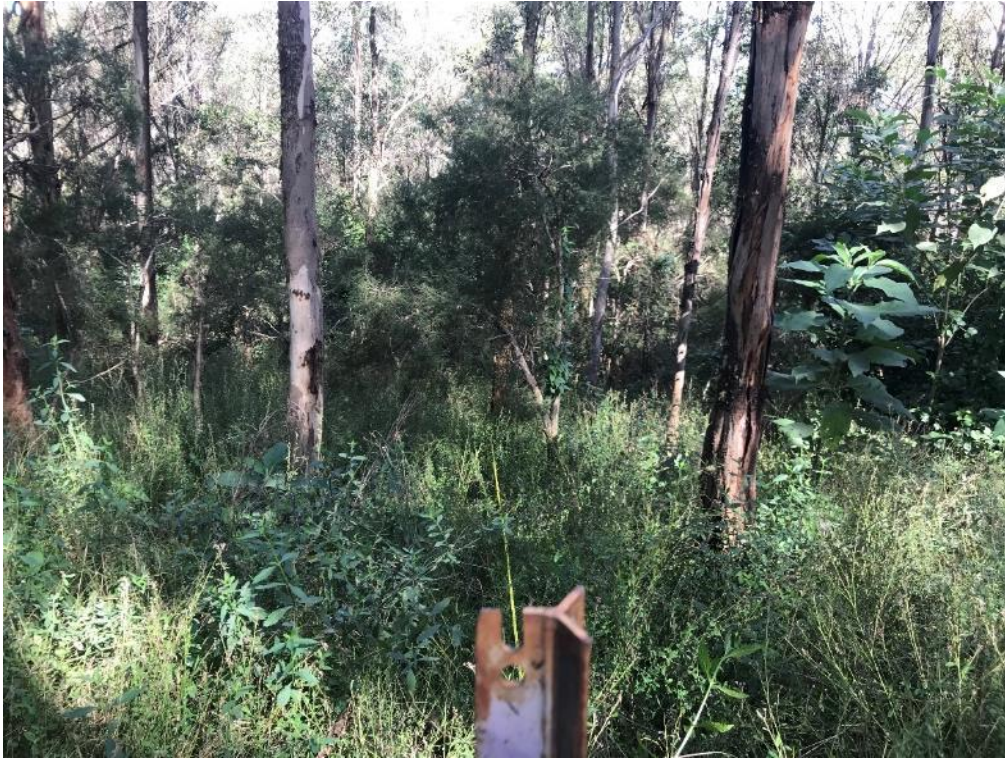
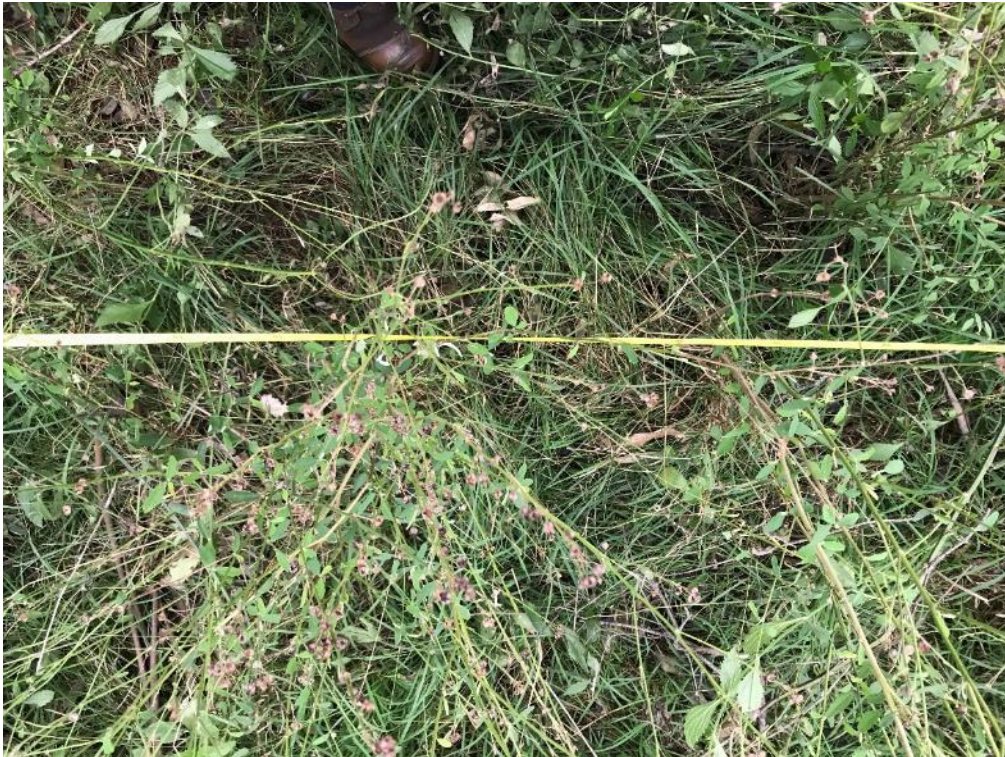
Plate 4: Stratford Woodland Rehabilitation Transect T16 (1996/97) showing LFA transect (top) and typical grassy and forb (exotic and native) and litter groundcover (bottom). Note the abundance of woody weeds species Wild Tobacco and Lantana in the top photo

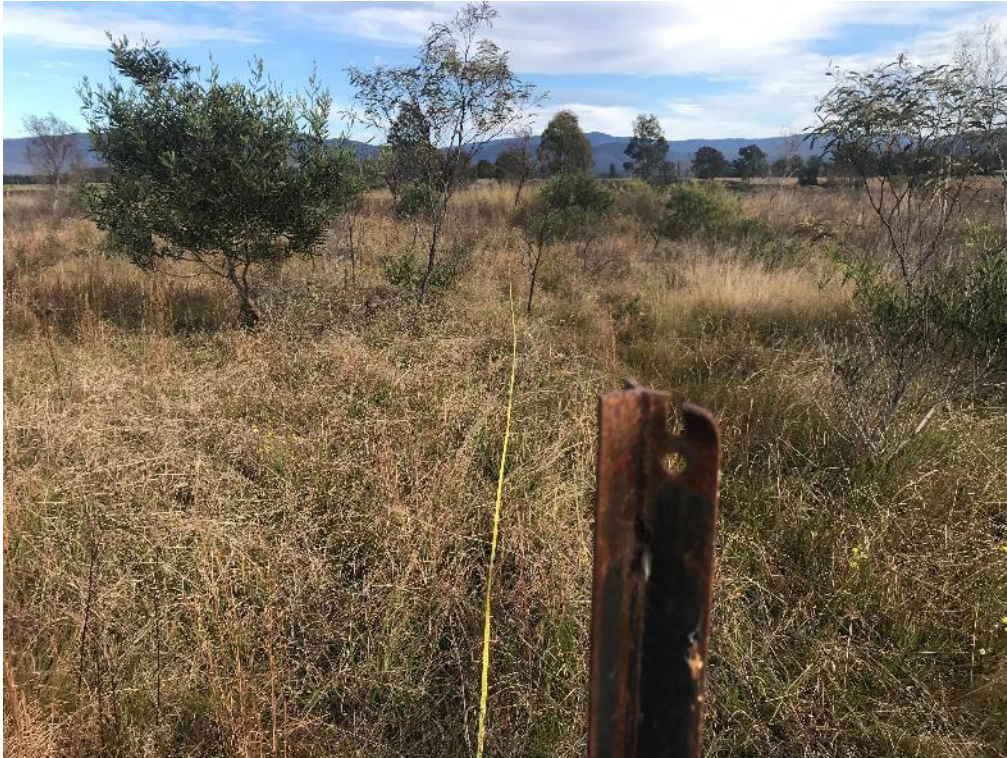
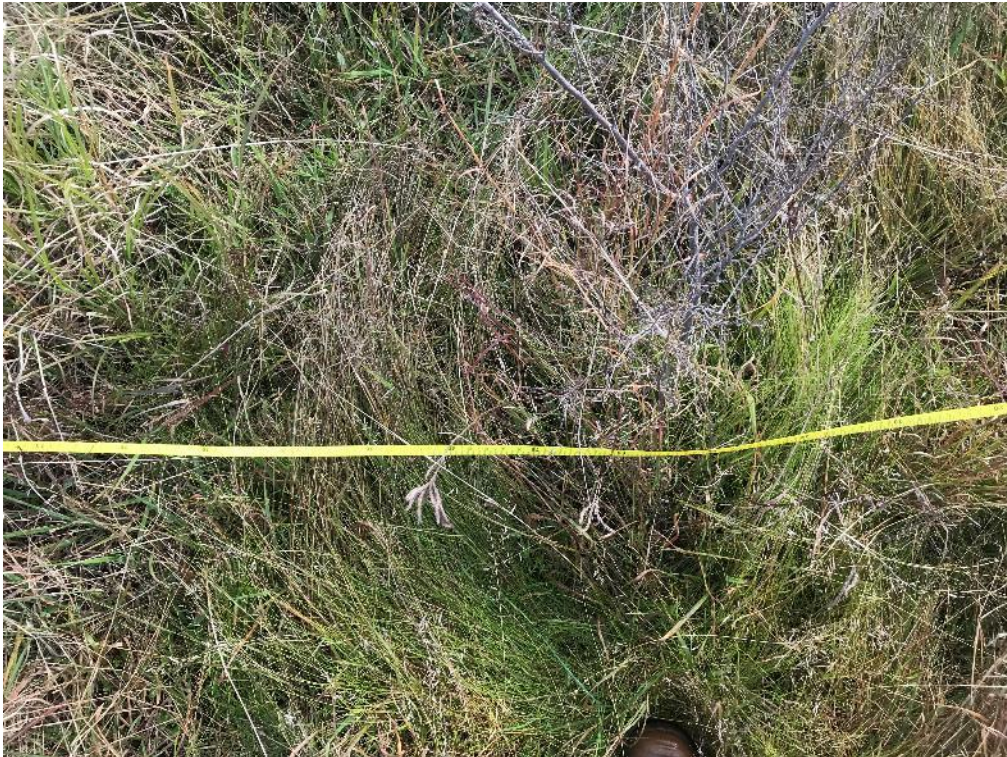
Plate 5: Roseville Waste Emplacement South Transect T18. LFA transect (top) showing sparse native flora rehabilitation and (bottom) typical grassy groundcover.

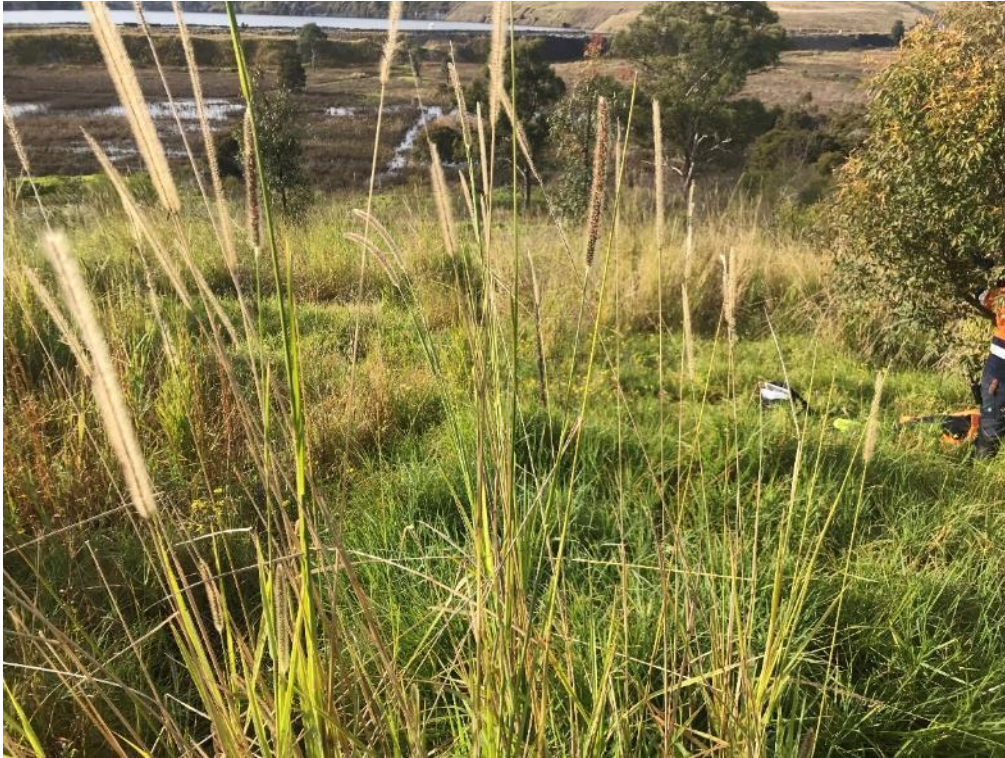
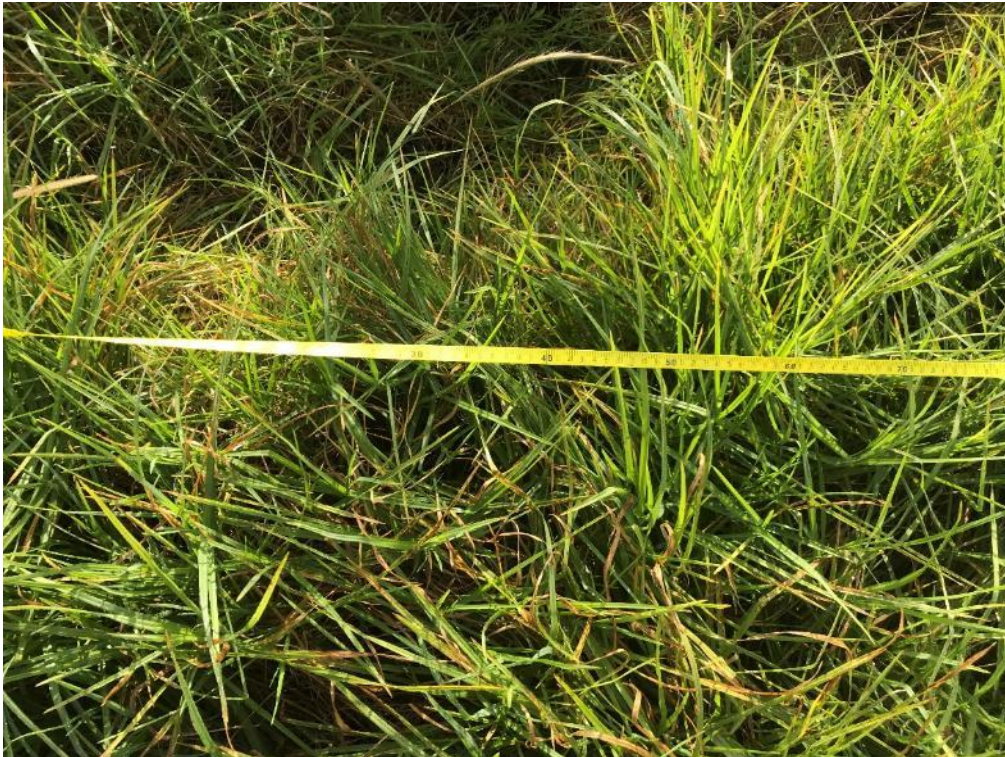
Plate 6: Roseville Waste Emplacement North Transect T21. LFA transect (top) showing sparse native flora rehabilitation and (bottom) typical dense kikuyu grassy groundcover.

The northern emplacement was monitored by T21 on the east facing slope. This area in contrast to T18, is similar to the 2020 transect T19 with a dense groundcover of exotic grasses *Cenchrus clandestinus* (Kikuyu) and *Setaria sphacelata* (South African Pigeon Grass) and only a few overstory and other natives from the planting undertaken in 2016 (**Plate 6**). The density in this area was calculated to be 315 stems/ha, with all strata included in this count

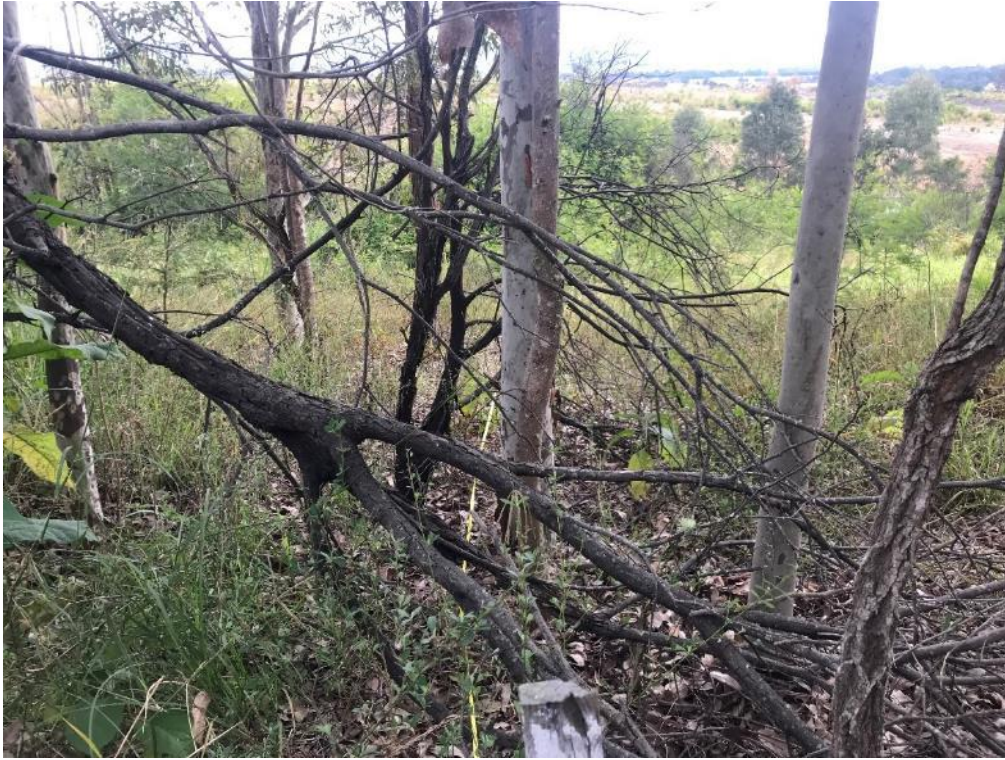
Plate 7: Bowens Road North Waste Emplacement Rehabilitation Transect T25 showing the LFA transect. The upper transect is under dense canopy before opening up to grassy sward and then under dense shrubs/midstorey. Groundcover photo was not taken.

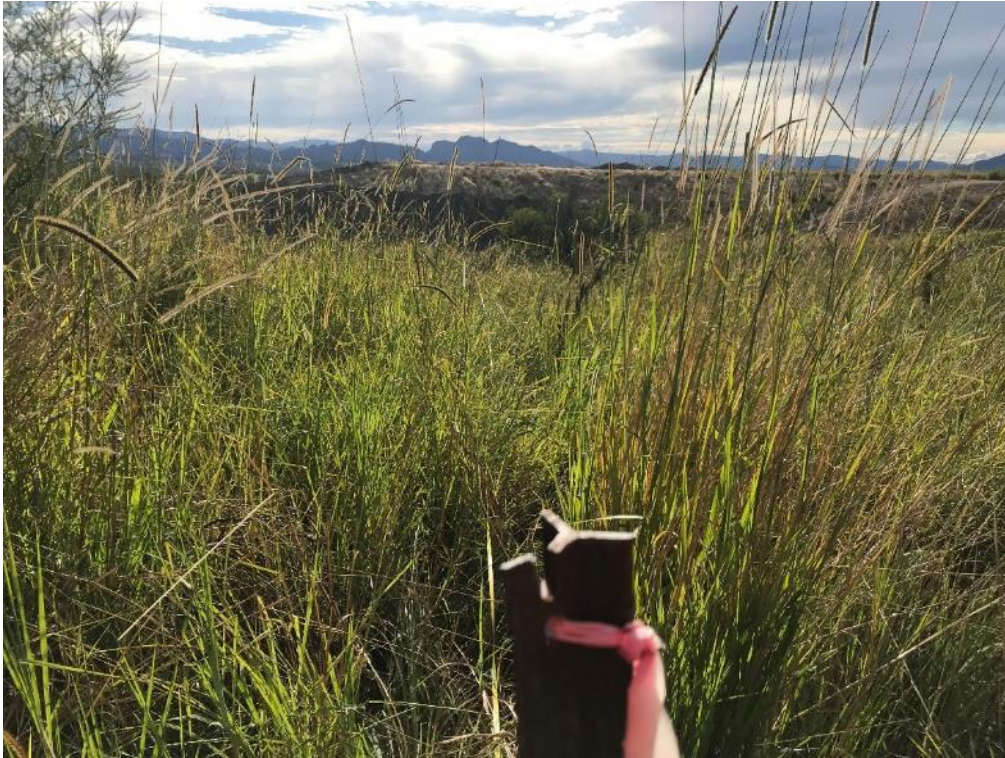
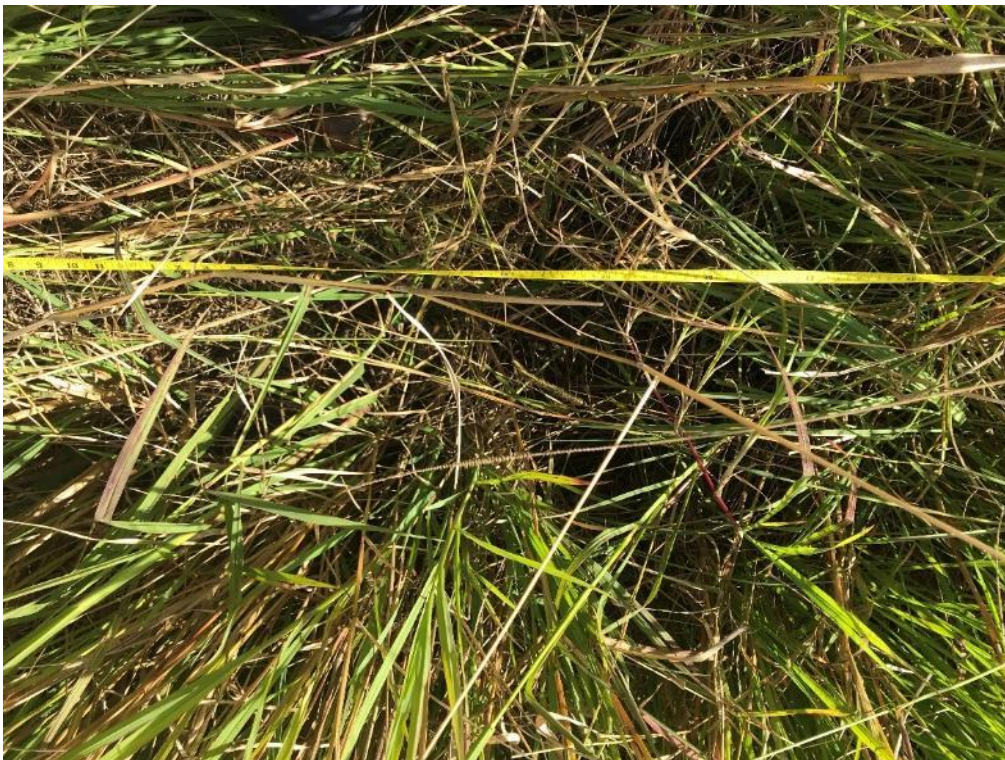
Plate 8: Bowens Road North Waste Emplacement Rehabilitation Transect T27. Top, LFA Transect showing total absence of overstory species and dense grassy understorey. Bottom, view of typical dense *Setaria* dominated grassy groundcover

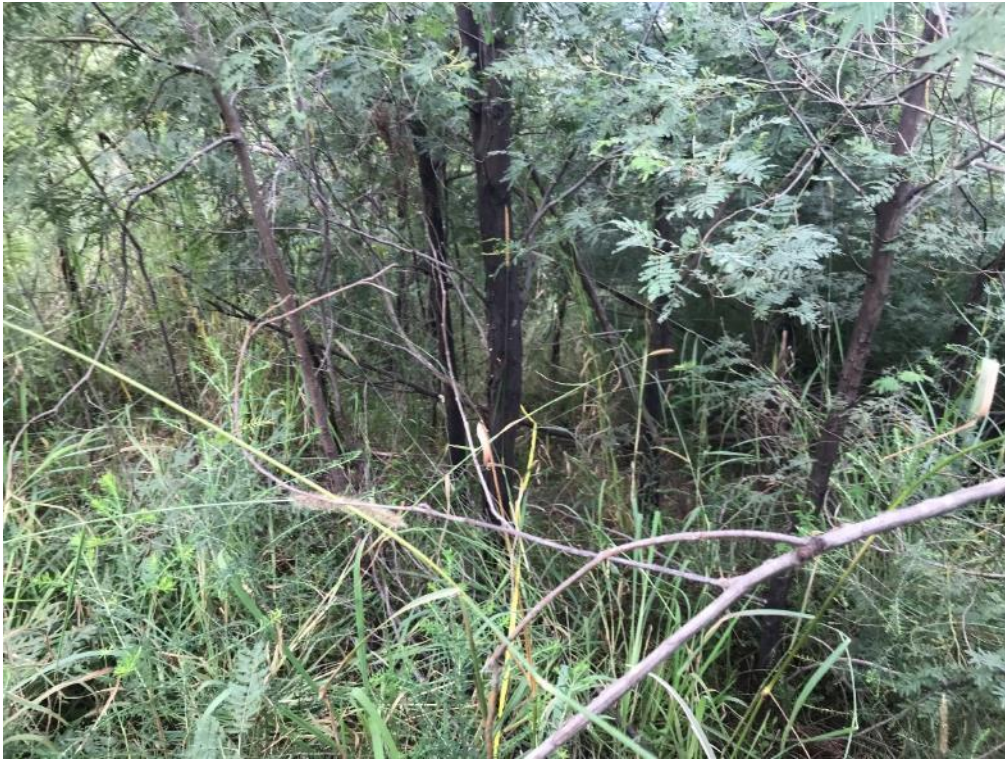
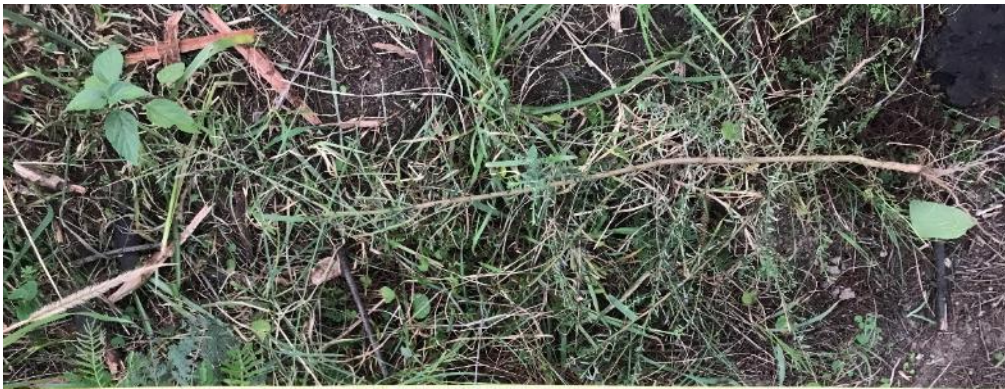
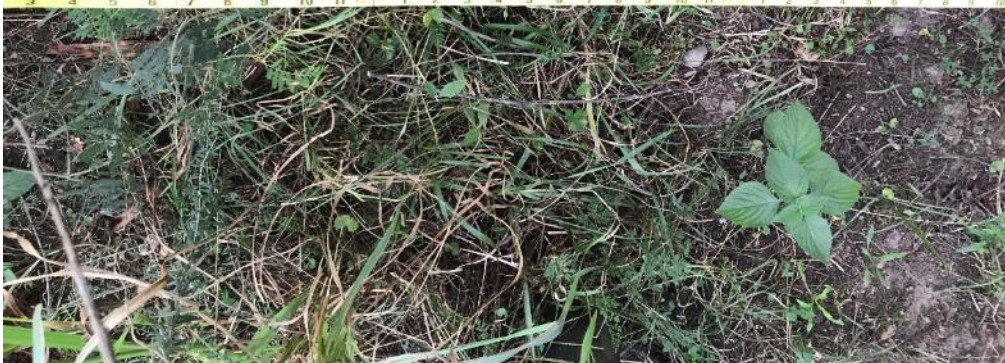
Plate 9: Bowens Road North Waste Emplacement Rehabilitation Transect T30. Top, LFA transect showing dense *Acacias*. Bottom, showing typical groundcover under the *Acacia* canopy. Note the number of seedlings including *Acacias* and *Lantana*, the sparse nature of the grasses and the amount of exposed soil and litter

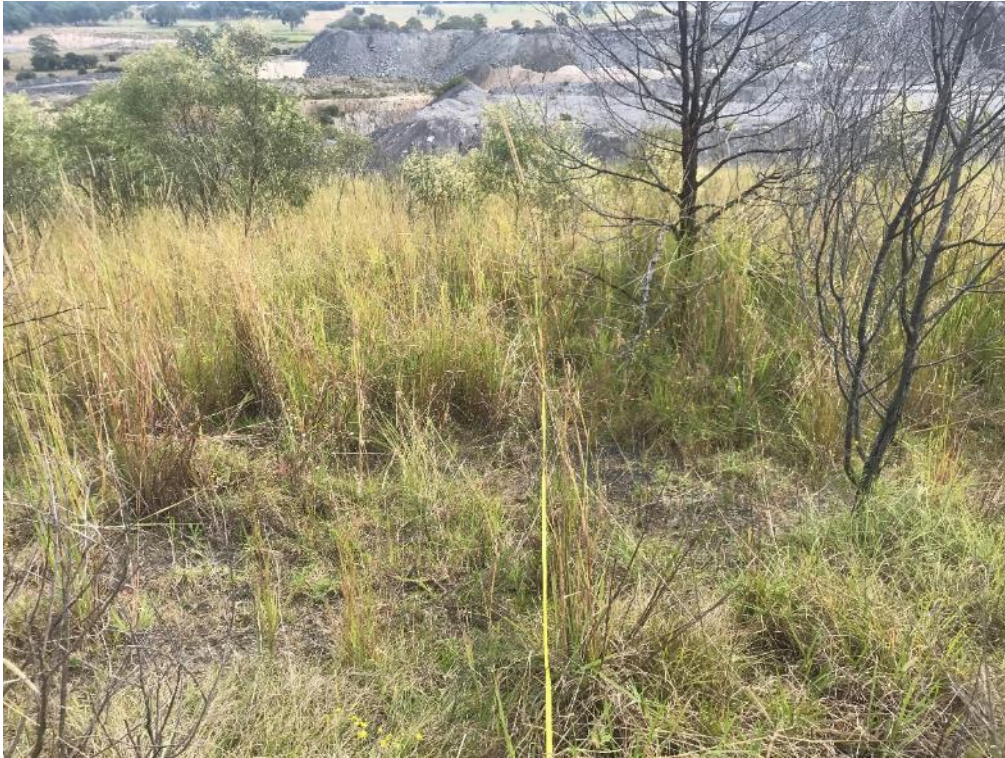
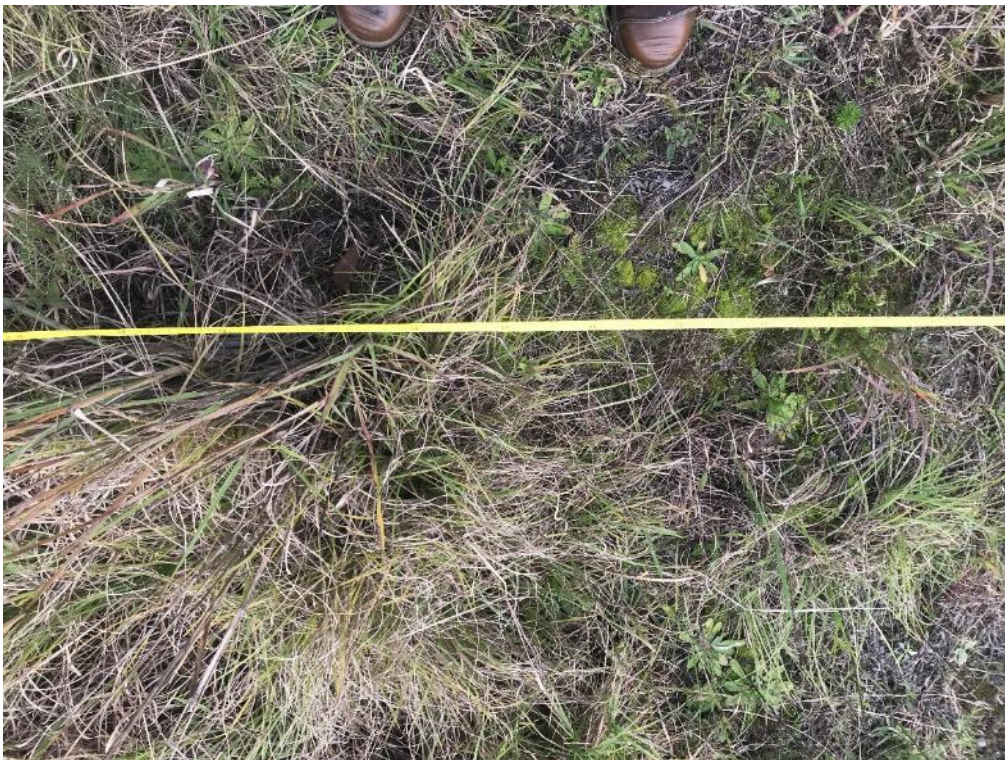
Plate 10: Bowens Road North Waste Emplacement Rehabilitation Transect T30. Top, LFA transect showing typical *Acacia* dominated woody vegetation with die-back and patchy grassy groundcover. Bottom, view of typical groundcover grass, cryptograms and sparse litter and some bare soil.
