Stratford Mining Complex Annual Review

ANNUAL REVIEW 2021

Reporting Period: 1st January 2021 to 31st December 2021

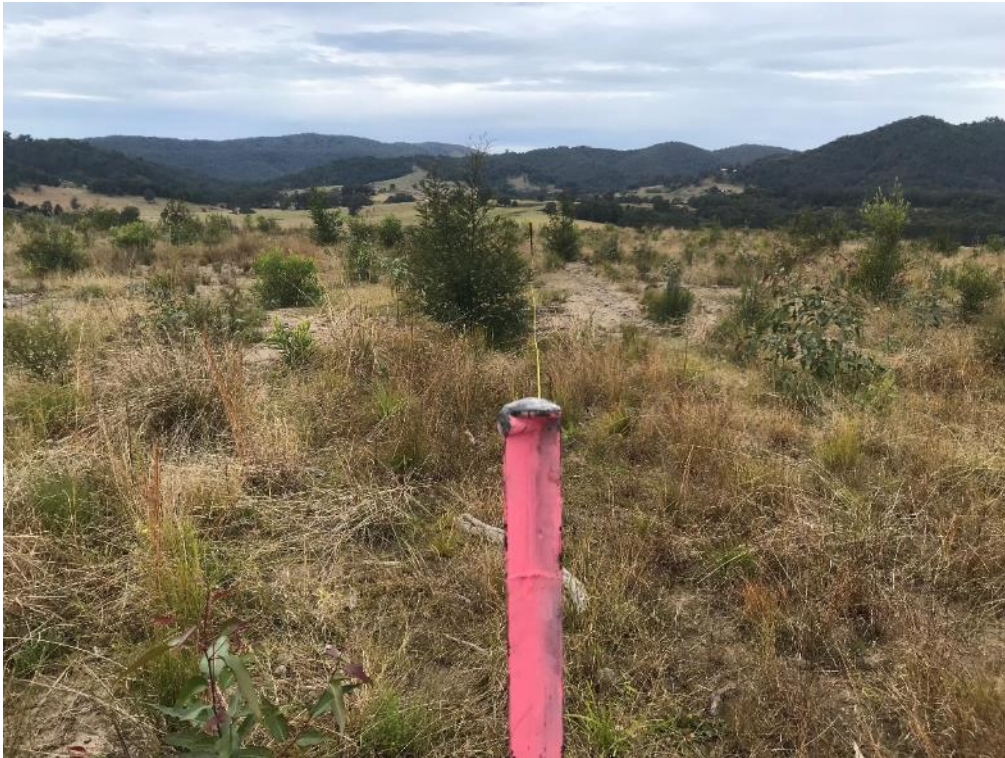
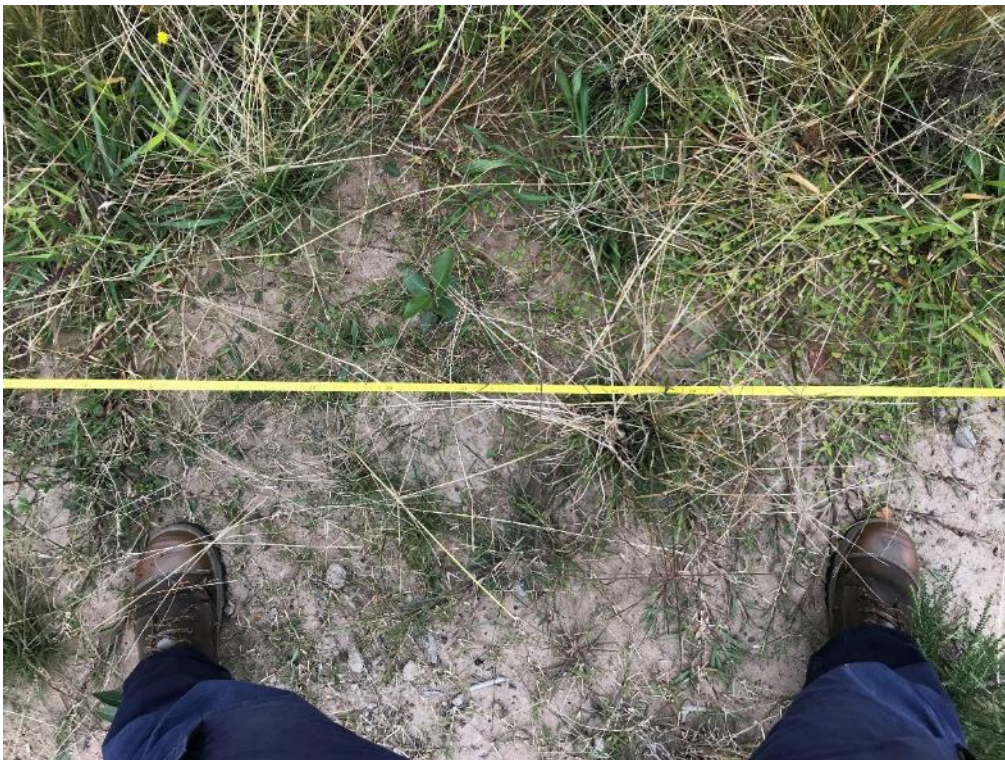
Plate 11: Avon North Waste Emplacement Rehabilitation Transect T36. Top, LFA transect showing the young native flora revegetation. Note the young *Eucalyptus* species and multiple *Acacia* and other shrub species. Grasses and forbs – native and exotic – have established, but bar soil is still quite common. Bottom, view of typical groundcover with good establishment of native grasses

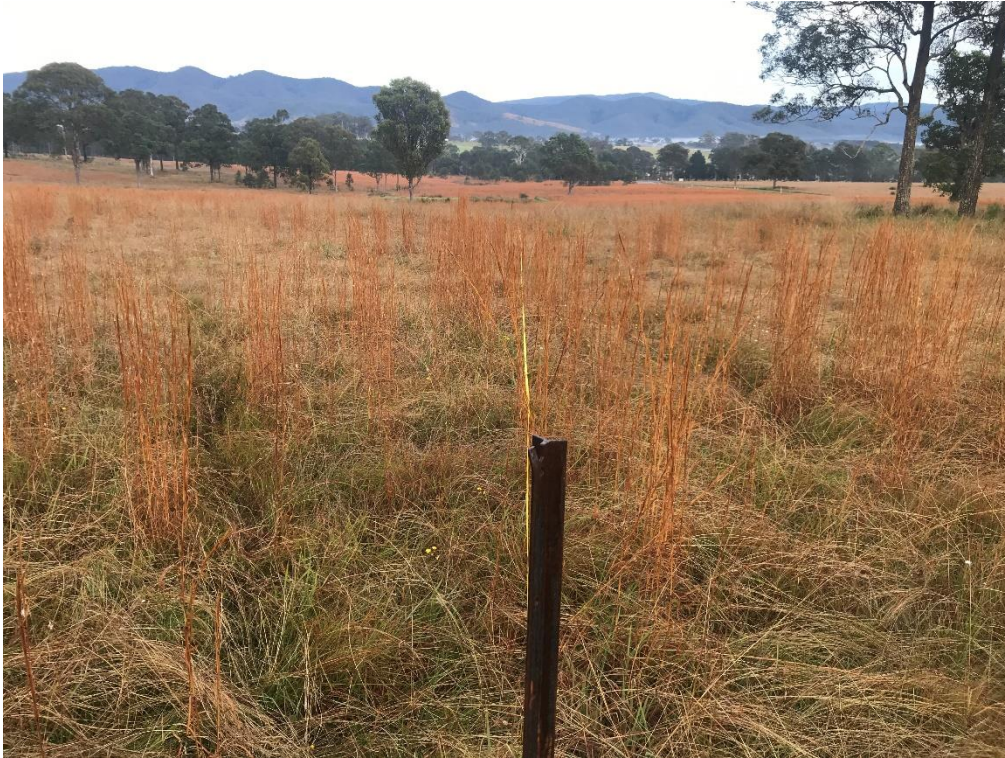
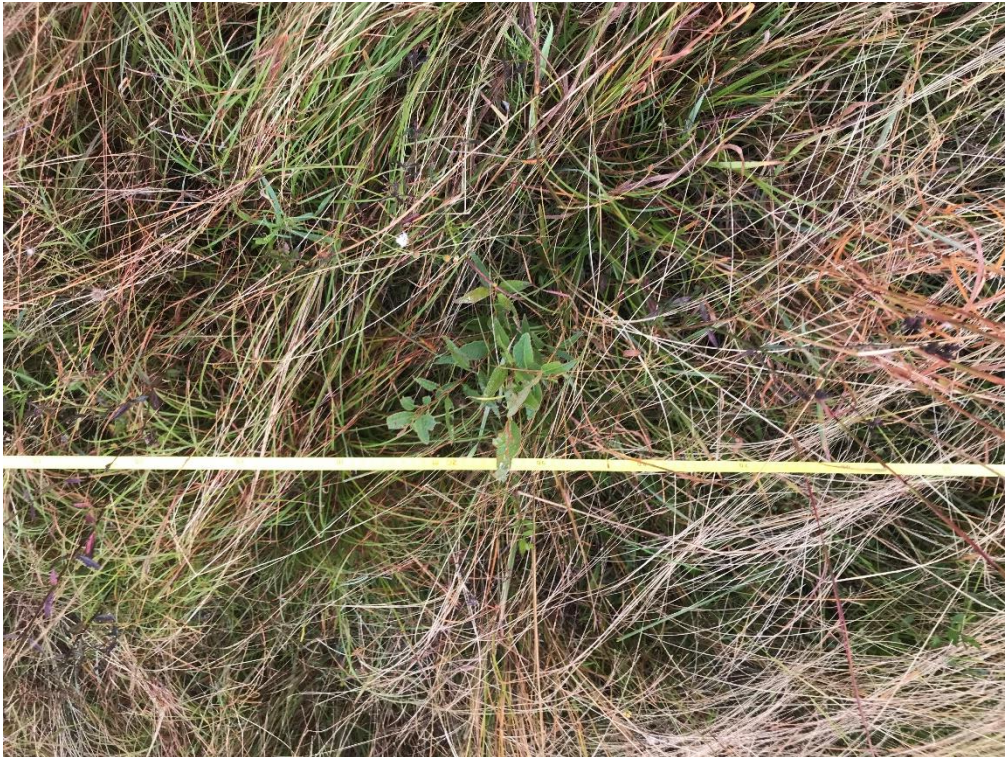
Plate 12: Pasture Rehabilitation Analogue Transect T33. Top, LFA transect showing the prevalence of Whisky Grass (upright reddish-brown grass). Bottom, view of typical grass and forb groundcover. Note the Rough-barked Apple seedling.

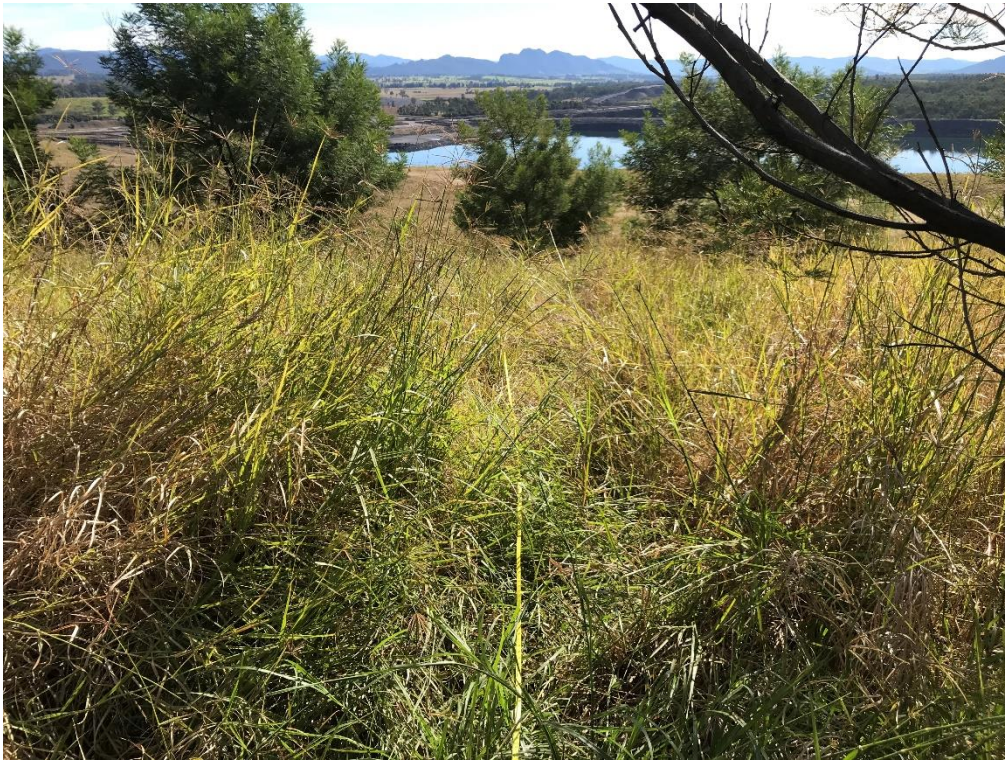
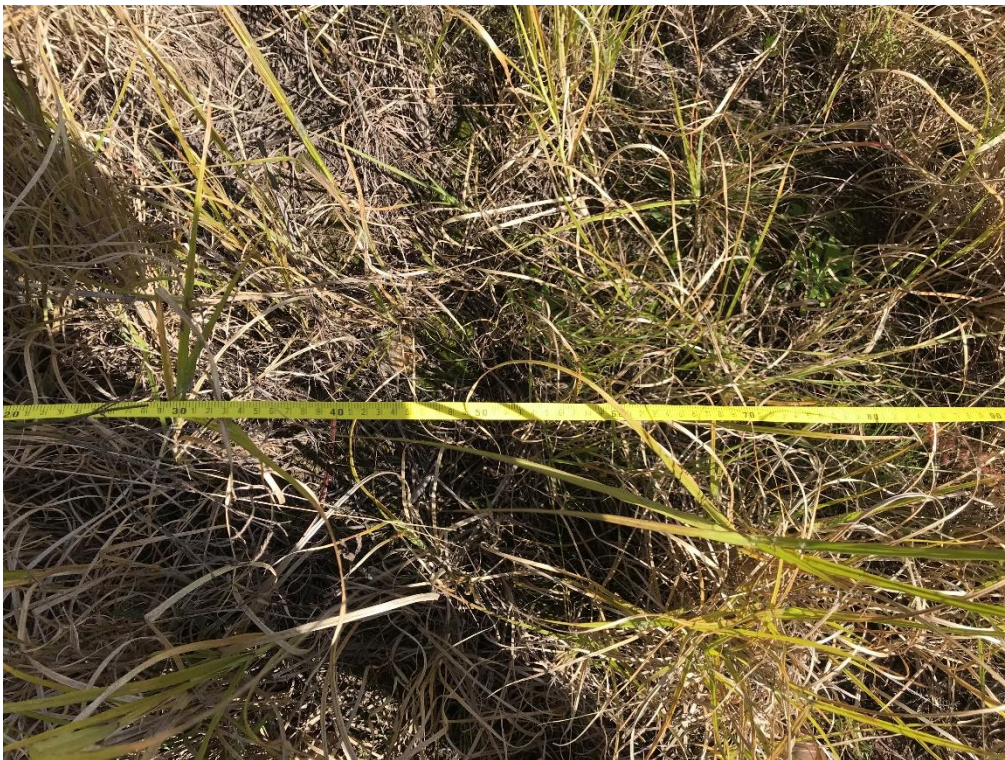
Plate 13: Stratford Waste Emplacement Pasture Rehabilitation Transect T5 (2003 rehabilitation). Top, LFA transect showing dense *Setaria* sward and mature *Acacias*. Bottom, typical dense grassy groundcover.

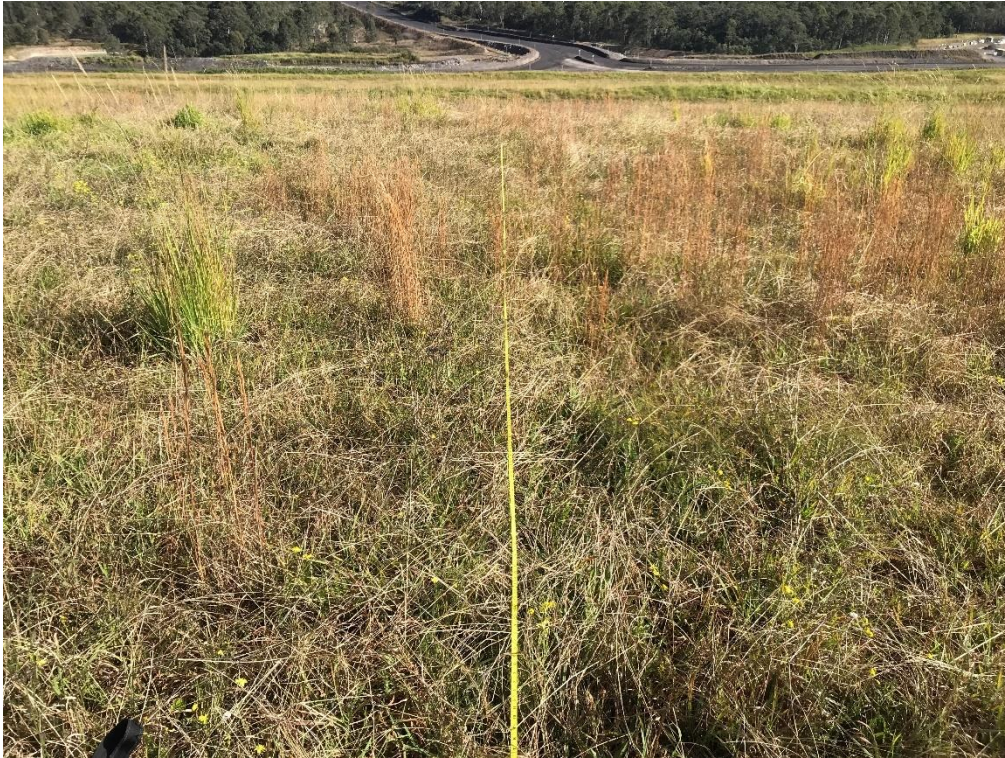
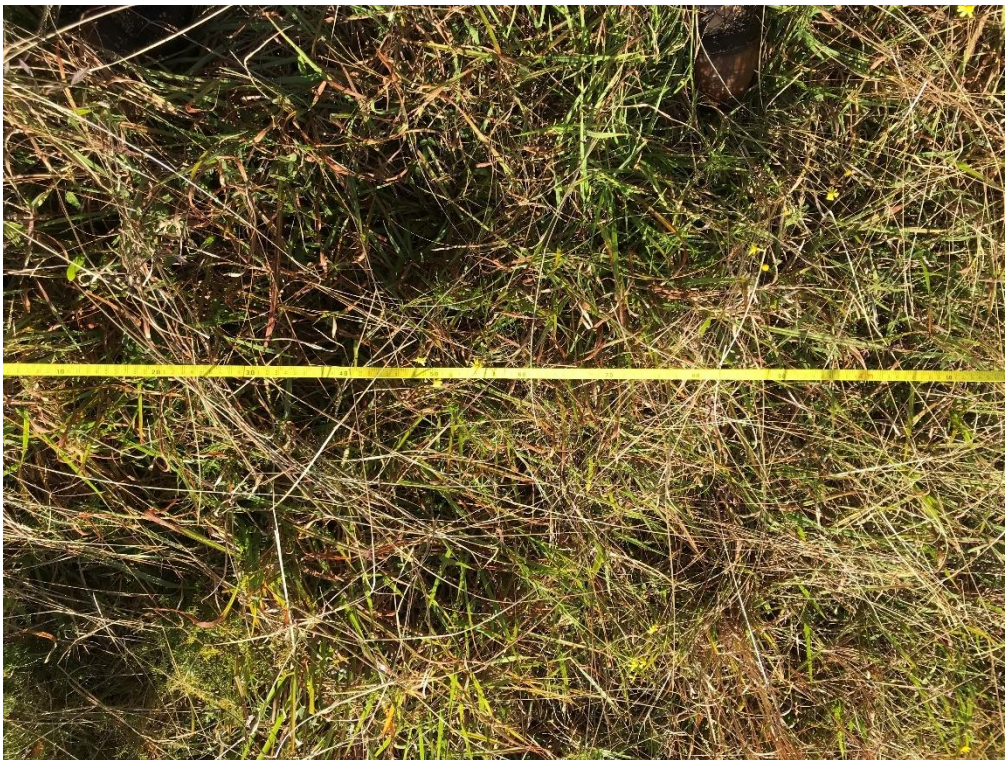
Plate 14: Stratford Waste Emplacement Pasture Rehabilitation Transect T8 (1996/97 rehabilitation). Top, LFA transect, Bottom, view of typical grassy groundcover.
