# Monthly Environmental Monitoring Report

Yancoal Mount Thorley Warkworth

February 2022

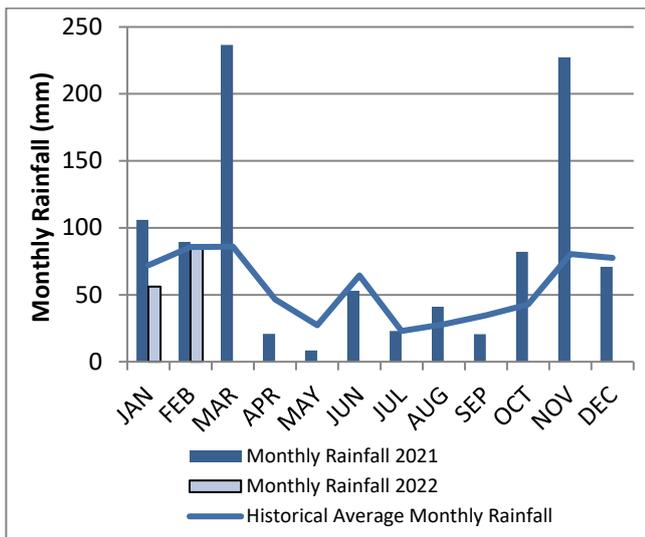
**Figure 1: Rainfall Trend YTD**

Rainfall for the reporting period is summarised in **Table 1**. The year-to-date monthly rainfall totals, 2022 monthly rainfall totals and historical average monthly rainfall trend are shown in **Figure 1**.

*Note: The historical average monthly rainfall is calculated from 2007 to 2021 monthly totals*

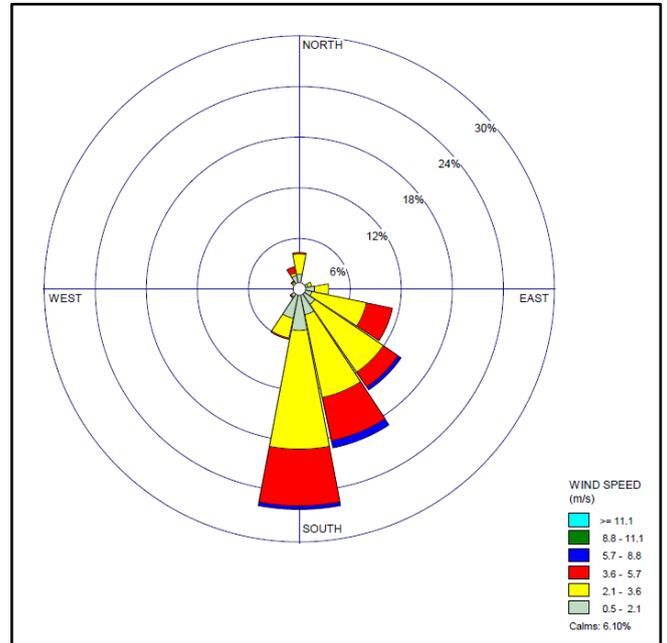
**Figure 2: Charlton Ridge Wind Rose – February 2022**

Winds from the south were dominant during the reporting period as shown in **Figure 2**.

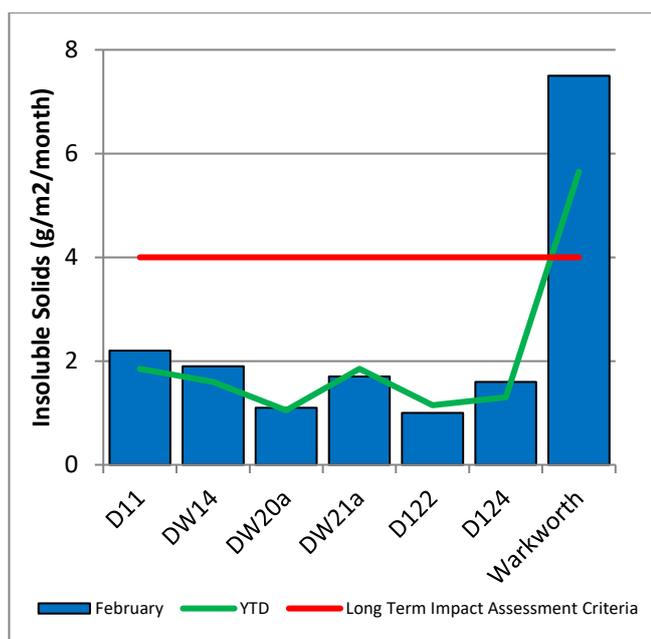
Figure 4: Depositional Dust – February 2022

During the reporting period the Warkworth monitor recorded a monthly result above the long-term impact assessment criteria of 4.0 g/m<sup>2</sup> per month. There is no evidence to suggest that the Warkworth result is contaminated. Accordingly, the result will be included in the annual average calculation.

Figure 4 displays insoluble solids results from depositional dust gauges during the reporting period compared against the year-to-date average and the annual impact assessment criteria.

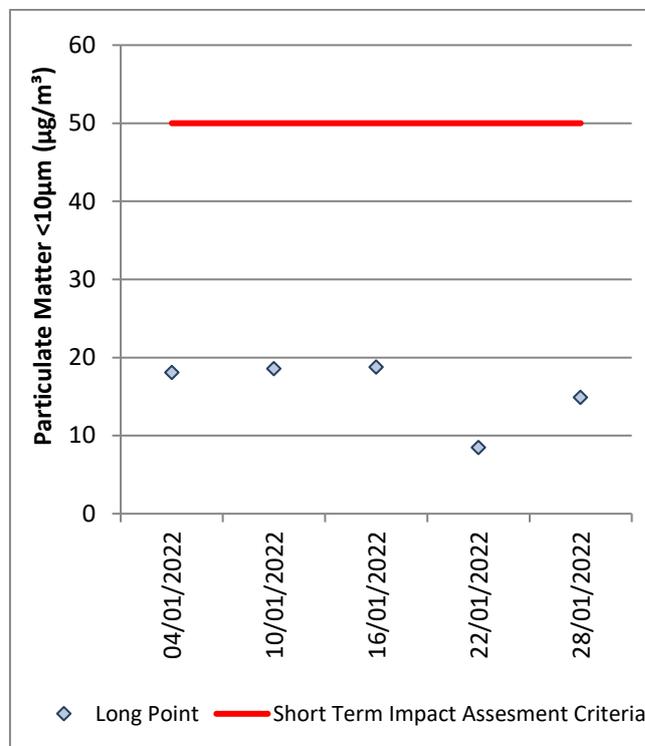
Figure 5: Individual PM10 Results – February 2022

Figure 5 shows the individual PM<sub>10</sub> results at each monitoring station against the short-term impact assessment criteria of 50µg/m<sup>3</sup>.

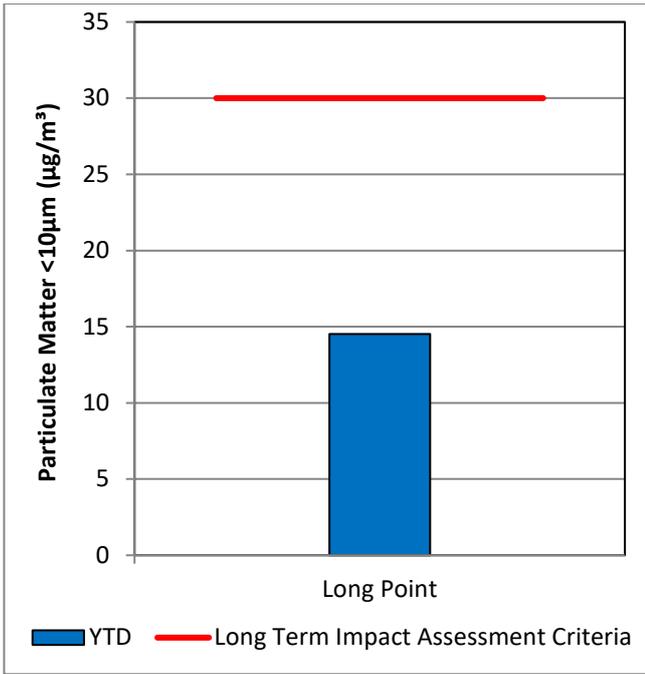
Figure 6: Annual Average PM<sub>10</sub> – February 2022

Figure 6 shows the annual average PM10 result against the long term impact assessment criteria.

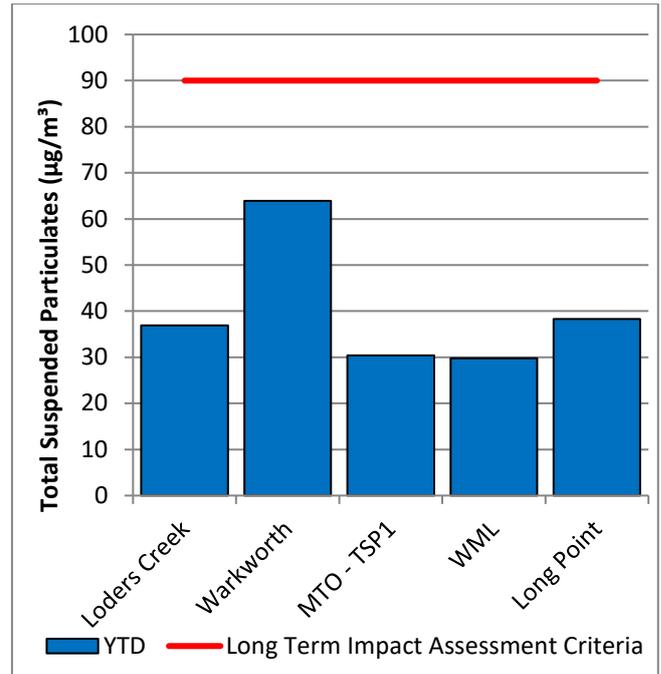
Figure 7: Annual Average Total Suspended Particulates – February 2022

Figure 7 shows the annual average TSP results compared against the long-term impact assessment criteria of 90µg/m<sup>3</sup>.

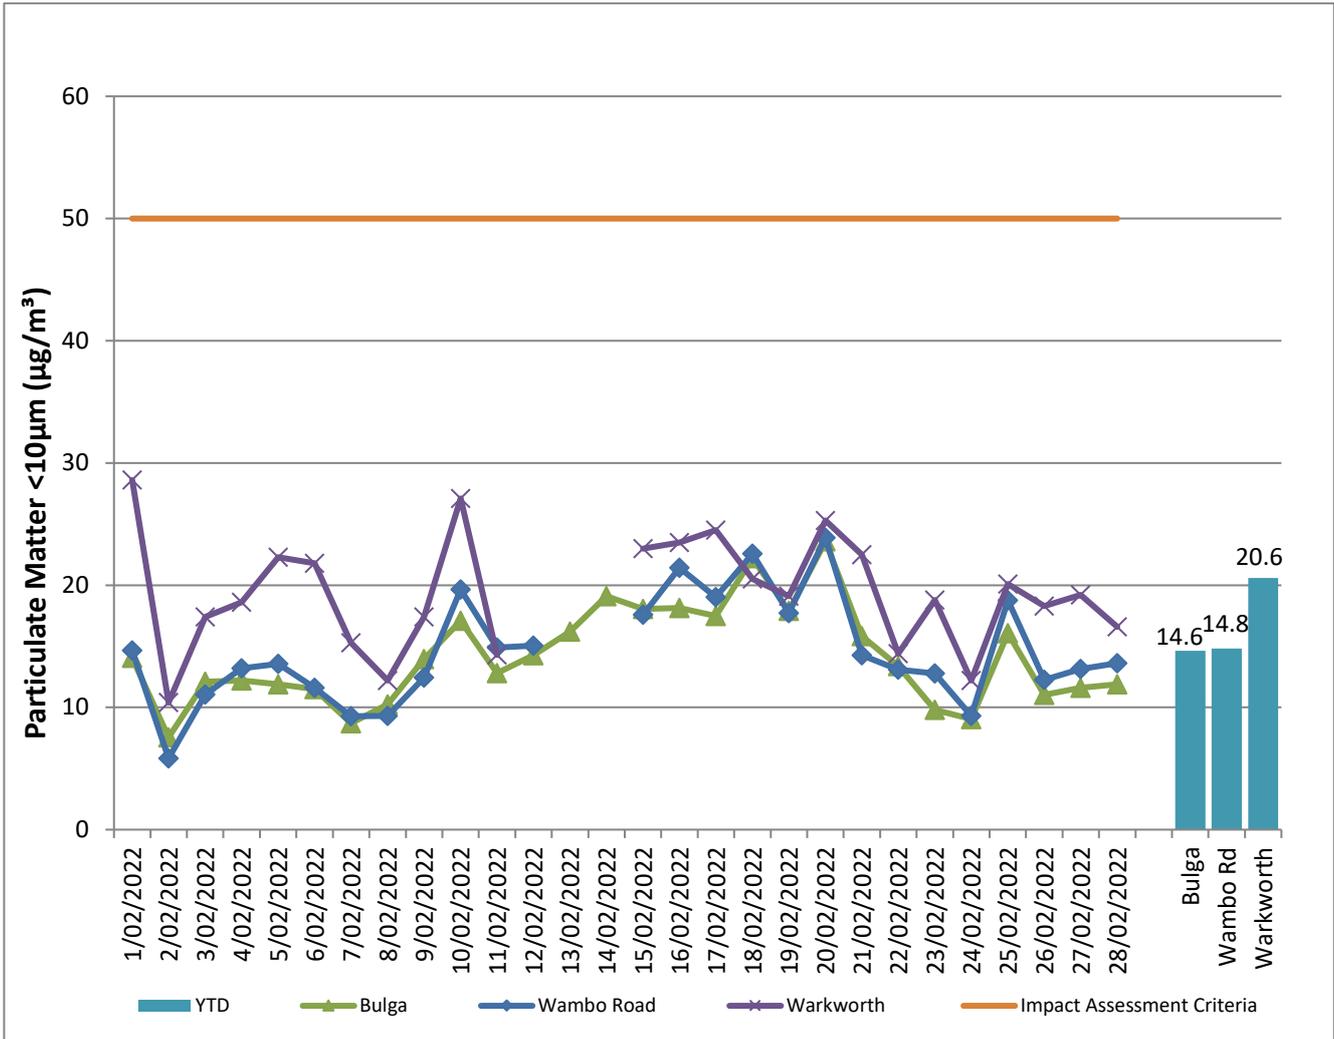
Figure 8: Real Time PM<sub>10</sub> daily 24hr average (line graphs) and YTD annual average (column graphs) – February

Results for real time dust sampling are shown in Figure 8, including the daily 24-hour average PM<sub>10</sub> result and the annual PM<sub>10</sub> average.

Data was not available on 13 and 14 February 2022 from the Wambo Road monitor and from 12 to 14 February from the Warkworth Monitor due to equipment issues.

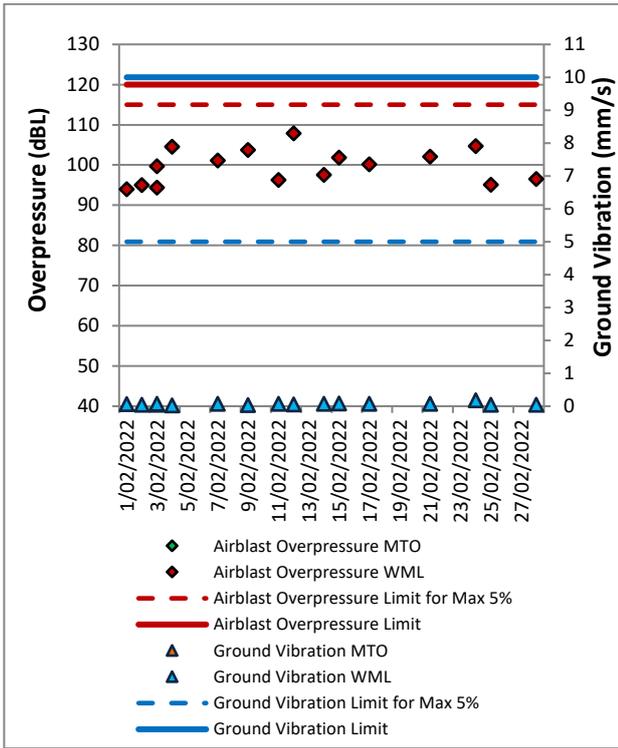
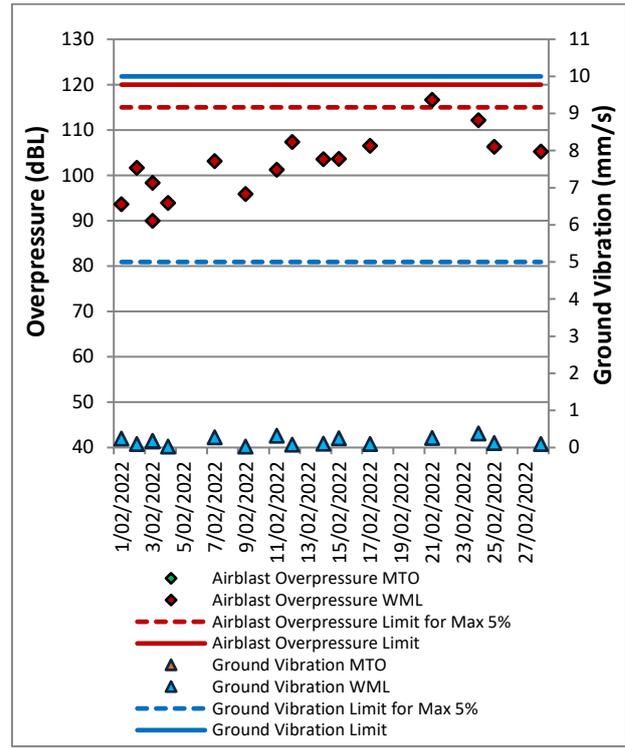
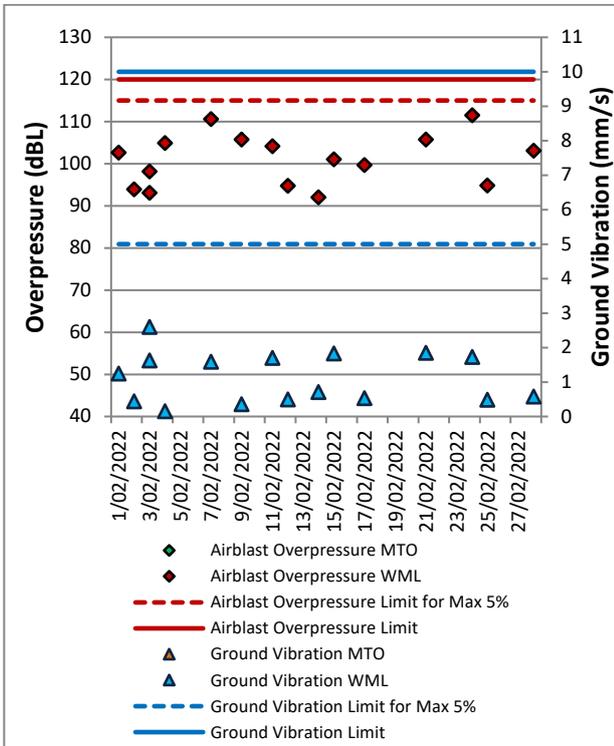
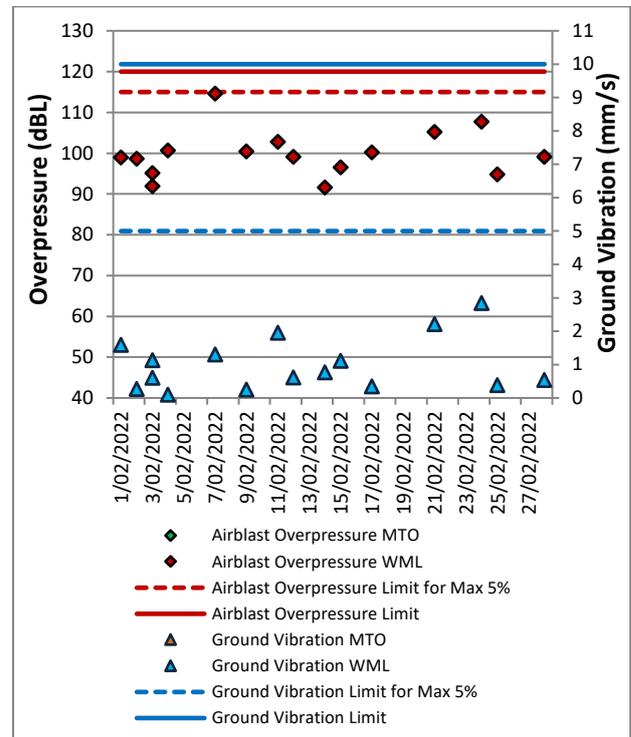
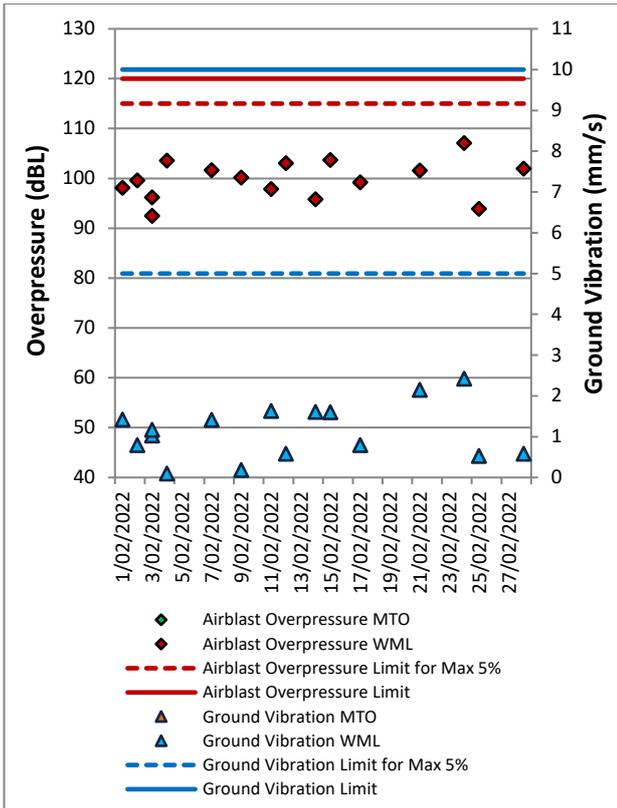
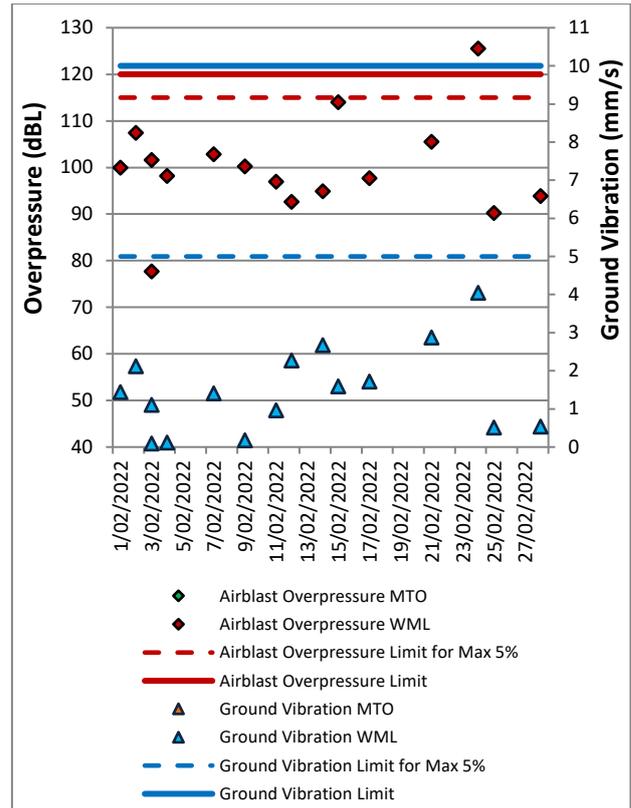
During February 2022, 16 blasts were initiated at MTW. **Figure 9** to **Figure 14** show the blast monitoring results for the reporting period against the impact assessment criteria. The criteria are summarised in **Table 2**.

During the reporting period one blast exceeded the 120 dB(L) threshold for airblast overpressure at the Warkworth monitoring location and was reported to the Department of Planning and Environment and the Environment Protection Authority on 24 February 2022 and investigated (refer to section 8.0 below). One blast also exceeded the 115dB(L) threshold for airblast overpressure at the MTIE monitoring location. No blast exceeded the 5mm/s criteria for ground vibration.

On the 24 February 2022, one blast event exceeded the 120dB(L) threshold for airblast overpressure at the Warkworth blast monitor. The exceedance was reported to the Department of Planning and Environment (DPE) and to the Environment Protection Authority (EPA) on 24 February 2022. A written report was also provided to DPE and to the EPA for this blast which noted preliminary analysis indicates that elevated airblast overpressure above the maximum limit in development consent SSD-6464 may have been caused by the effects of meteorology, which may have differed to the predicted meteorological effects. No blasts exceeded the 5mm/s threshold for ground vibration.

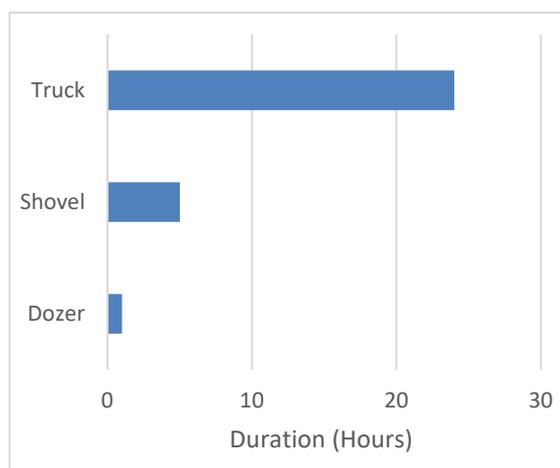
**Figure 17: Operational Downtime by Equipment Type – February 2022**

During February, a total of 31 hours of equipment downtime was logged in response to environmental events such as dust, noise and adverse meteorological conditions. Operational downtime by equipment type is shown in **Figure 17**.

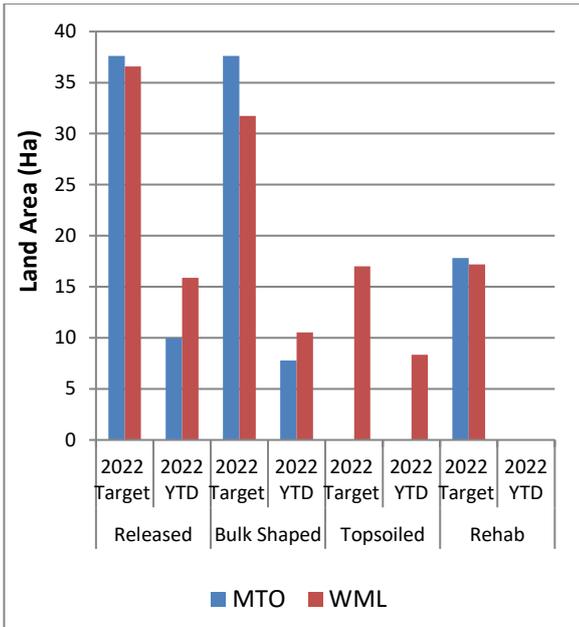
Figure 18: Rehabilitation YTD - February 2022

During February 2022, 7.06 Ha of land was released and 0.37 Ha was bulk shaped. No land was topsoiled, composted or rehabilitated.
