# Monthly Environmental Monitoring Report

Yancoal Mount Thorley Warkworth

June 2022

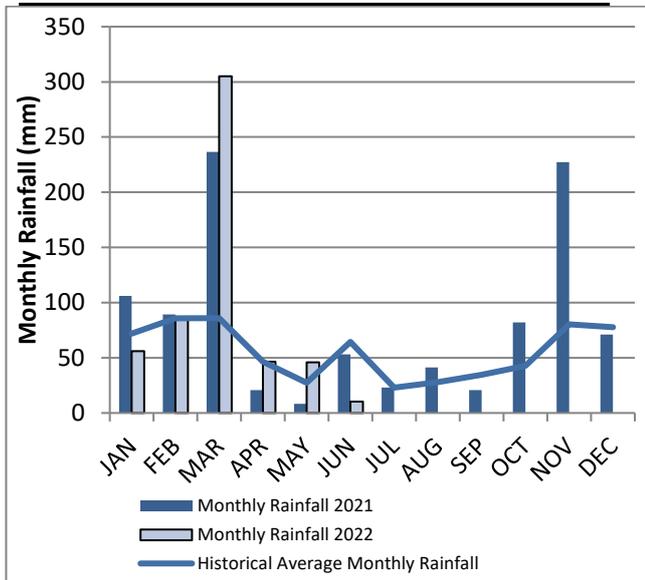
**Figure 1: Rainfall Trend YTD**

Rainfall for the reporting period is summarised in **Table 1**. The year-to-date monthly rainfall totals, 2022 monthly rainfall totals and historical average monthly rainfall trend are shown in **Figure 1**.

2022	Monthly Rainfall (mm)	Cumulative Rainfall (mm)
June	10.2	550.4

Note: The historical average monthly rainfall is calculated from 2007 to 2021 monthly totals

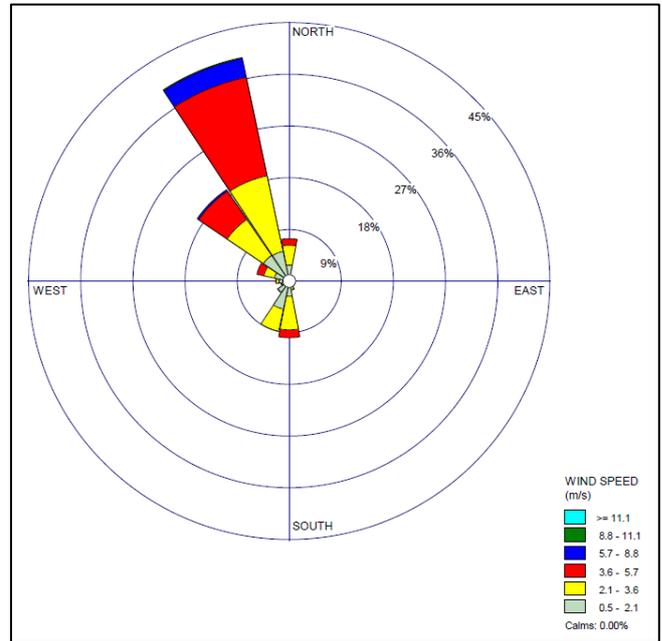
**Figure 2: Charlton Ridge Wind Rose – June 2022**

Winds from the north west were dominant during the reporting period as shown in **Figure 2**.

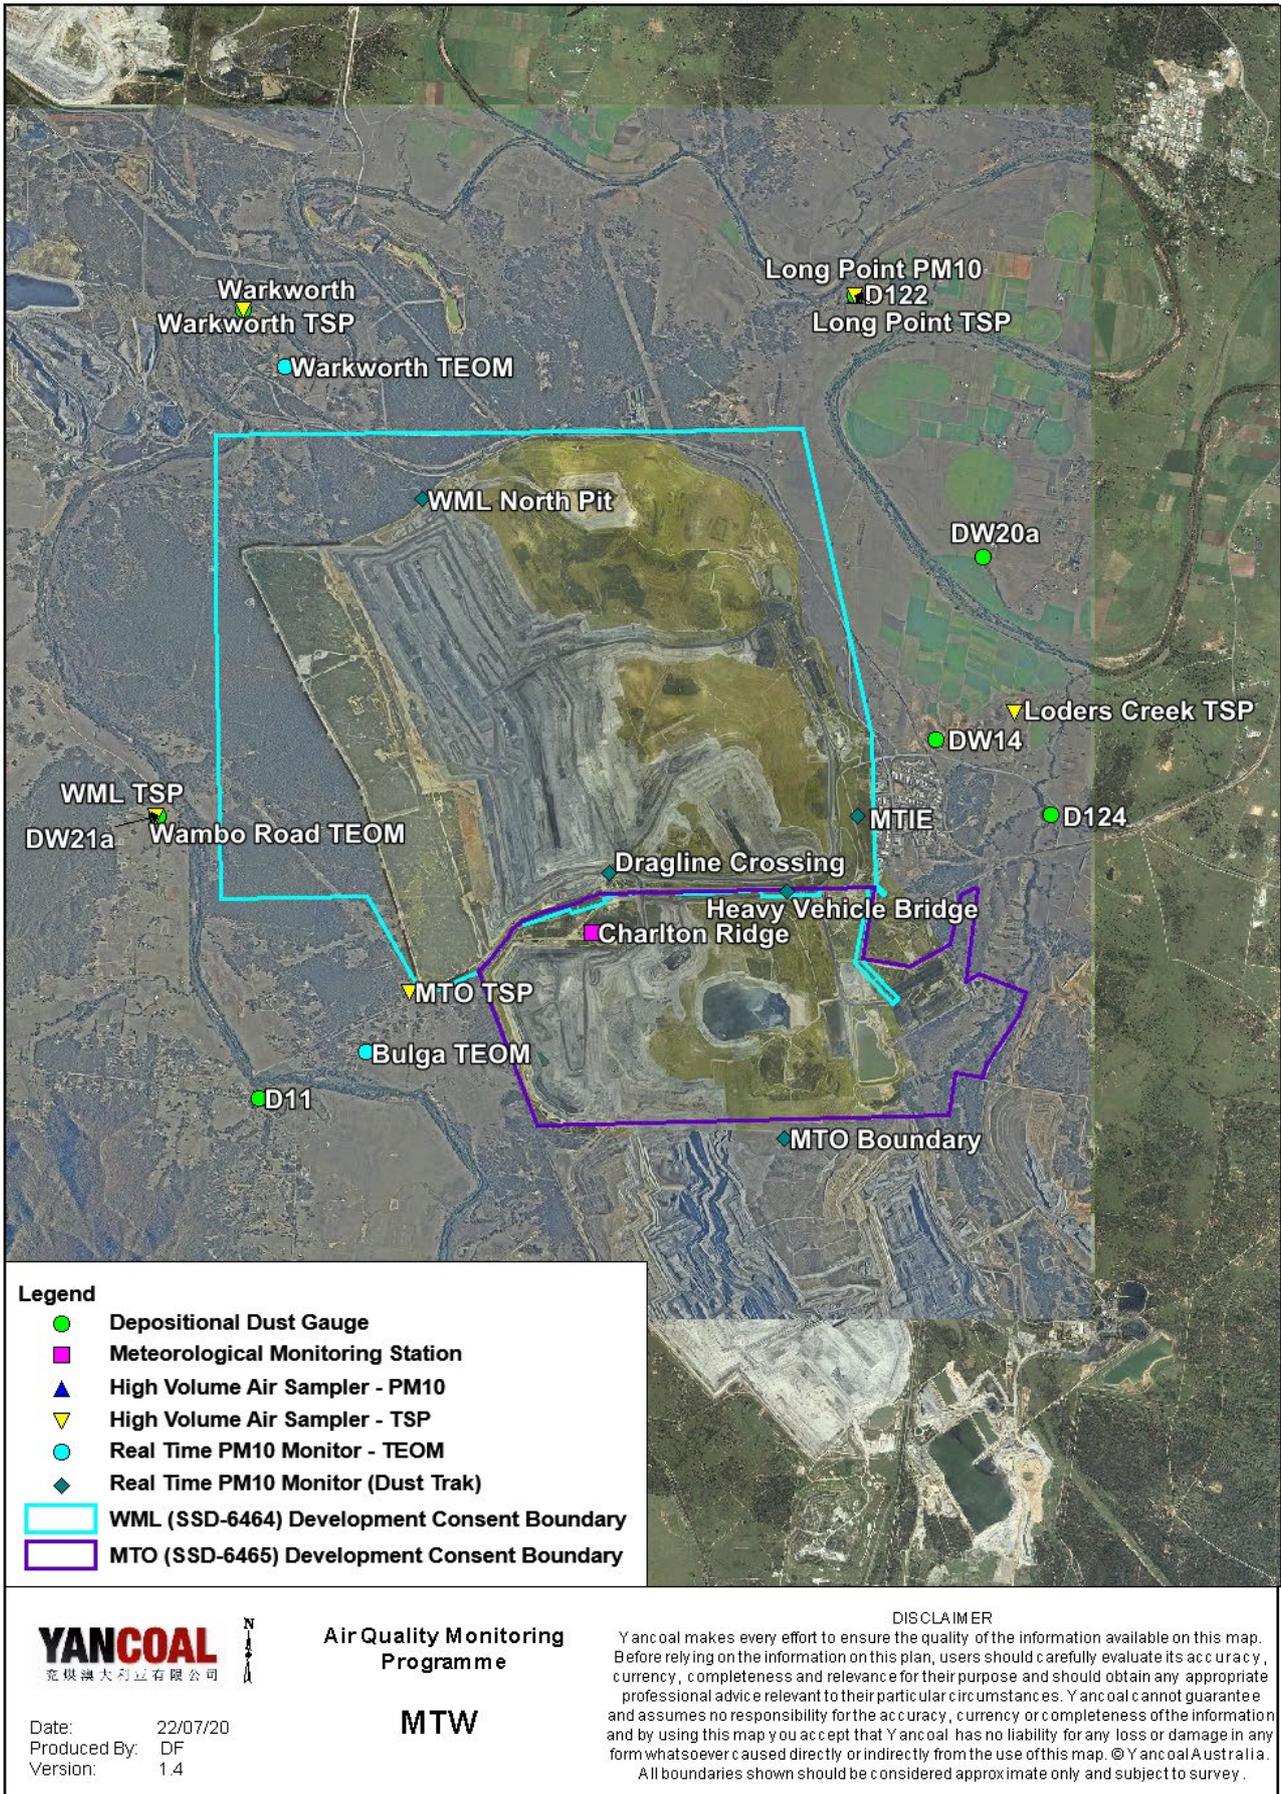
Figure 3: Air Quality Monitoring Locations

Meteorological data is collected at MTW's 'Charlton Ridge' meteorological station (refer to **Figure 3: Air Quality Monitoring Locations**).

Suspended particulates are measured by a network of High Volume Air Samplers (HVAS) measuring Total Suspended Particulates (TSP) and Particulate Matter <10µm (PM<sub>10</sub>). The location of these monitors can be found in **Figure 3**. Each HVAS was run for 24 hours on a six-day cycle in accordance with EPA requirements.

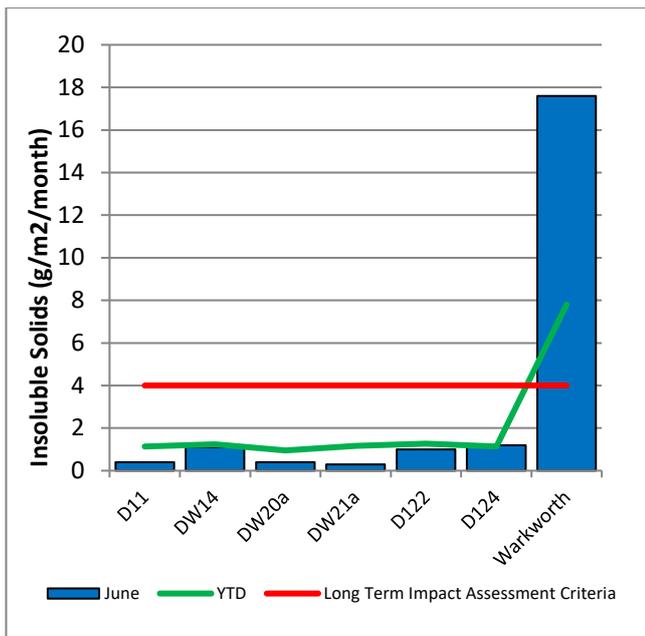
**Figure 4: Depositional Dust – June 2022**

During the reporting period the Warkworth monitor recorded a monthly result above the long-term impact assessment criteria of 4.0 g/m<sup>2</sup> per month. There is no evidence to suggest that the Warkworth result is contaminated. Accordingly, the result will be included in the annual average calculation.

**Figure 4** displays insoluble solids results from depositional dust gauges during the reporting period compared against the year-to-date average and the annual impact assessment criteria.

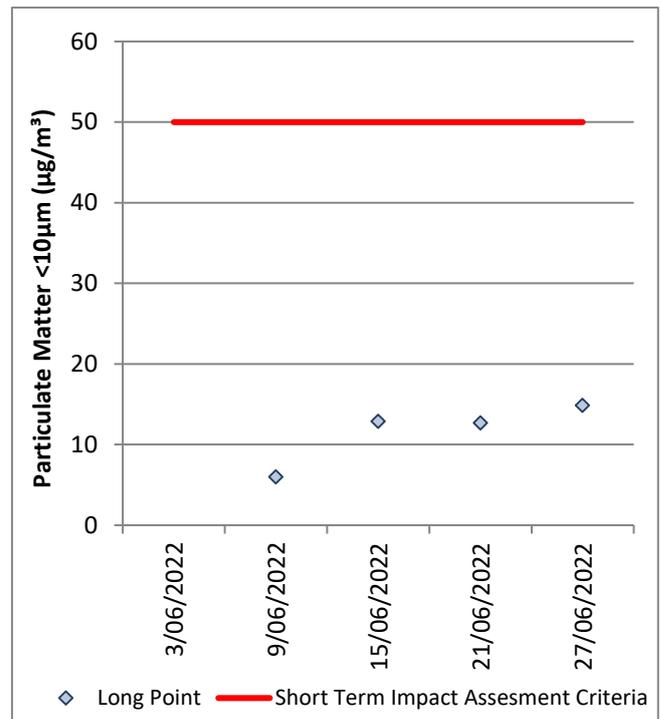
**Figure 5: Individual PM<sub>10</sub> Results – June 2022**

**Figure 5** shows the individual PM<sub>10</sub> results at each monitoring station against the short-term impact assessment criteria of 50µg/m<sup>3</sup>.

Data was not available on 3/06/2022 at the Long Point HVAS due to a power outage.

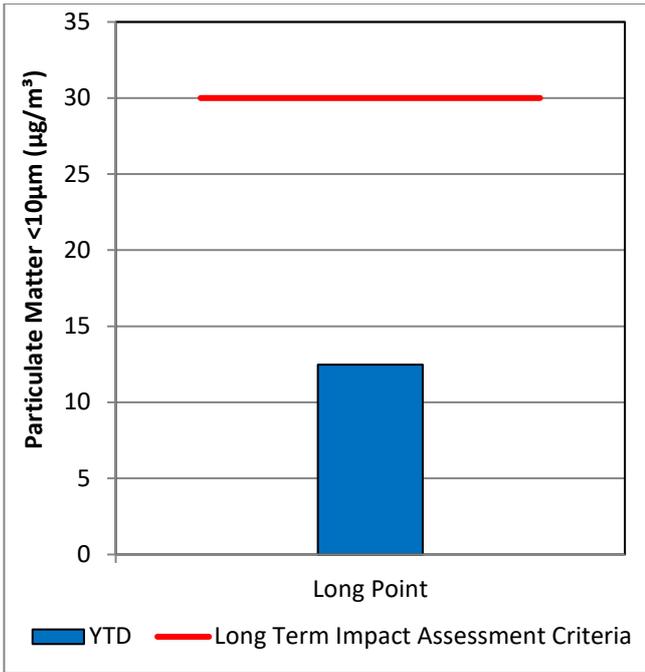
Figure 6: Annual Average PM<sub>10</sub> – June 2022

**Figure 6** shows the annual average PM<sub>10</sub> result against the long term impact assessment criteria.

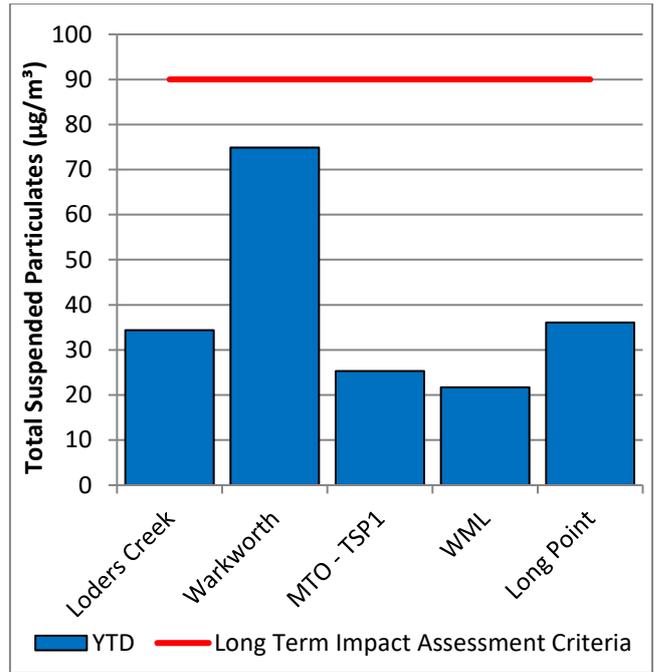
Figure 7: Annual Average Total Suspended Particulates – June 2022

Figure 7 shows the annual average TSP results compared against the long-term impact assessment criteria of 90µg/m<sup>3</sup>.

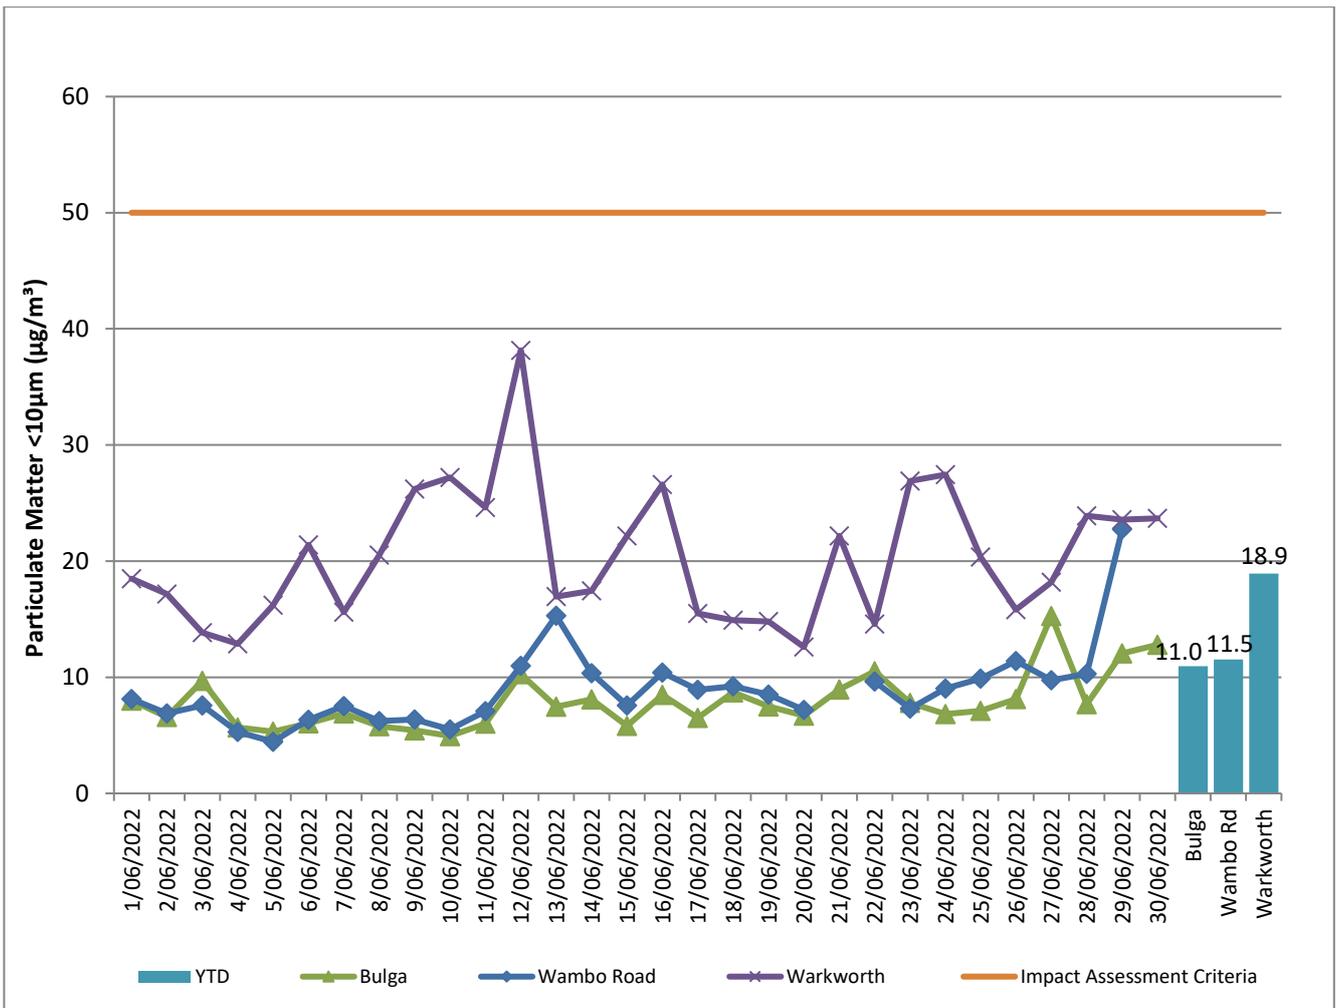
Results for real time dust sampling are shown in Figure 8, including the daily 24-hour average PM<sub>10</sub> result and the annual PM<sub>10</sub> average.

Data was not available on 21 and 30 June from the Wambo Road monitor due to equipment issues.

Figure 7: Real Time PM<sub>10</sub> daily 24hr average (line graphs) and YTD annual average (column graphs) – June 2022

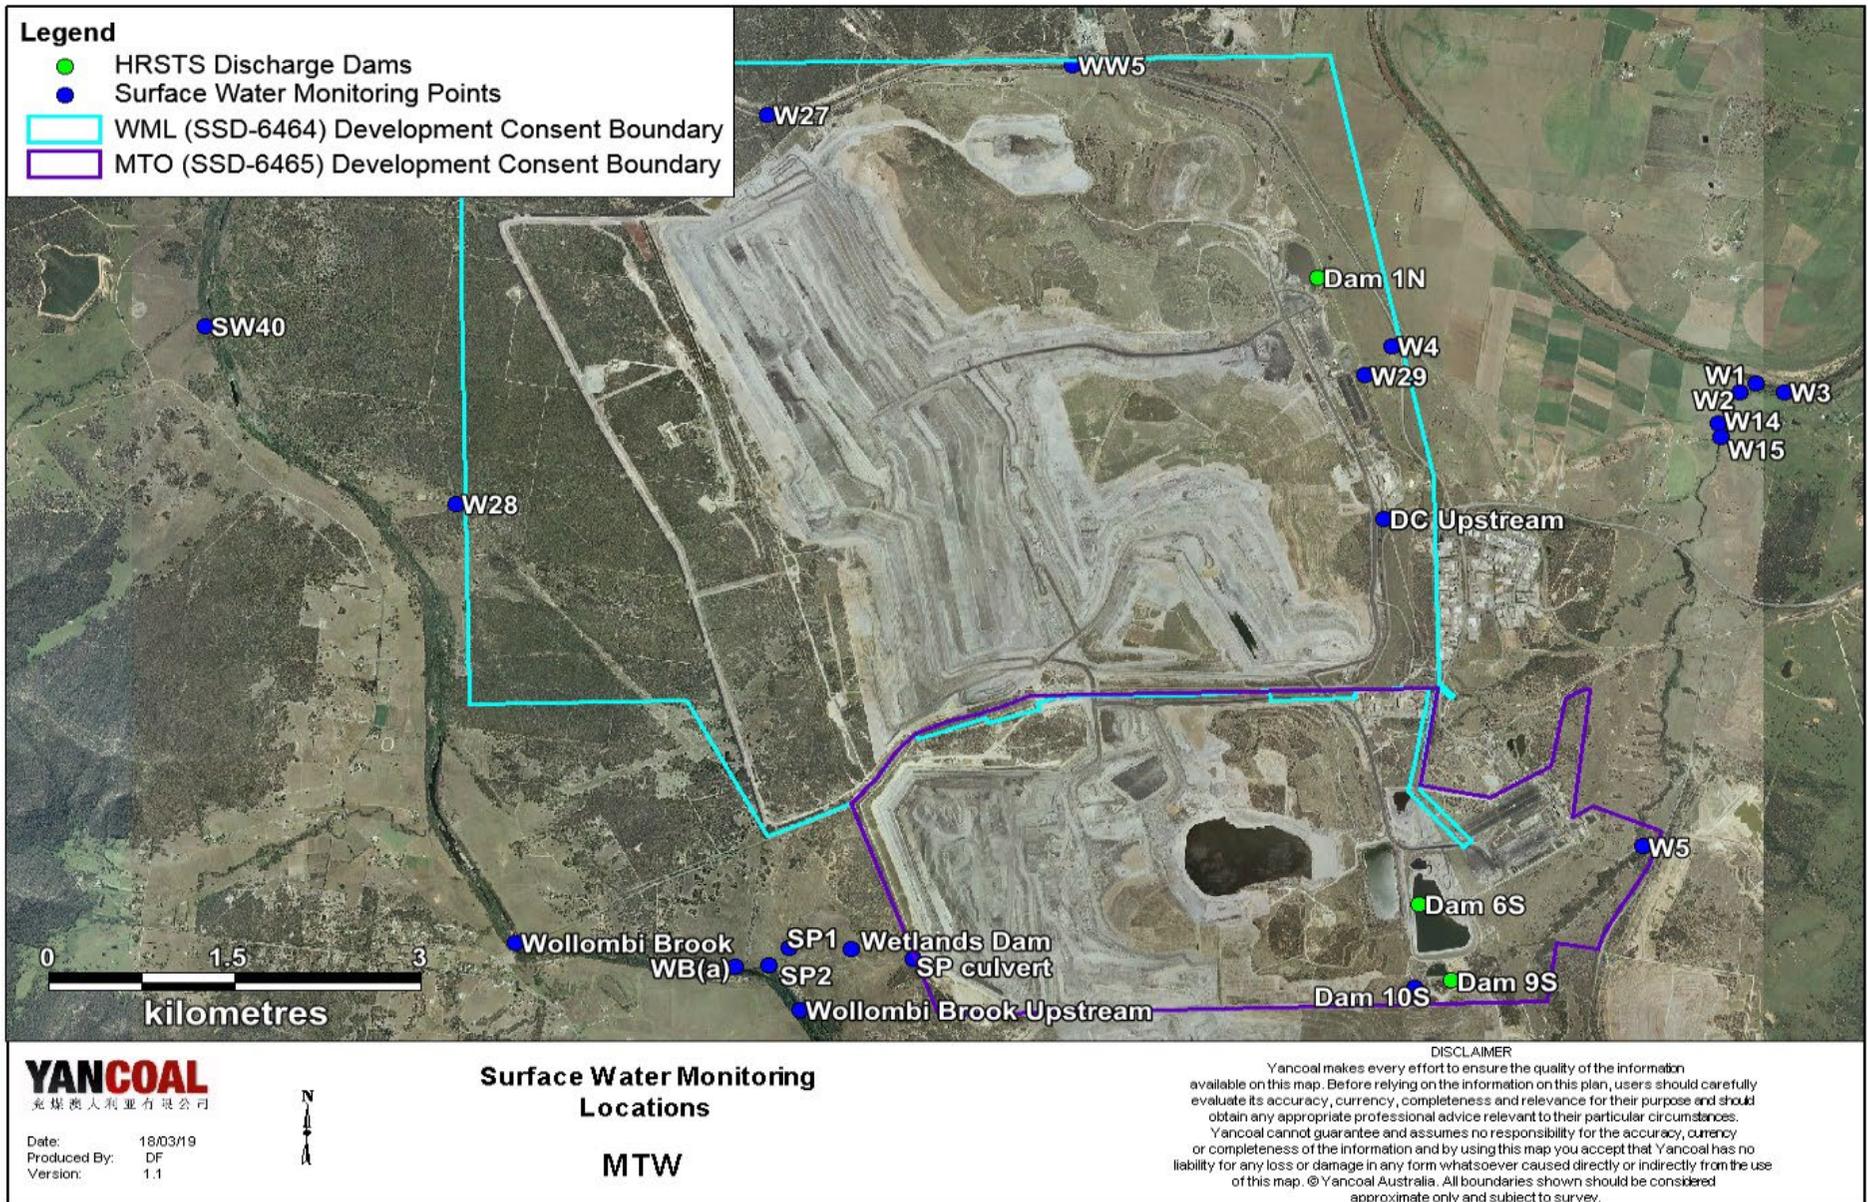
Figure 14: Surface Water Monitoring Location Plan

Monitoring is conducted at mine site dams and surrounding natural watercourses. The surface water monitoring locations are outlined in Figure 15.

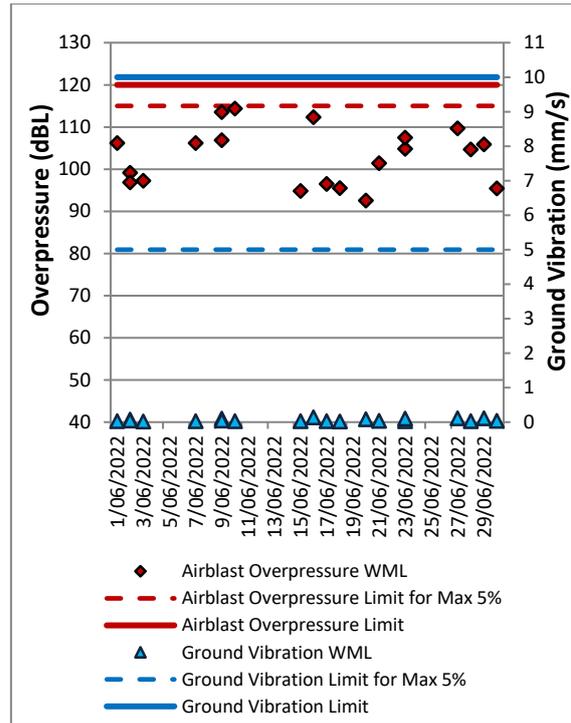
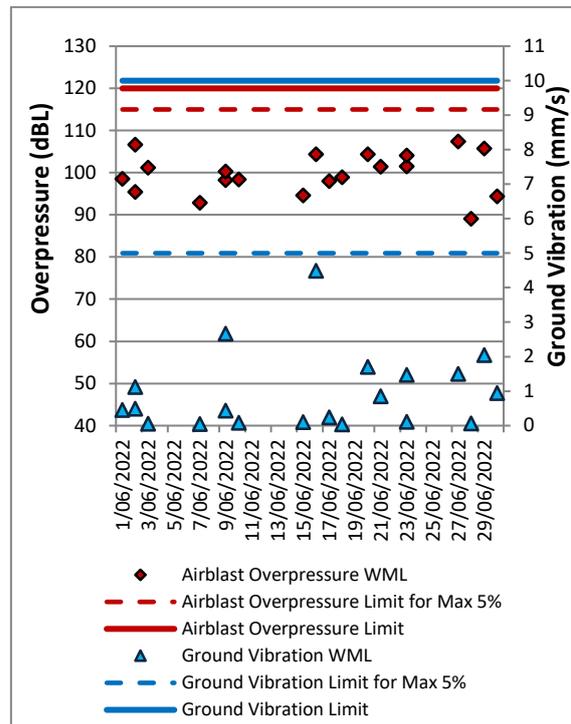
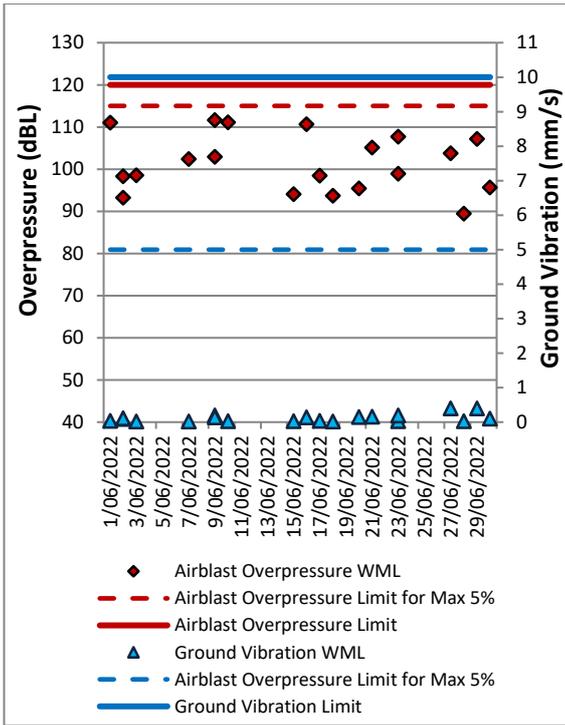
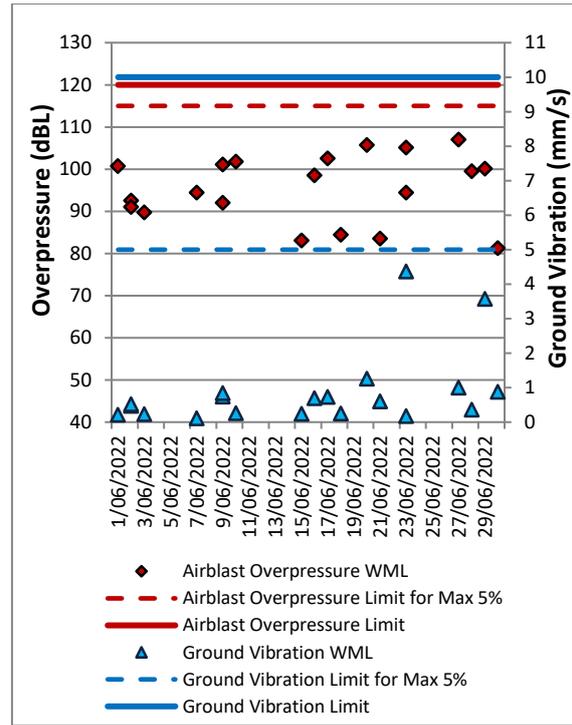
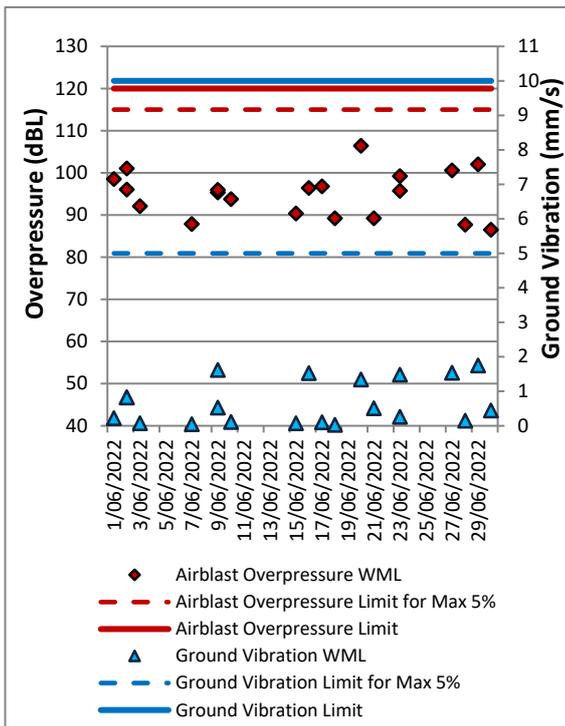
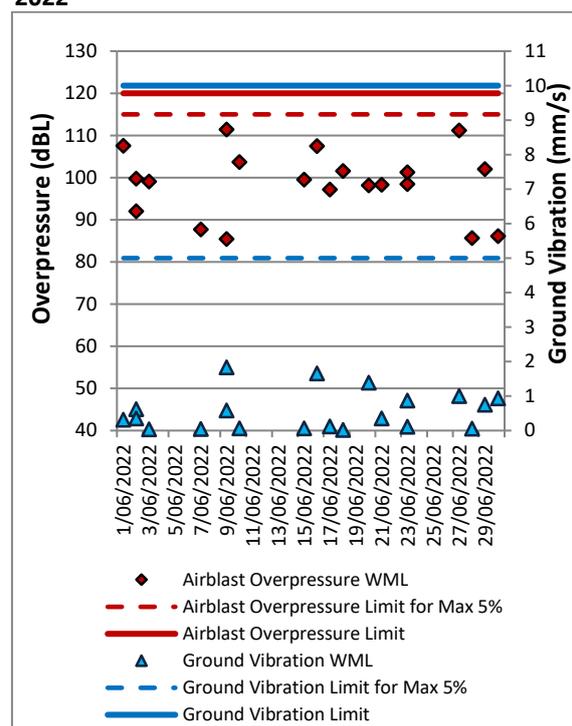
During June 2022, 20 blasts were initiated at MTW. **Figure 67** to **Figure 72** show the blast monitoring results for the reporting period against the impact assessment criteria. The criteria are summarised in **Table 4**.

During the reporting period no blasts exceeded the 115 dB(L) 5% threshold for airblast overpressure or 5mm/s 5% threshold for ground vibration.

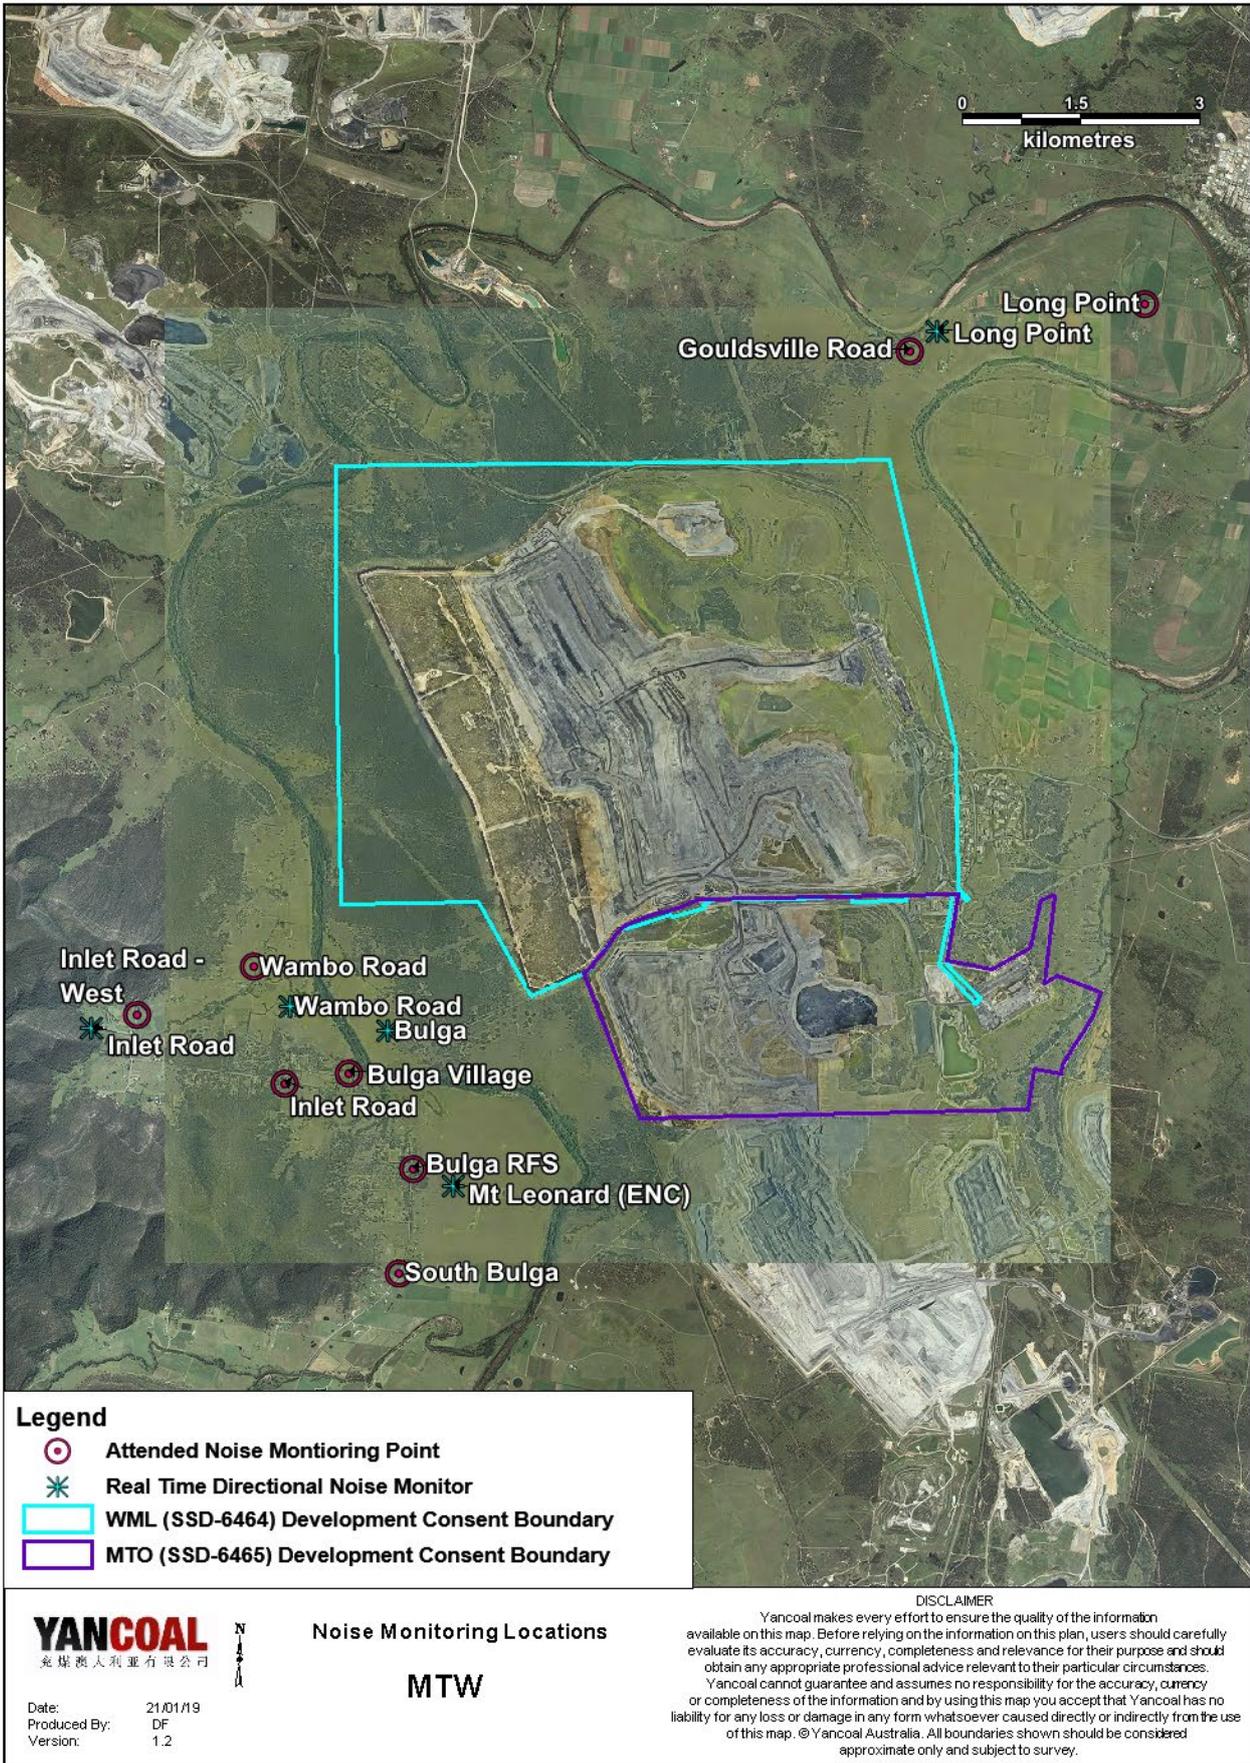
Figure 72: Noise Monitoring Location Plan

Routine attended noise monitoring is carried out in accordance with the MTW Noise Management Plan. A review against EIS predictions will be reported in the Annual Review. The purpose of the noise surveys is to quantify and describe the acoustic environment around the site and compare results with specified limits. Real time noise monitoring also occurs at five sites surrounding MTW. Noise monitoring locations are displayed in **Figure 74**.

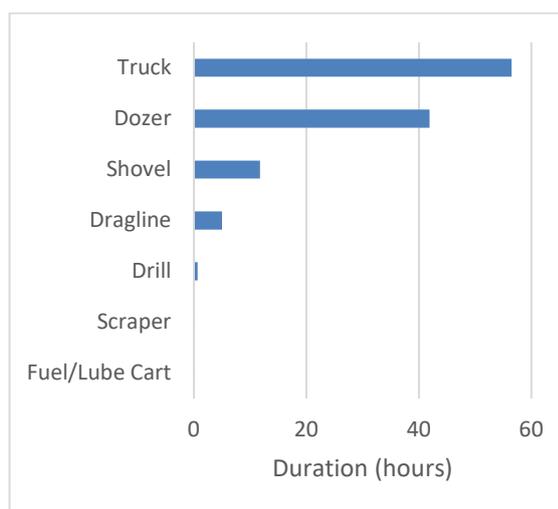
**Figure 73: Operational Downtime by Equipment Type – June 2022**

During June, a total of 116 hours of equipment downtime was logged in response to environmental events such as dust, noise and adverse meteorological conditions. Operational downtime by equipment type is shown in **Figure 75**.
