Monthly Environmental

Monitoring Report

Yancoal Mt Thorley Warkworth

February 2018

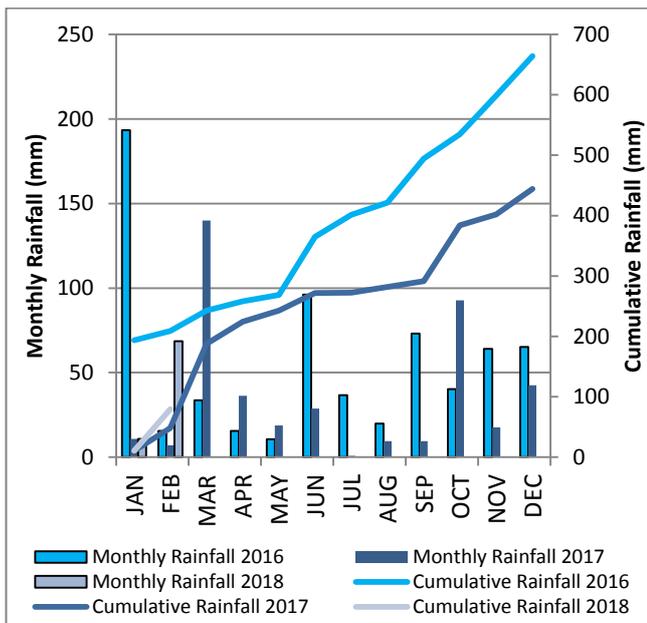
Figure 1: Rainfall Trend YTD

Rainfall for the period is summarised in Table 1, the year-to-date trend and historical trend are shown in **Error! Reference source not found.**

2018	Monthly Rainfall (mm)	Cumulative YTD Rainfall (mm)
February	68.6	79.4

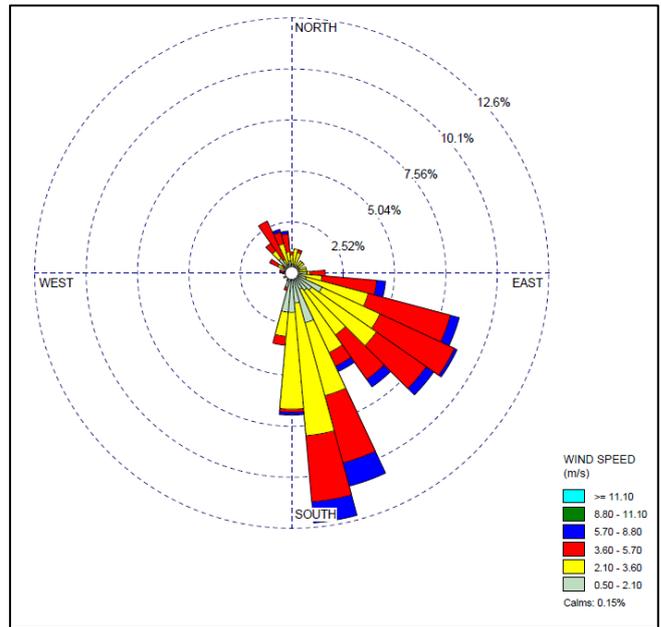
Figure 2: Charlton Ridge Wind Rose – February 2018

Winds from the South – East were dominant throughout the reporting period as shown in **Error! Reference source not found.**

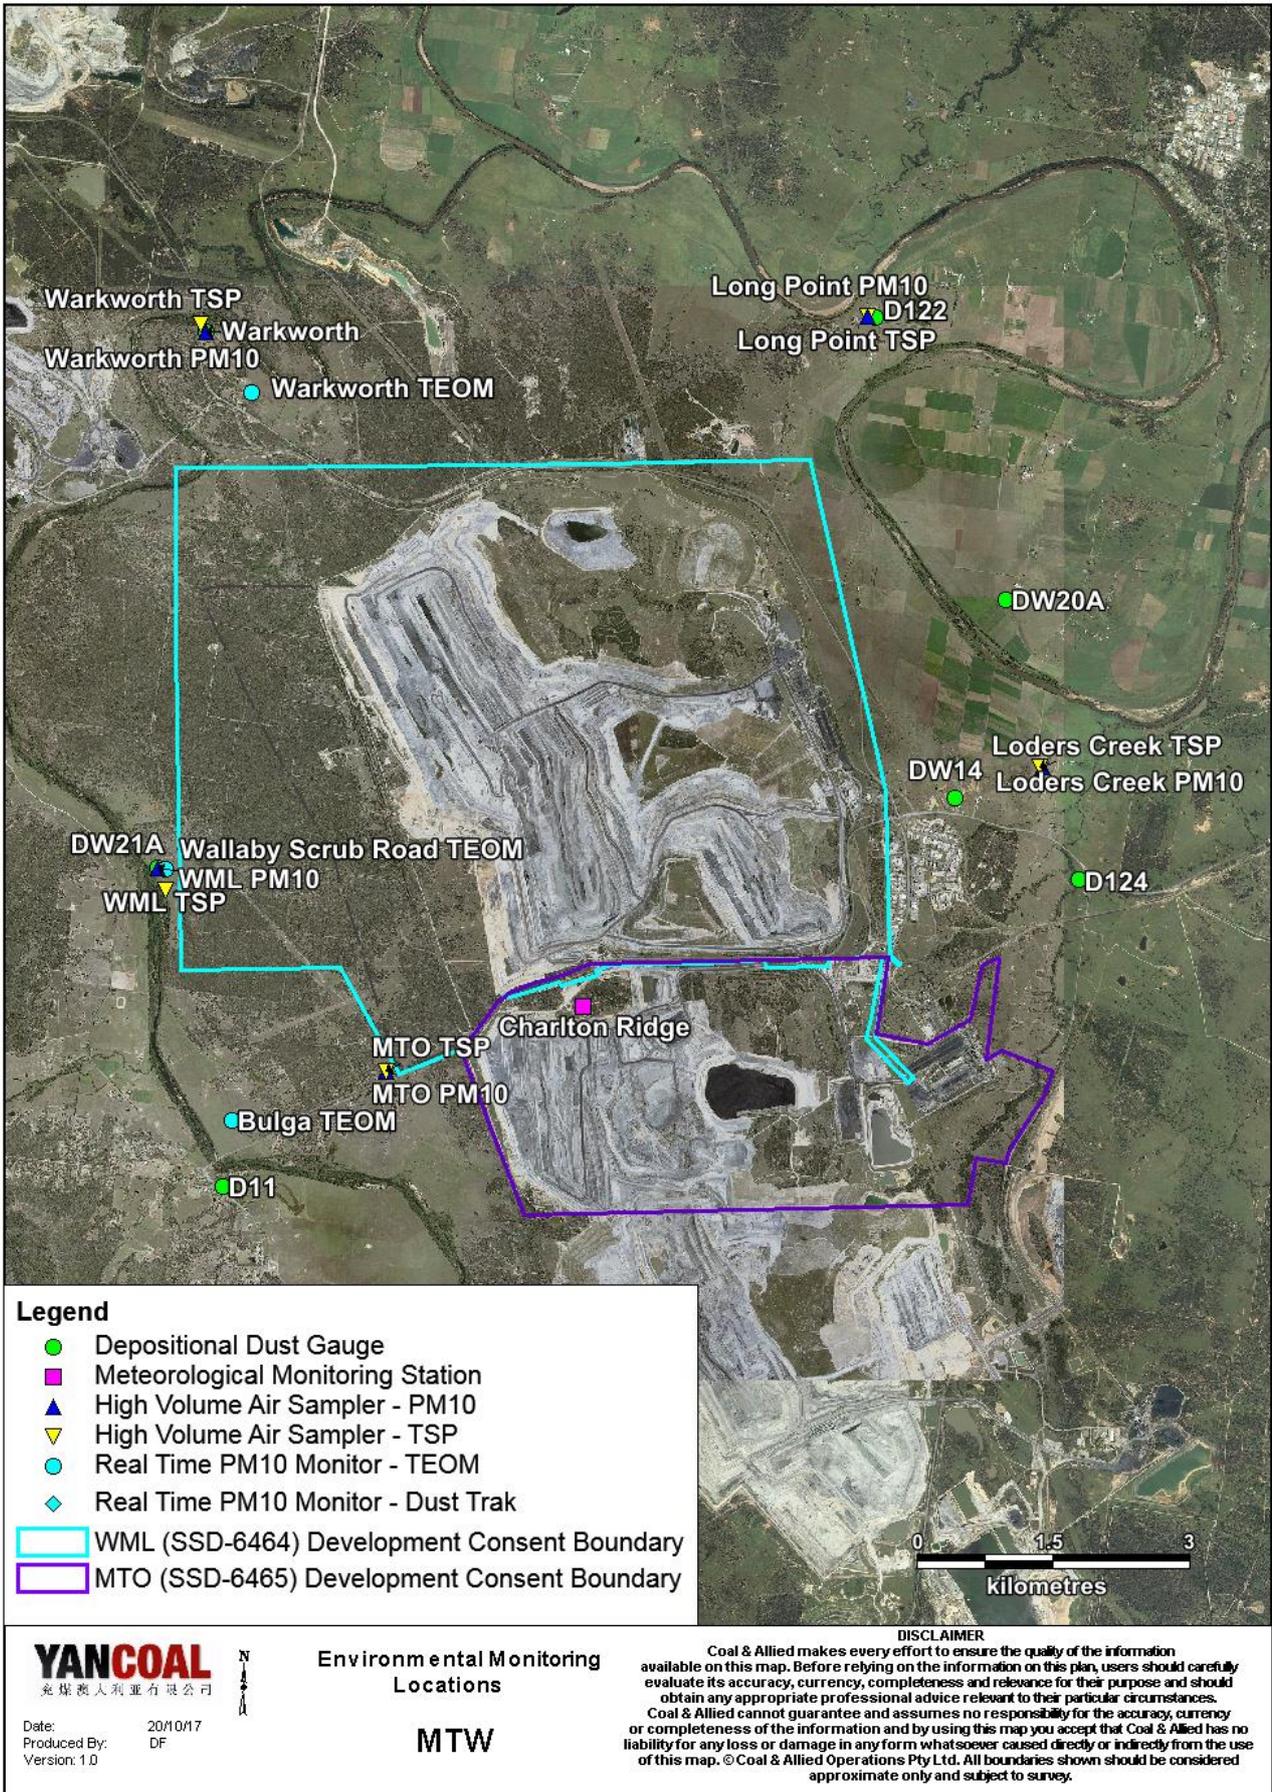
Figure 3: Air Quality Monitoring Locations

Meteorological data is collected at MTW’s ‘Charlton Ridge’ meteorological station (refer to Figure 3: Air Quality Monitoring Locations).

Suspended particulates are measured by a network of High Volume Air Samplers (HVAS) measuring Total Suspended Particulates (TSP) and Particulate Matter <10µm (PM₁₀). The location of these monitors can be found in Figure 3. Each HVAS was run for 24 hours on a six-day cycle in accordance with EPA requirements.

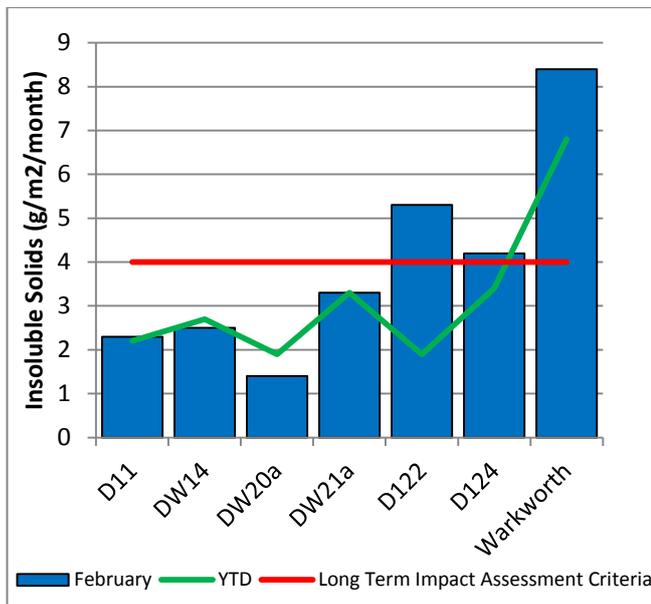
Figure 4: Depositional Dust – February 2018

Error! Reference source not found. displays insoluble solids results from depositional dust gauges during the reporting period compared against the year-to-date average and the annual impact assessment criteria.

During the reporting period the D122, D124 and Warkworth monitors recorded monthly results above the long term impact assessment criteria of 4.0 g/m² per month. Field notes associated with D122, D124 and Warkworth confirm the presence of bird droppings and/or vegetation and/or insects. As such the results are considered contaminated and will be excluded from calculation of the annual average.

An assessment of MTW's contribution to the long term assessment criteria will be reported in the 2018 Annual Return.

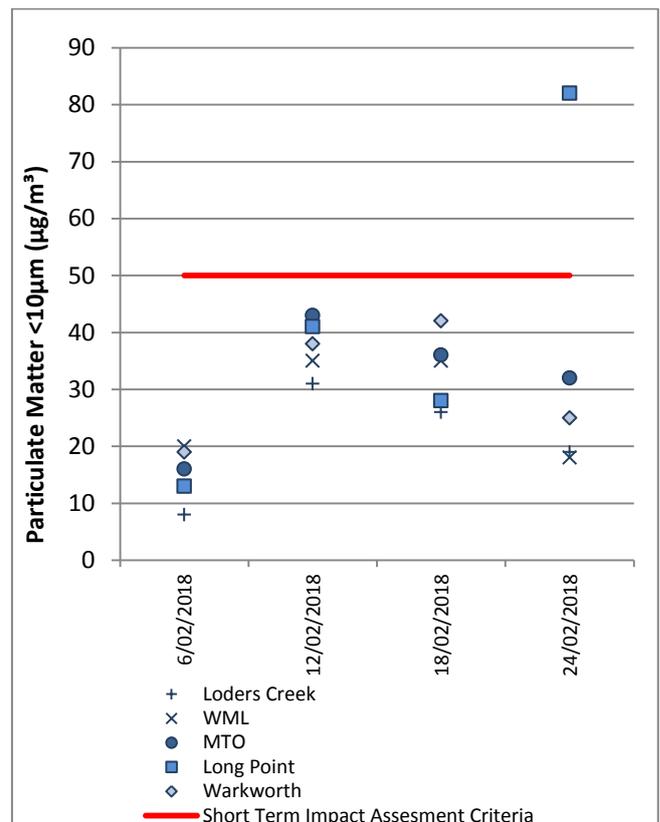
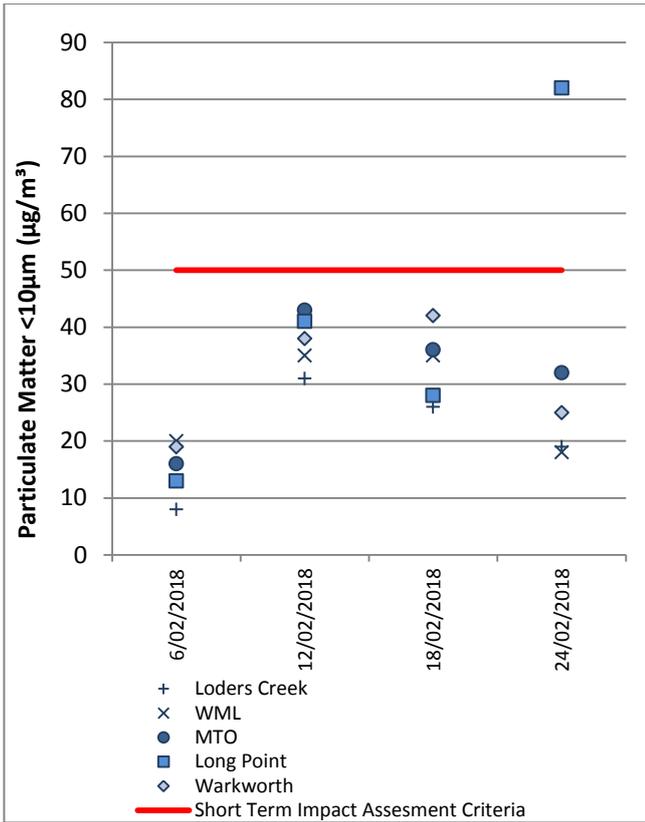
Figure 5: Individual PM₁₀ Results – February 2018

Figure 5 shows the individual PM₁₀ results at each monitoring station against the short term impact assessment criteria of 50µg/m³.

On 24/02/2018 the Long Point HVAS PM₁₀ unit recorded a result of 82µg/m³, which is greater than the short term (24hr) PM₁₀ impact assessment criteria.

An Investigation determined that the wind direction was generally not from MTW's angle of influence at Long Point on the 24th February. Accordingly, no further action is required.

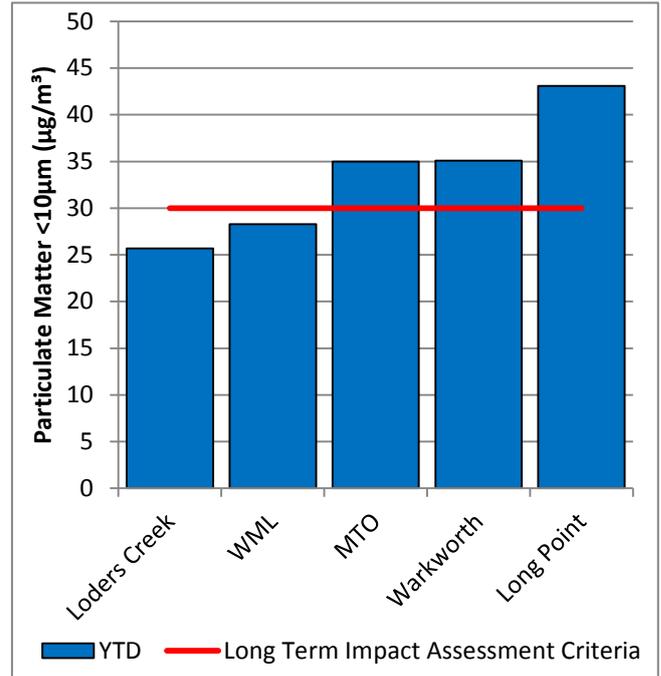
Figure 6: Annual Average PM₁₀ – February 2018

Figure 6 shows the annual average PM₁₀ results against the long term impact assessment criteria.

An assessment of MTW’s contribution to the long term assessment criteria will be reported in the 2018 Annual Return.

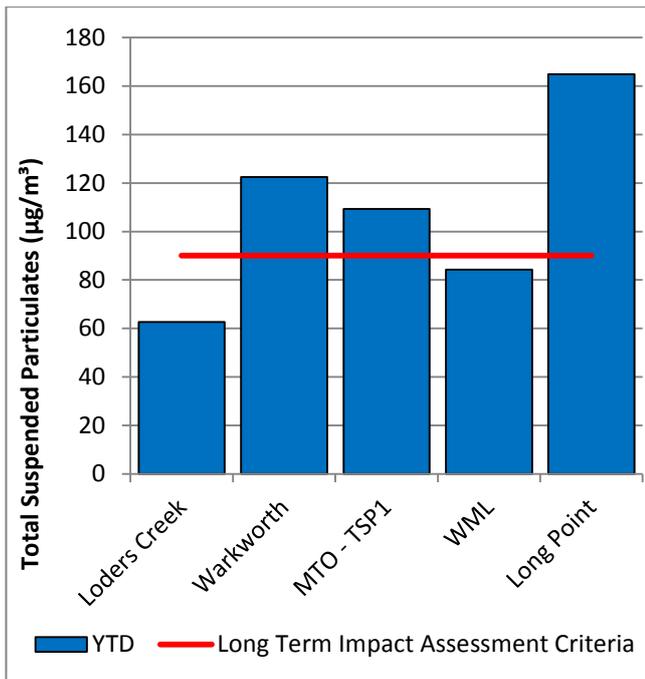
Figure 7: Annual Average Total Suspended Particulates – February 2018

Figure 7 shows the annual average TSP results compared against the long term impact assessment criteria of 90µg/m³.

An assessment of MTW’s contribution to the long term assessment criteria will be reported in the 2018 Annual Return.

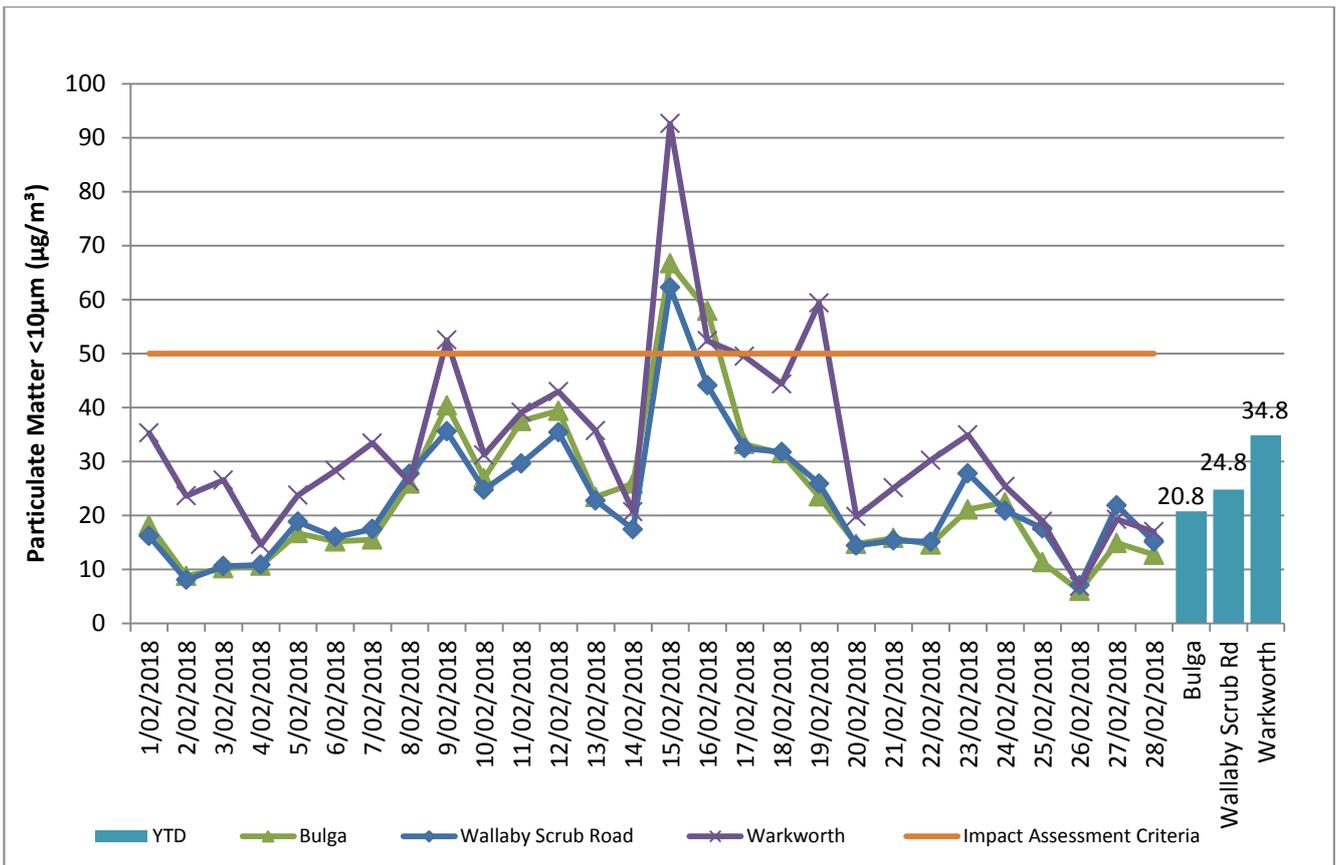
Figure 8: Real Time PM₁₀ daily 24hr average and annual average – February 2018

Results for real time dust sampling are shown in Figure 8, including the daily 24 hour average PM₁₀ result and the annual PM₁₀ average.

Seven TEOM PM₁₀ measurements exceeded the 24 hour short term impact assessment criteria during the reporting period. Each was investigated to determine the level of contribution from MTW activities in accordance with the compliance protocol outlined in the MTW Air Quality Management Plan. All recorded exceedances were determined to be compliant with the relevant criterion.

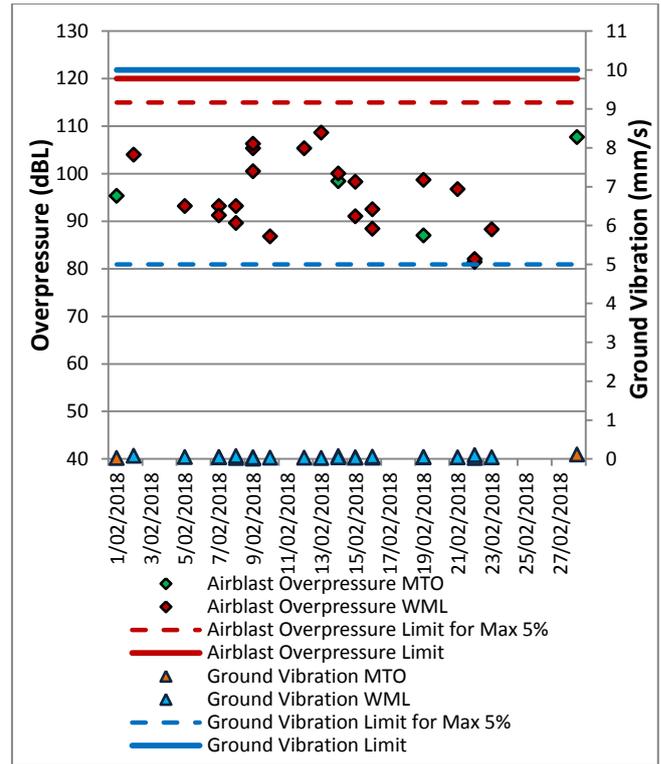
Figure 9: Abbey Green Blast Monitoring Results – February 2018

During the reporting period no blasts exceeded the 115 dB(L) 5% threshold for airblast overpressure or 5mm/s 5% threshold for ground vibration.

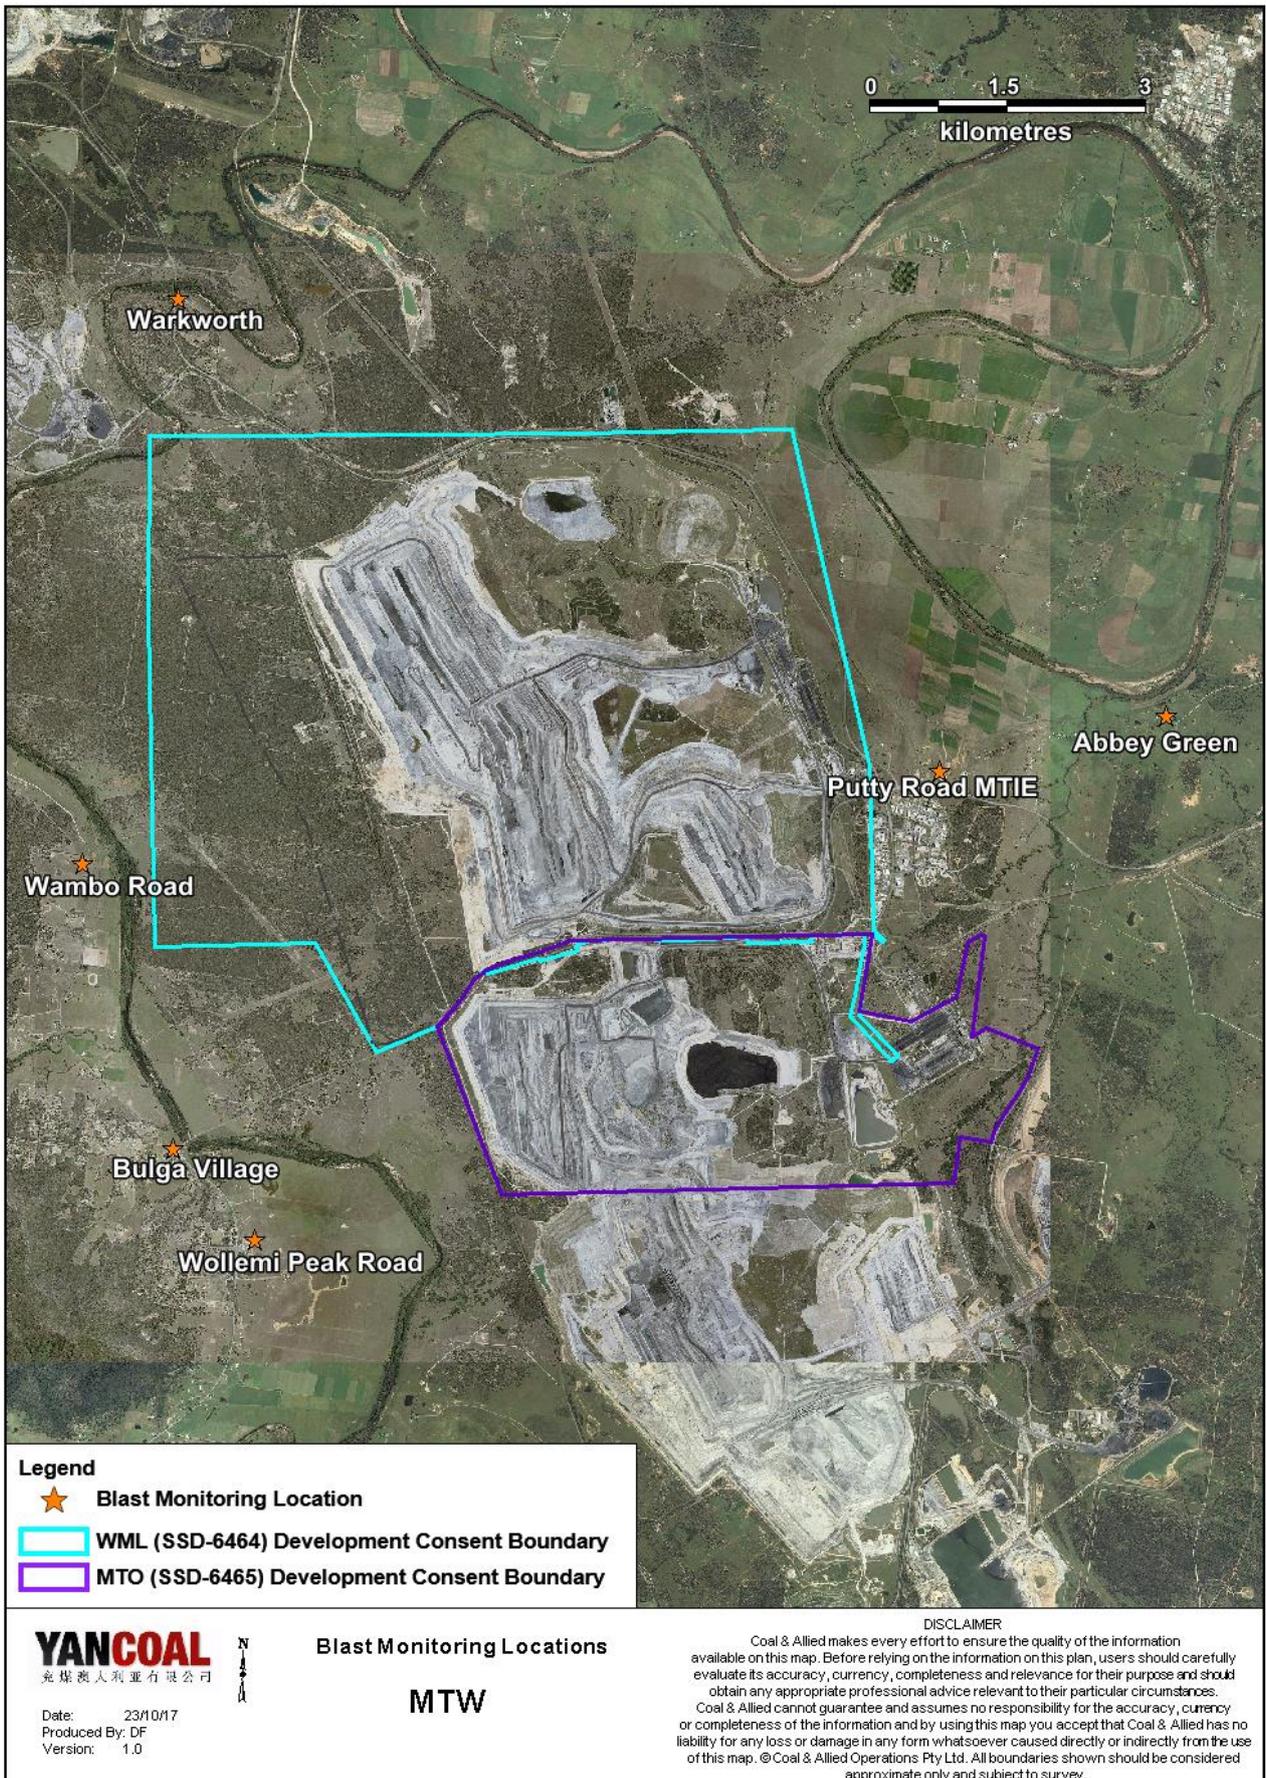
Figure 15: MTW Blast Monitoring Location Plan

MTW have a network of six blast monitoring units. These are located at nearby privately owned residences and function as regulatory compliance monitors.

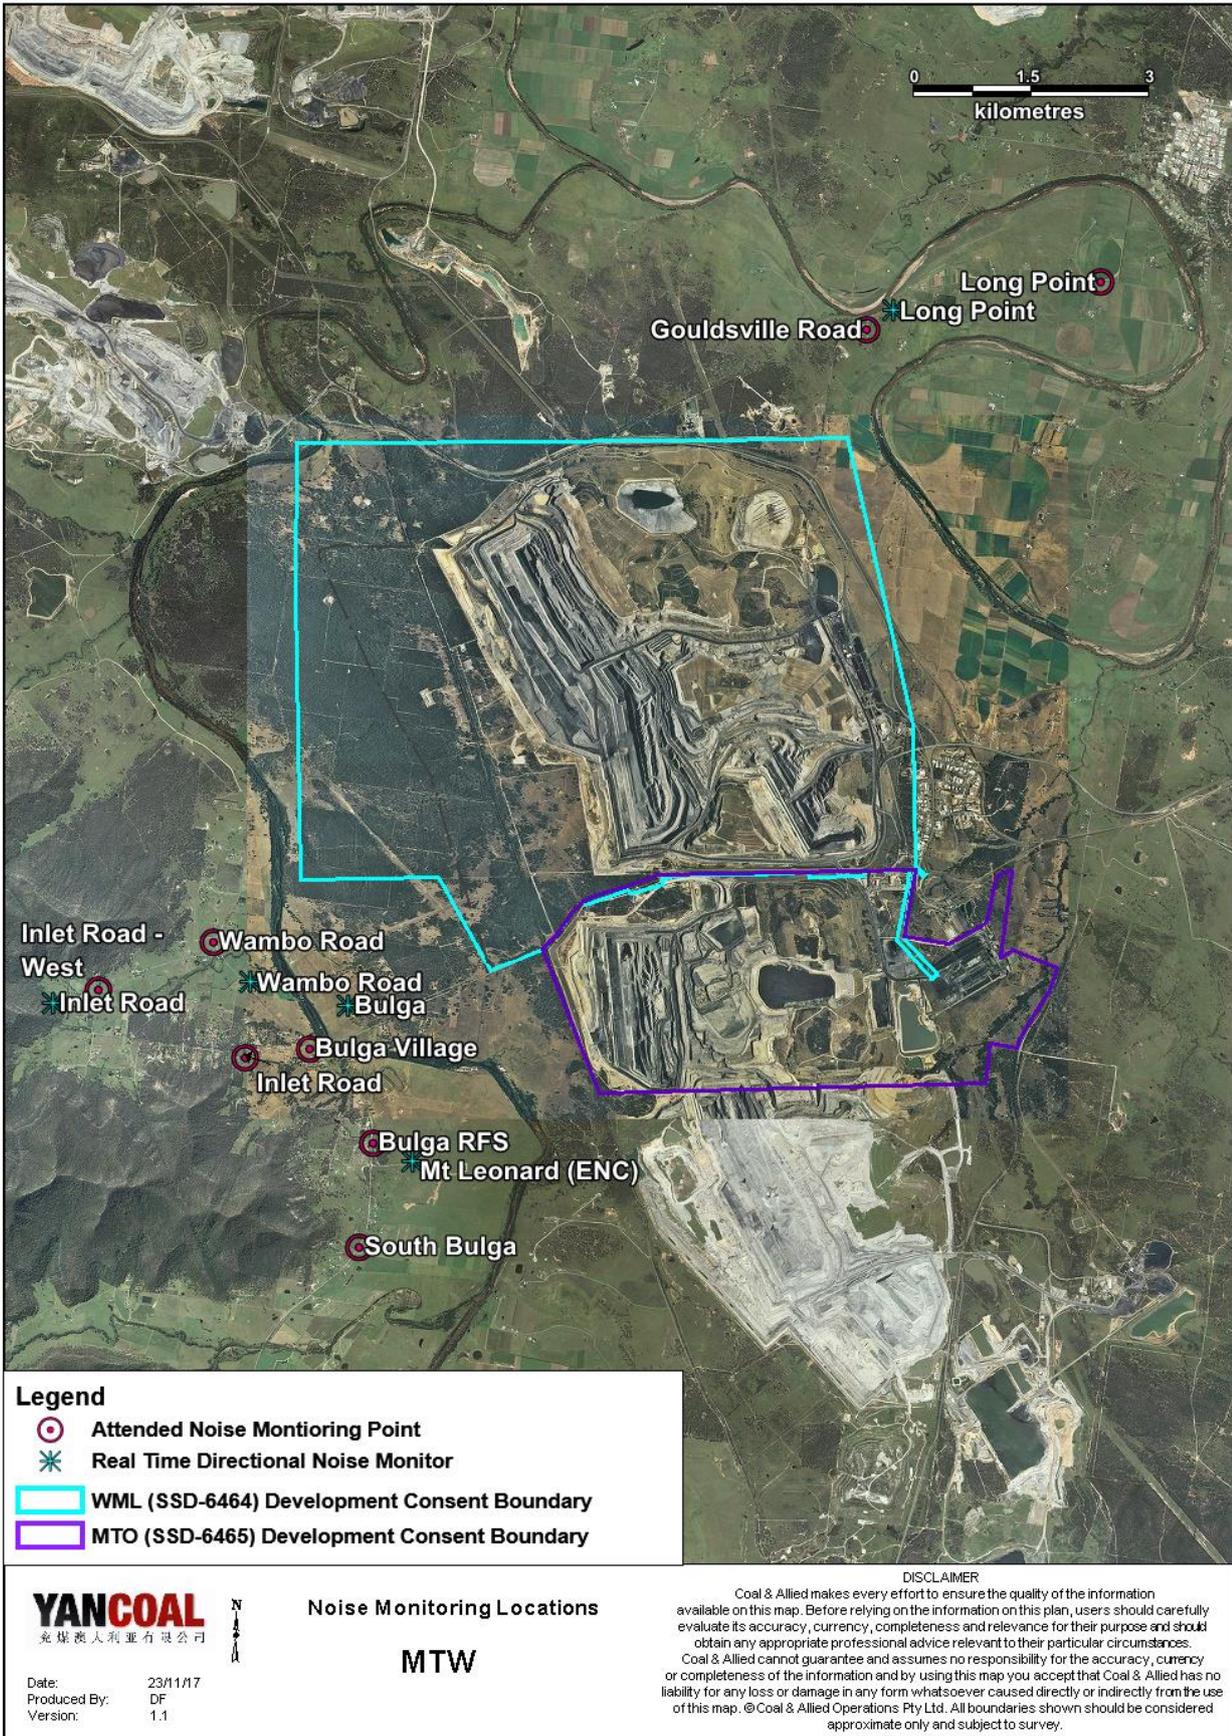
Figure 16: Noise Monitoring Location Plan

Routine attended noise monitoring is carried out in accordance with the MTW Noise Management Plan. A review against EIS predictions will be reported in the Annual Review. The purpose of the noise surveys is to quantify and describe the acoustic environment around the site and compare results with specified limits. Real time noise monitoring also occurs at five sites surrounding MTW. Noise monitoring locations are displayed in Figure 16.

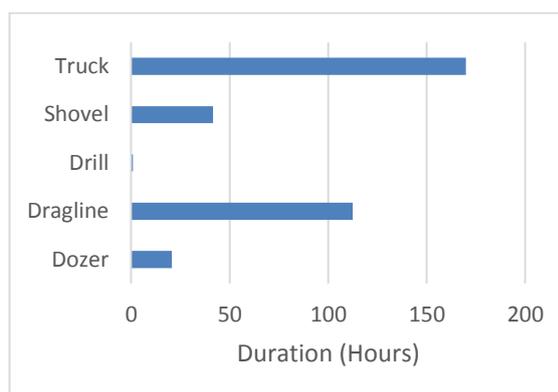
Figure 17: Operational Downtime by Equipment Type – February 2018

During February, a total of 346 hours of equipment downtime was logged in response to environmental events such as dust, noise and adverse meteorological conditions. Operational downtime by equipment type is shown in Figure 17.

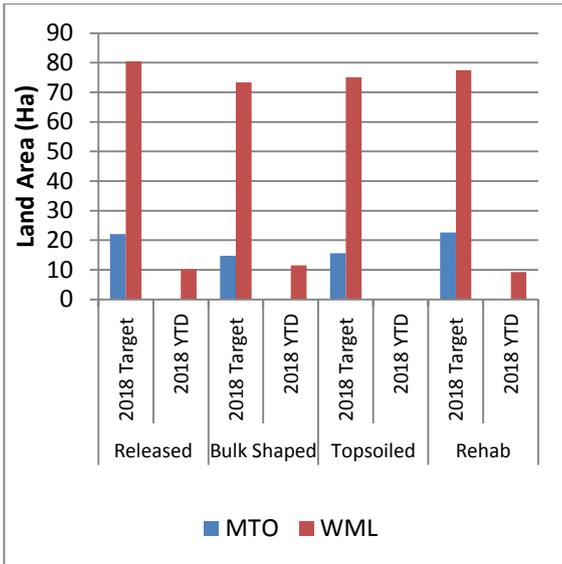
Figure 18: Rehabilitation YTD – February 2018

During February, 8.9 Ha of land was released, 9.7 Ha of land was bulk shaped and 2.4 Ha of land was composted.
