Mount Thorley Warkworth  
Monthly Environmental Report  
January 2017

Coal & Allied Operations Pty Ltd

This report has been compiled to provide a monthly summary of environmental monitoring results for Mount Thorley Warkworth (MTW). This report includes all monitoring data collected for the period 1<sup>st</sup> January to 31<sup>st</sup> January 2017.

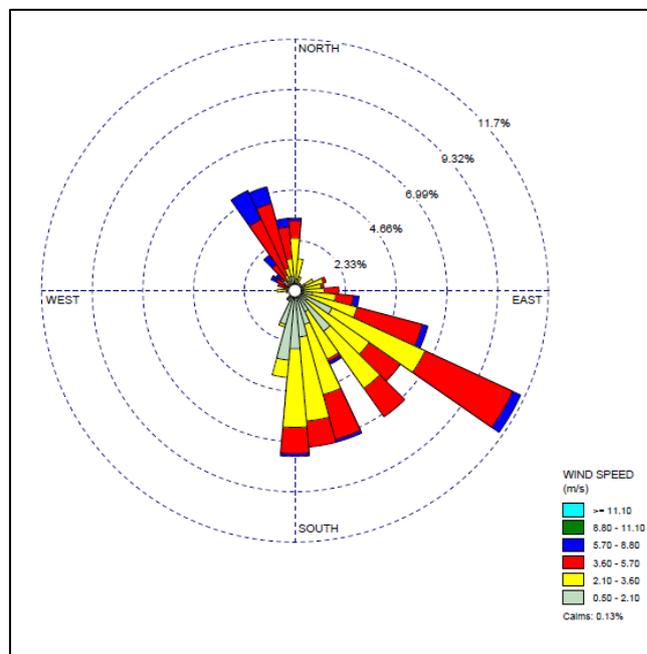
**Figure 2: Charlton Ridge Wind Rose – January 2017**

Winds from the South-East were dominant throughout the reporting period as shown in Figure 2.

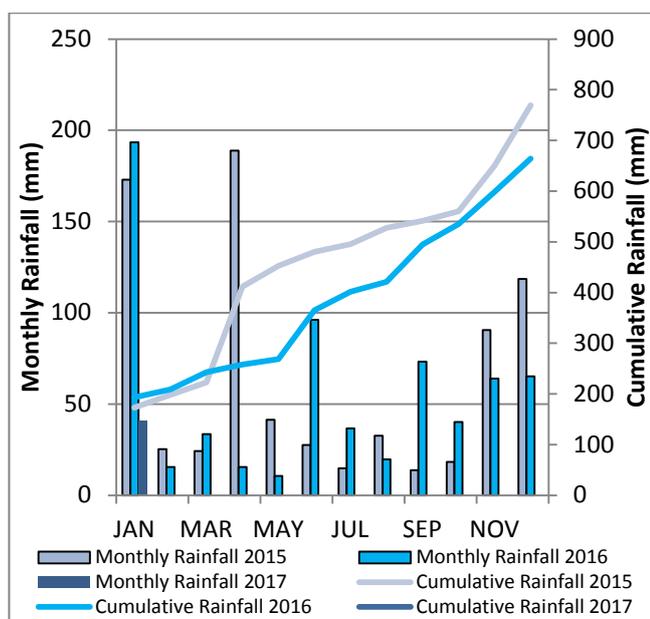
**Figure 1: Rainfall Trend YTD**

Rainfall for the period is summarised in Table 1, the year-to-date trend and historical trend are shown in Figure 1.

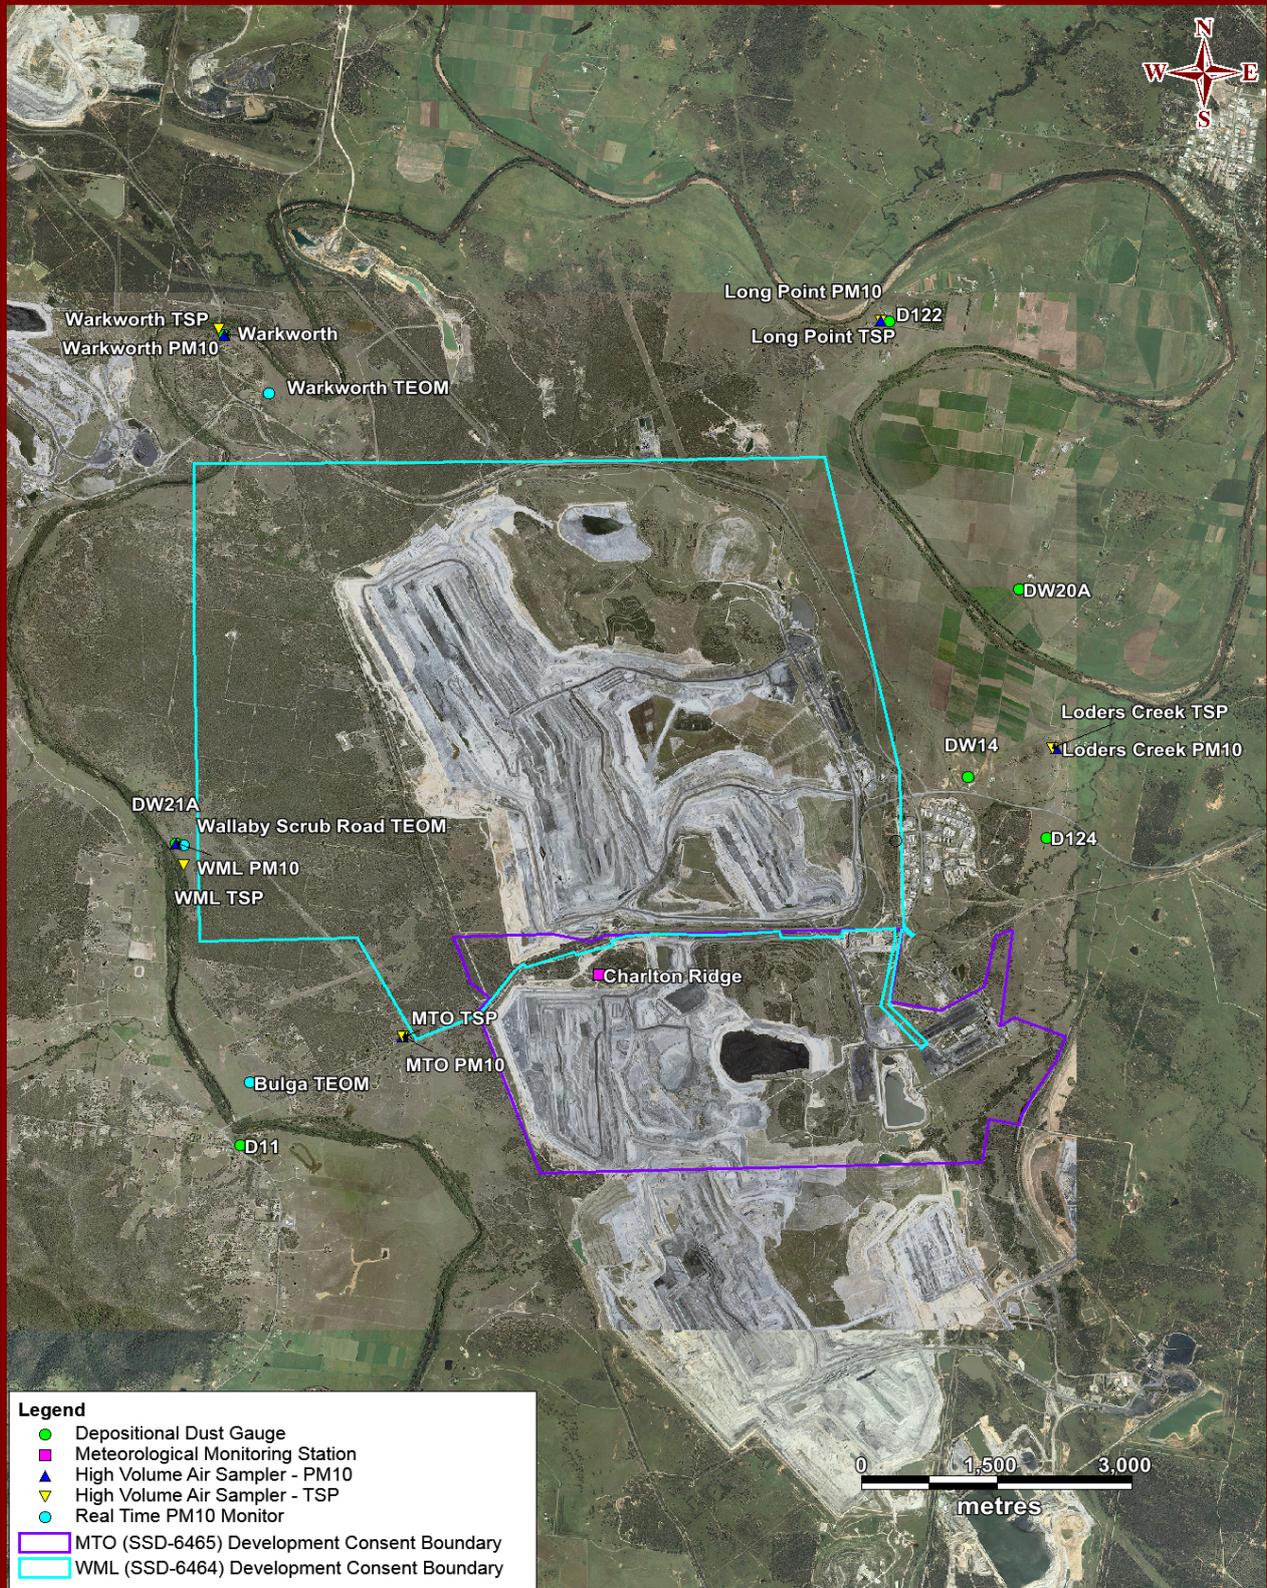
**Figure 3: Air Quality Monitoring Locations**

Meteorological data is collected at MTW's 'Charlton Ridge' meteorological station (refer to Figure 3: Air Quality Monitoring Locations).

Suspended particulates are measured by a network of High Volume Air Samplers (HVAS) measuring Total Suspended Particulates (TSP) and Particulate Matter <10µm (PM<sub>10</sub>). The location of these monitors can be found in Figure 3. Each HVAS was run for

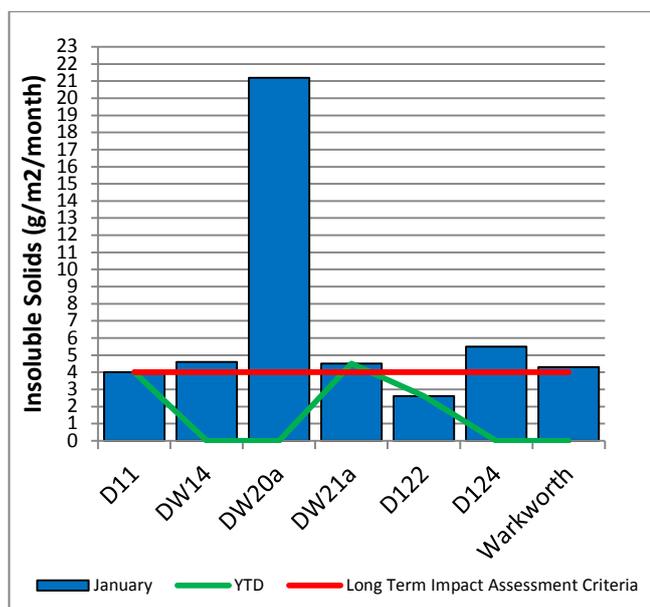
Figure 4: Depositional Dust – January 2017

Figure 4 displays insoluble solids results from depositional dust gauges during the reporting period compared against the year-to-date average and the annual impact assessment criteria.

During the reporting period the DW14, DW20a, DW21a, D124 and Warkworth monitors recorded monthly results above the long term impact assessment criteria of 4.0 g/m<sup>2</sup> per month. Field notes associated with DW20a, D124 and Warkworth confirm the presence of insects and bird droppings. As such the results are considered contaminated and will be excluded from calculation of the annual average. There is no evidence to suggest that the Dw21a result is contaminated. Accordingly, this result will be included in the annual average calculation.

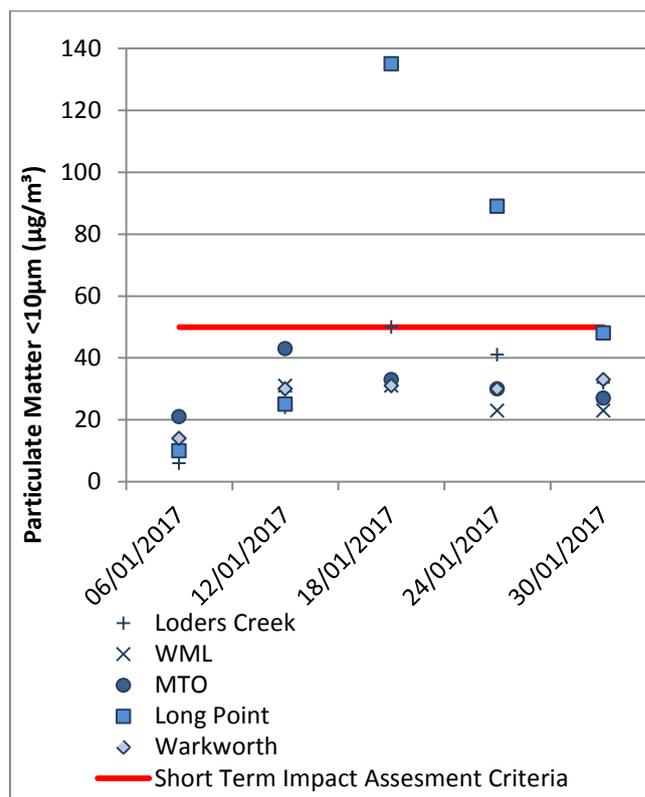
Figure 5: Individual PM<sub>10</sub> Results – January 2017

Figure 5 shows the individual PM<sub>10</sub> results at each monitoring station against the short term impact assessment criteria of 50µg/m<sup>3</sup>.

On 18/01/2017 and on 24/01/2017, one HVAS PM<sub>10</sub> unit recorded a result greater than the short term (24hr) PM<sub>10</sub> impact assessment criteria; Long Point (135 µg/m<sup>3</sup>) and Long Point (89 µg/m<sup>3</sup>) respectively.

Investigation indicates that the Long Point HVAS failed to collect valid samples on the 18<sup>th</sup> and 24<sup>th</sup> January due to local livestock impacting the monitor. The proximity of the monitor to livestock is being increased, through the relocation of a nearby chook yard and also a demountable horse yard away from the monitor.

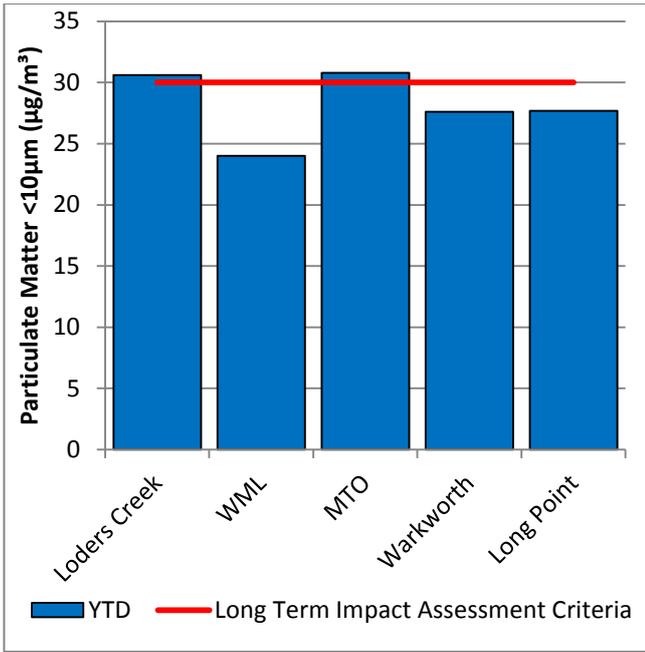
**Figure 6: Annual Average PM<sub>10</sub> – January 2017**

Figure 6 shows the annual average PM<sub>10</sub> results against the long term impact assessment criteria.

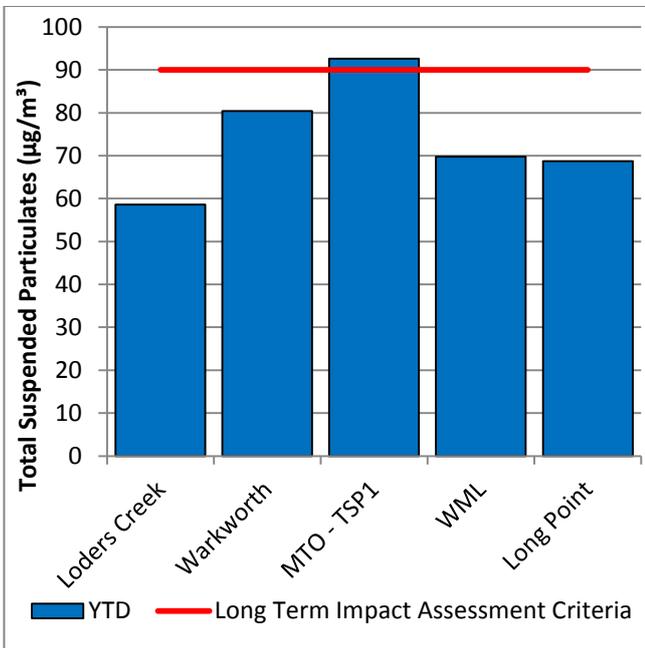
**Figure 7: Annual Average Total Suspended Particulates – January 2017**

Figure 7 shows the annual average TSP results compared against the long term impact assessment criteria of 90µg/m<sup>3</sup>.

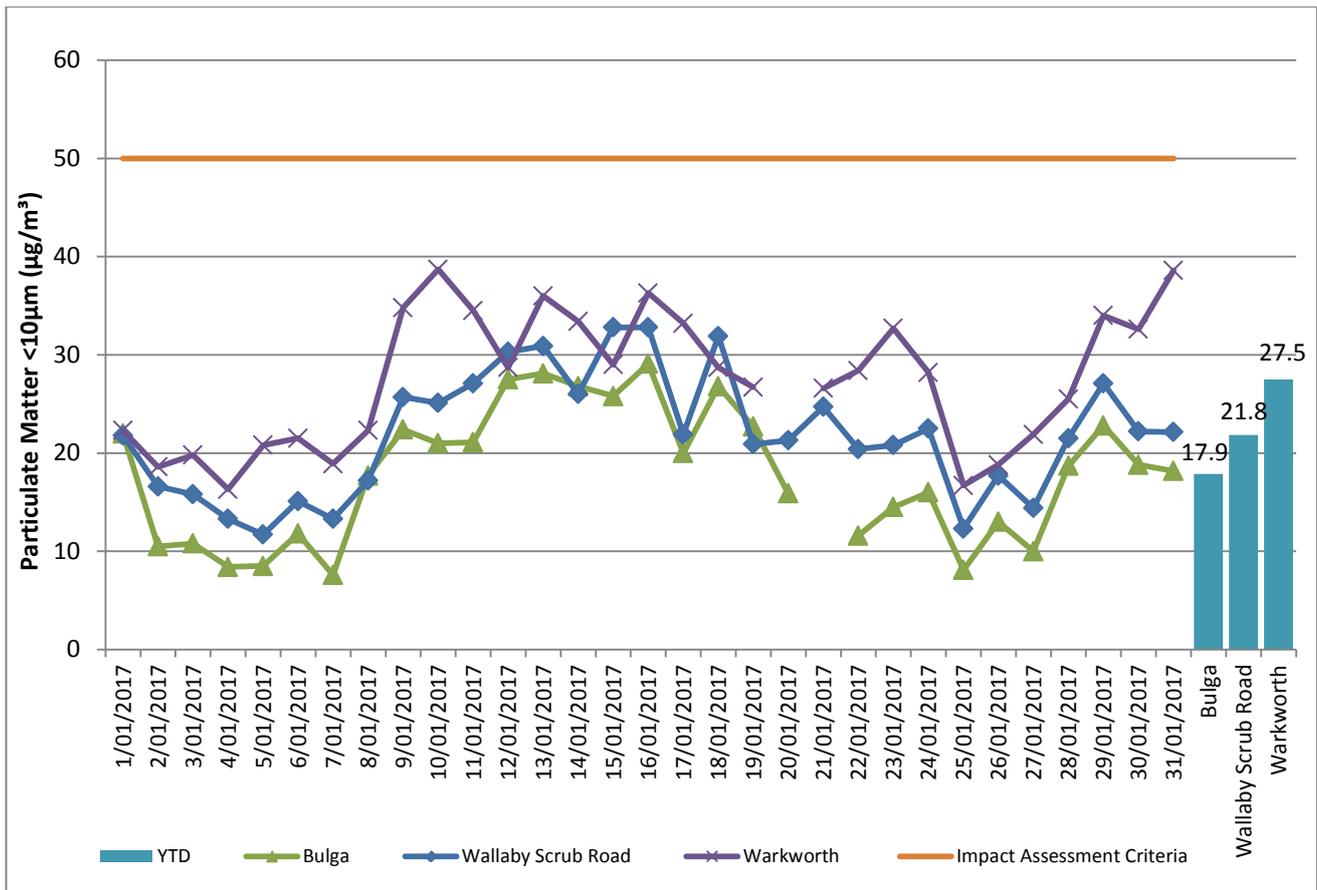
**Figure 8: Real Time PM<sub>10</sub> daily 24hr average and annual average – January 2017**

Results for real time dust sampling are shown in Figure 8, including the daily 24 hour average PM<sub>10</sub> result and the annual PM<sub>10</sub> average.

Data was not available on the 20<sup>th</sup> January (Warkworth) or on 21<sup>st</sup> January (Bulga) due to technical issues.

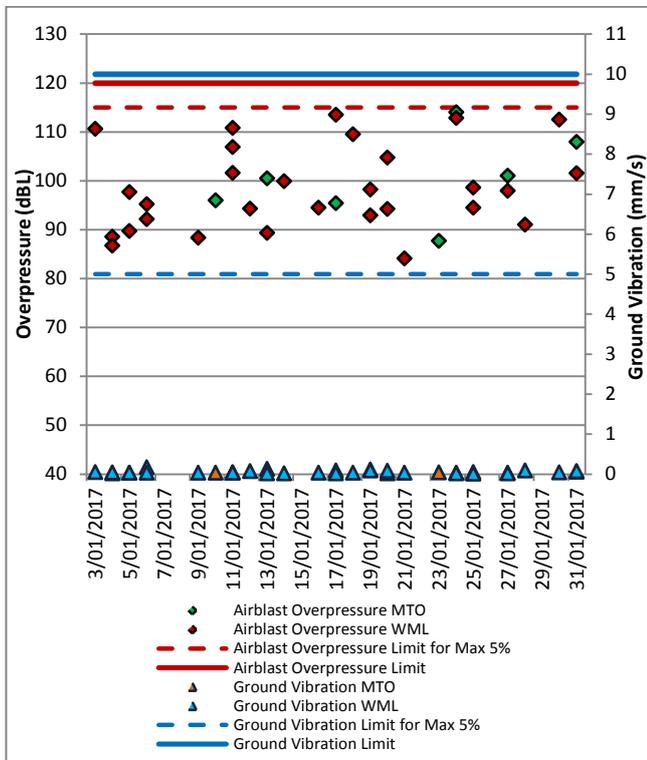
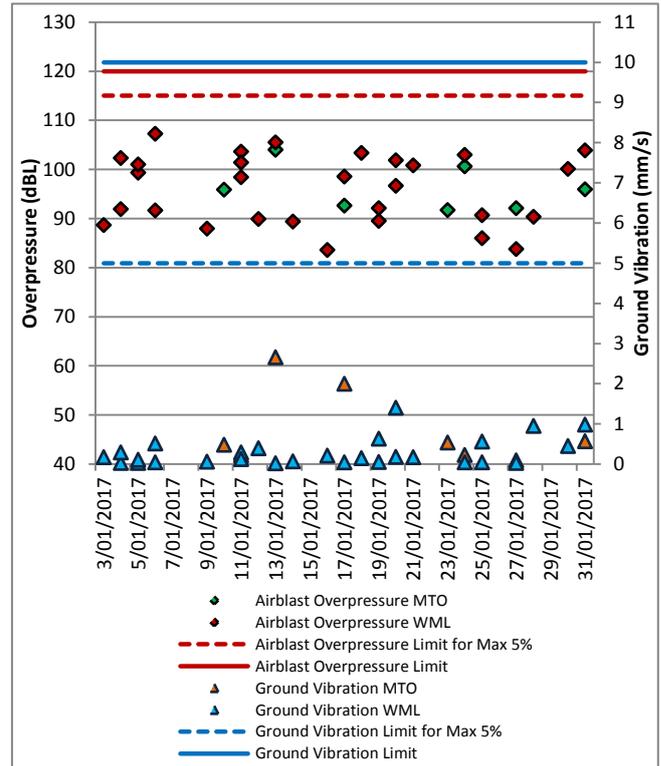
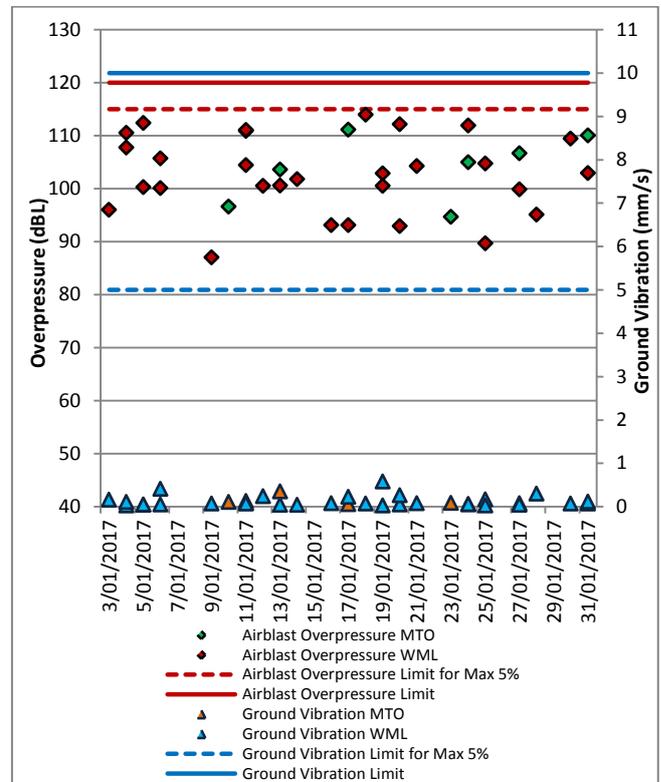
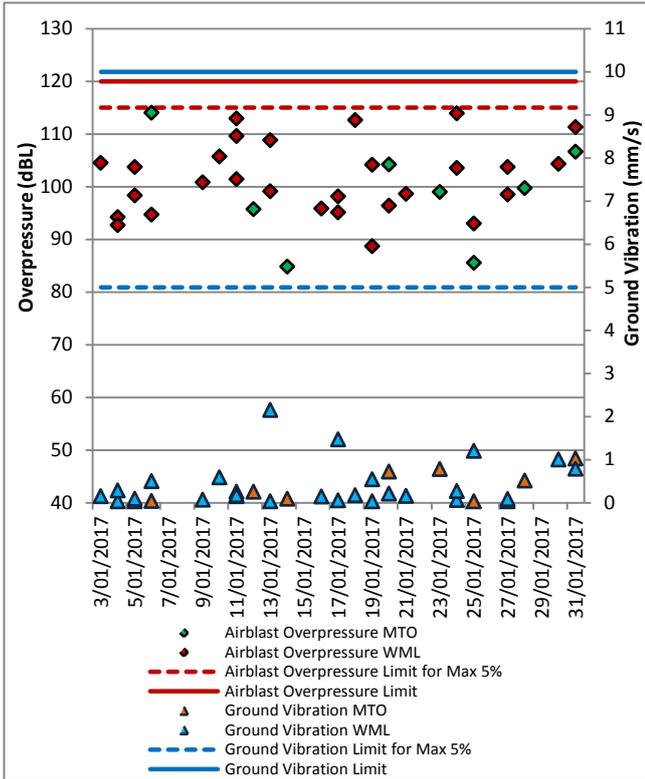
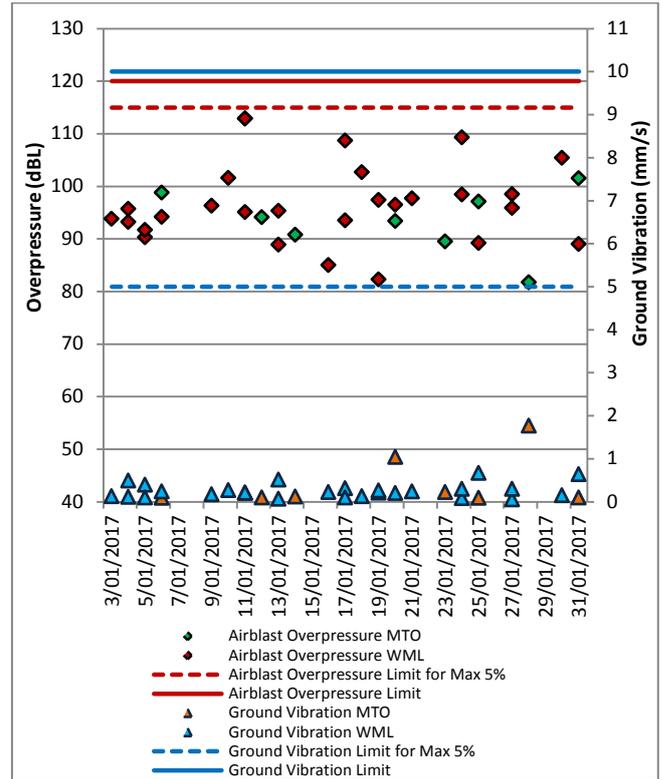
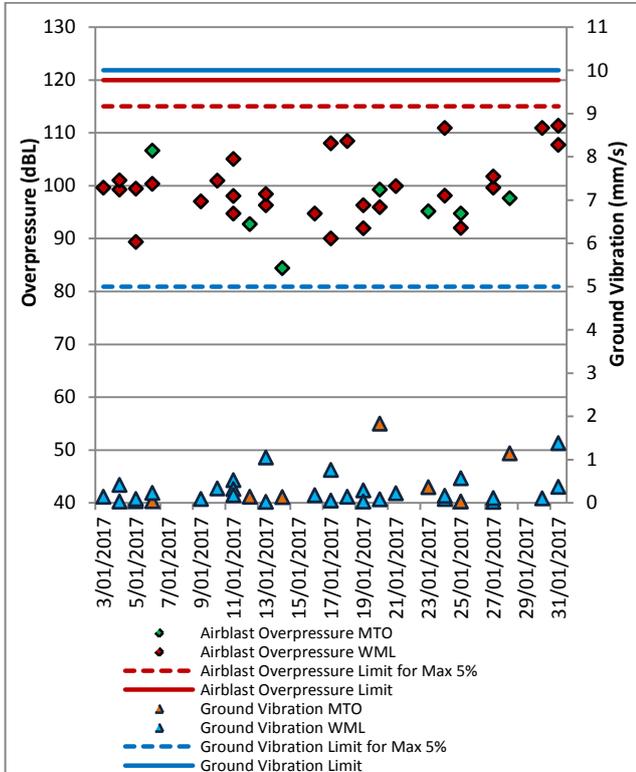
During January 2017, 36 blasts were initiated at MTW. Figure 9 to Figure 14 show the blast monitoring results for the reporting period against the impact assessment criteria. The criteria are summarised in Table 2.

During the reporting period no blasts exceeded the 115 dB(L) 5% threshold for airblast overpressure or 5mm/s 5% threshold for ground vibration

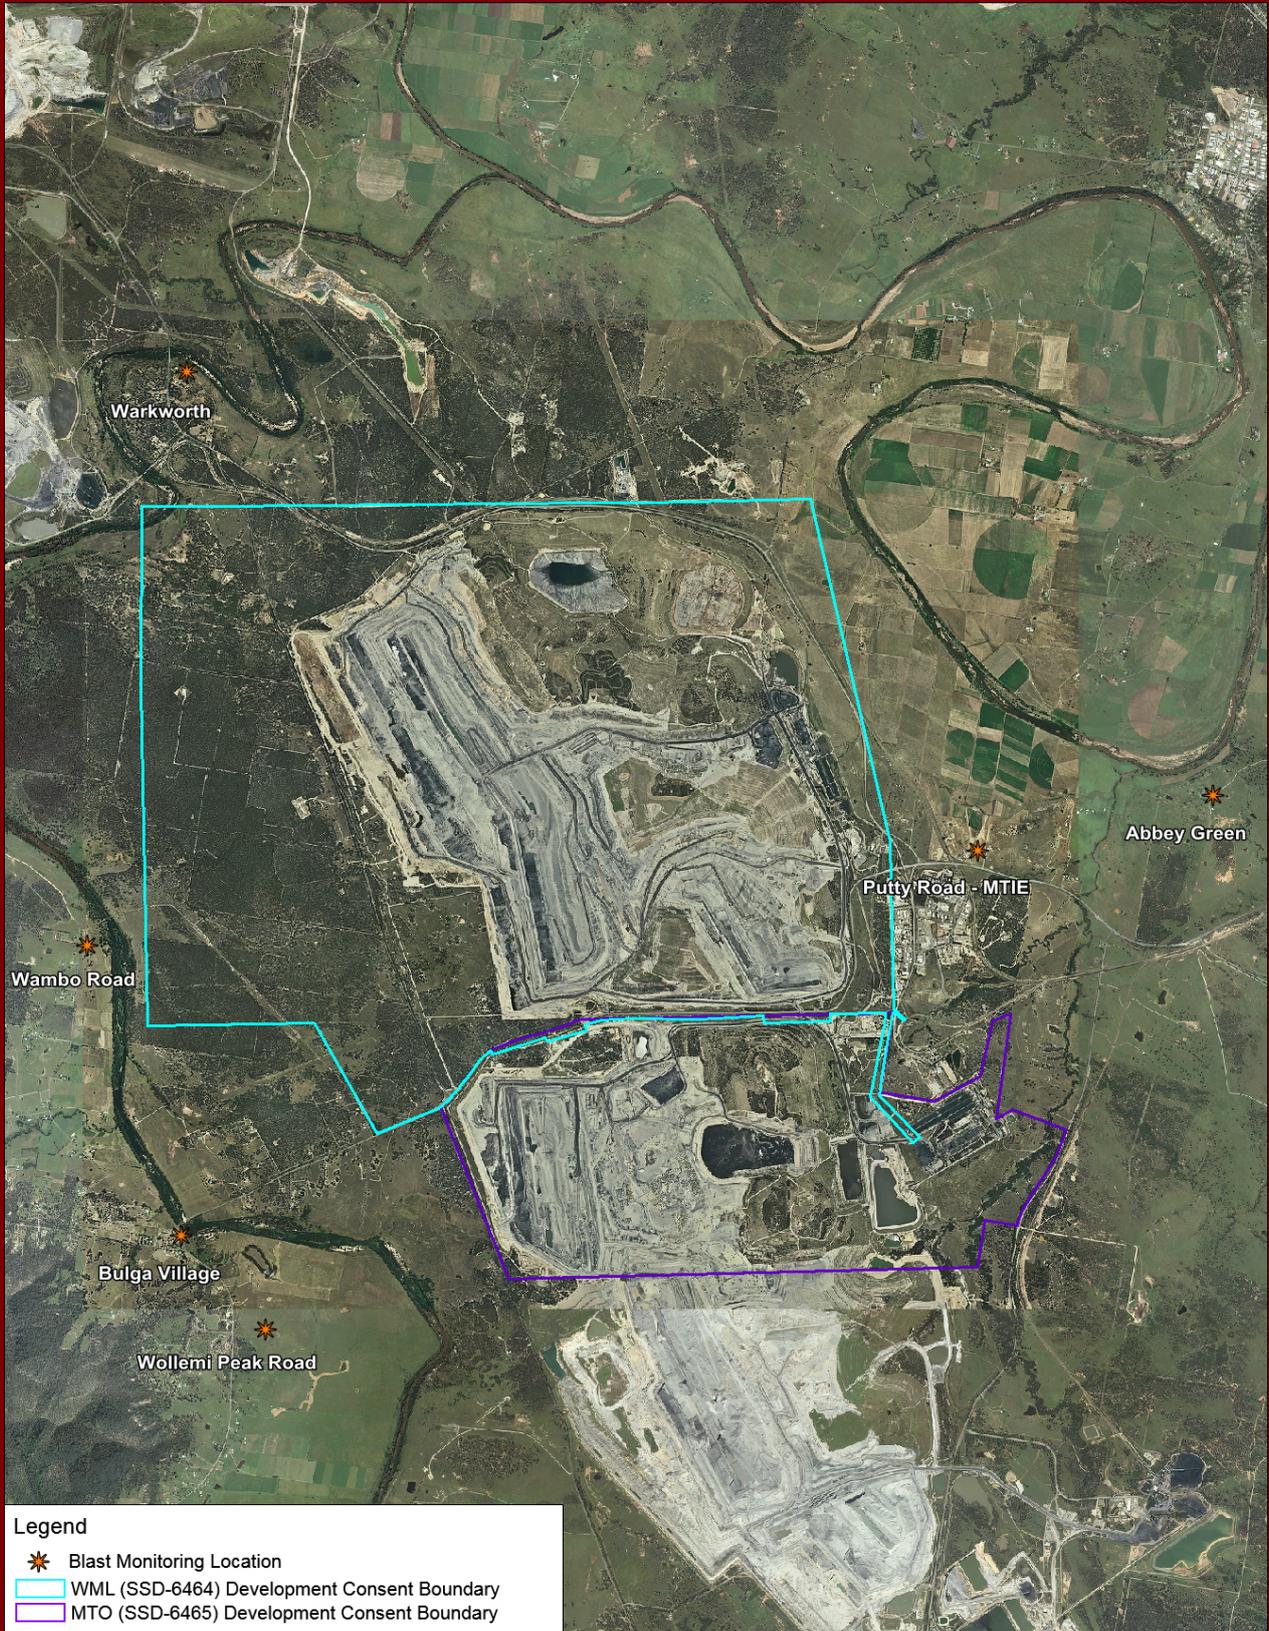
Figure 15: MTW Blast Monitoring Location Plan

MTW have a network of six blast monitoring units. These are located at nearby privately owned residences and function as regulatory compliance monitors.

The location of these monitors can be found in Figure 15.

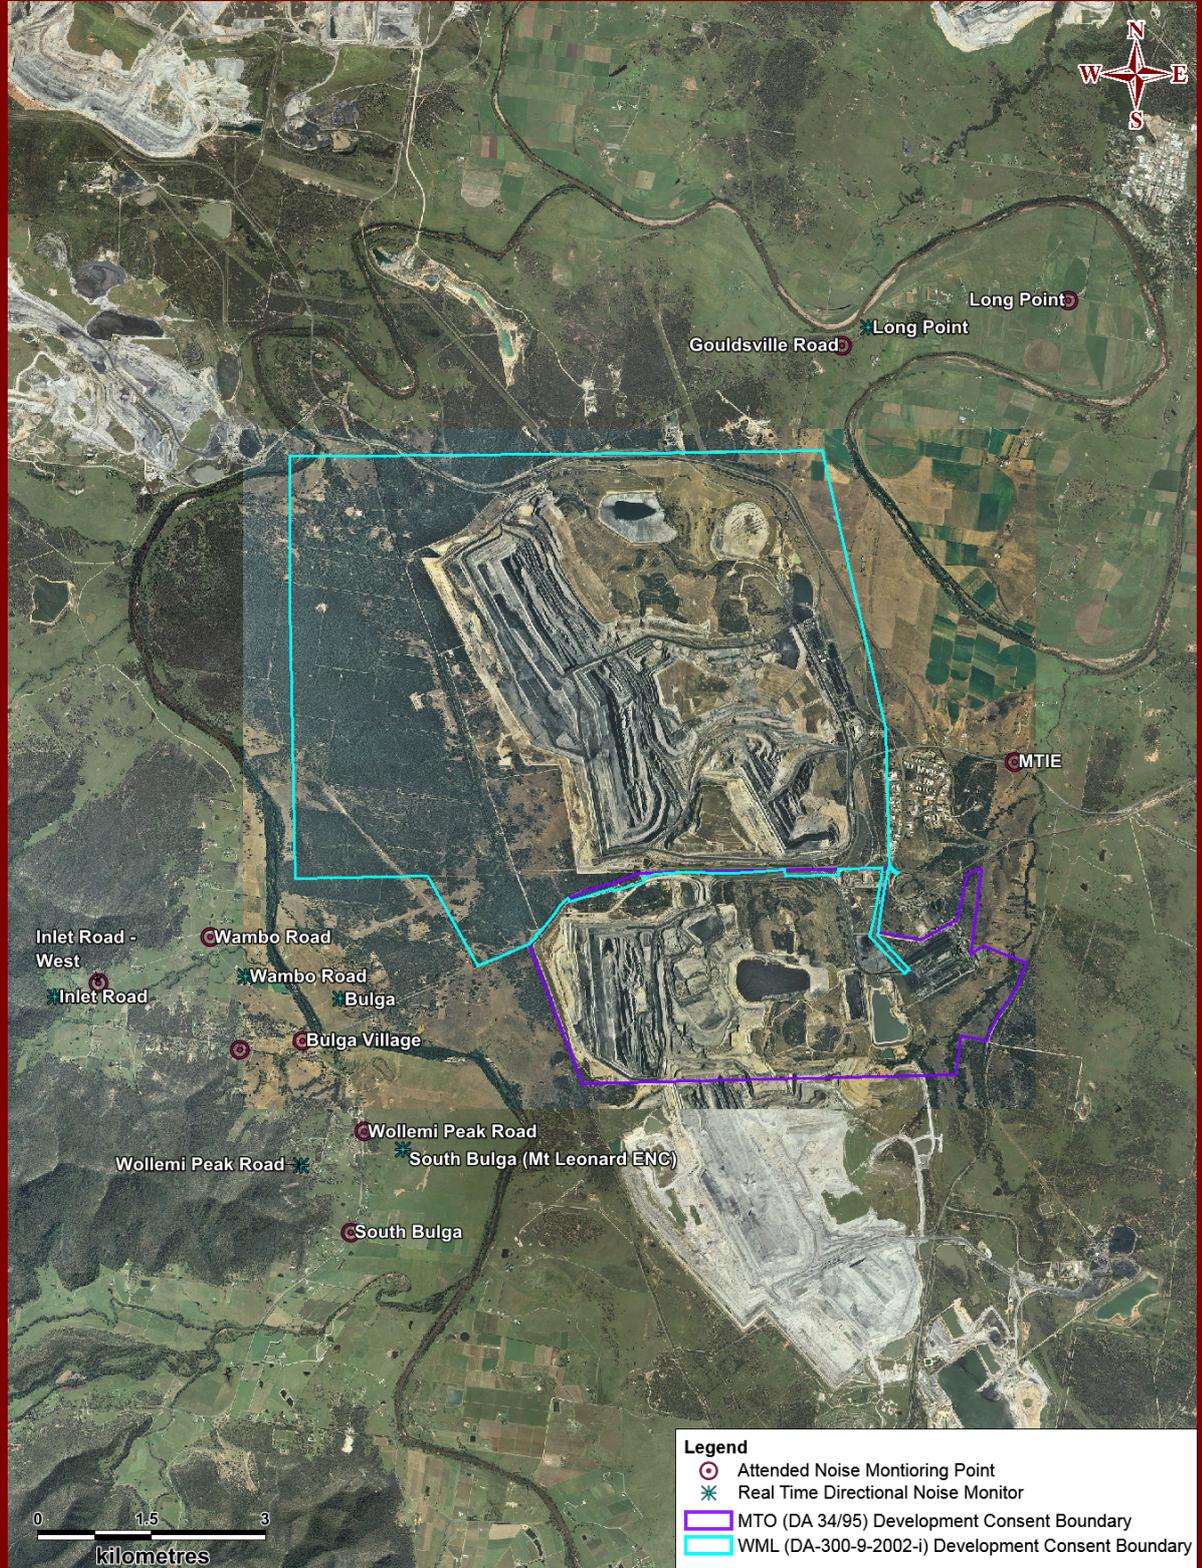
Figure 16: Noise Monitoring Location Plan

Routine attended noise monitoring is carried out in accordance with the MTW Noise Management Plan. A review against EIS predictions will be reported in the Annual Review. The purpose of the noise surveys is to quantify and describe the acoustic environment around the site and compare results with specified limits. Real time noise monitoring also occurs at nine sites surrounding MTW. Noise monitoring locations are displayed in Figure 16.

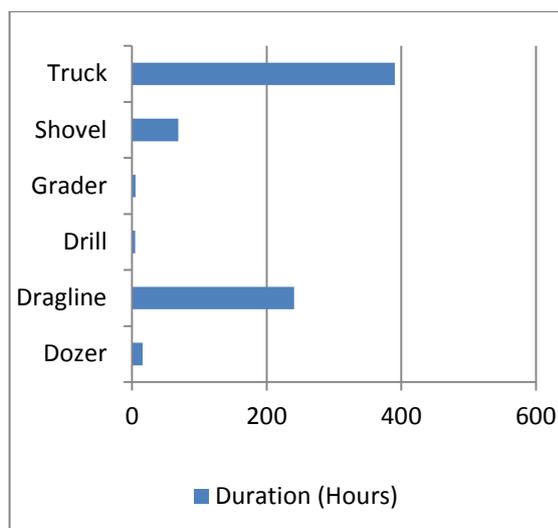
**Figure 17: Operational Downtime by Equipment Type – January 2017**

During January, a total of 726.1 hours of equipment downtime was logged in response to environmental events such as dust, noise and adverse meteorological conditions. Operational downtime by equipment type is shown in Figure 17.
