Monthly Environmental Monitoring Report

Yancoal Mount Thorley Warkworth

July 2018

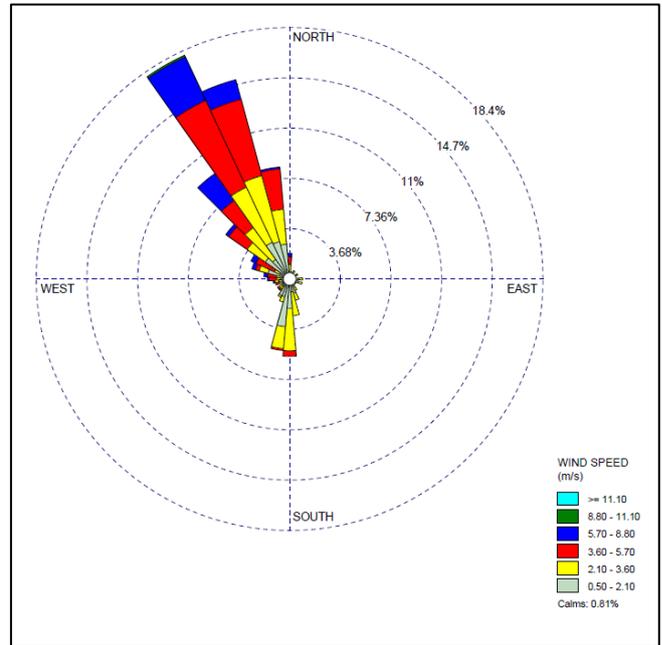
Figure 2: Charlton Ridge Wind Rose – July 2018

Winds from the northwest were dominant throughout the reporting period as shown in **Figure 2**.

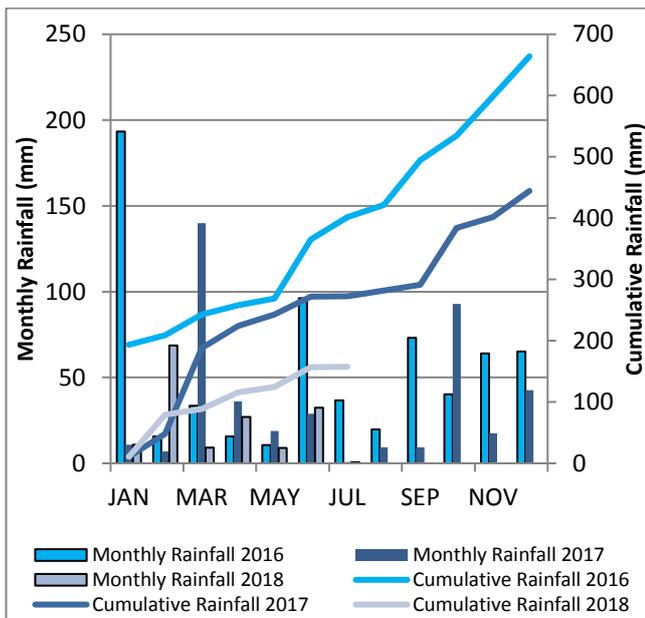
Figure 1: Rainfall Trend YTD

Rainfall for the period is summarised in **Table 1**, the year-to-date trend and historical trend are shown in **Figure 1**.

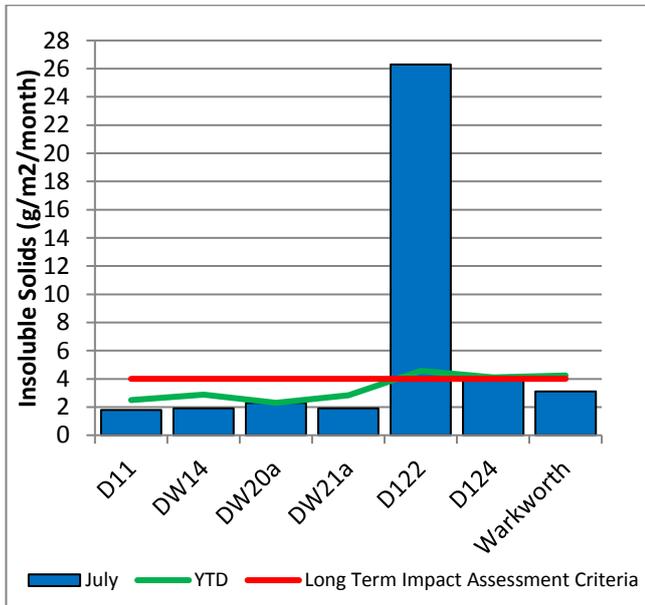
Figure 4: Depositional Dust – July 2018

Figure 4 displays insoluble solids results from depositional dust gauges during the reporting period compared against the year-to-date average and the annual impact assessment criteria.

During the reporting period the D122 and D124 monitors recorded monthly results above the long term impact assessment criteria of 4.0 g/m² per month. Field notes associated with D122 and D124 confirm the presence of insects and bird droppings. As such the results are considered contaminated and will be excluded from calculation of the annual average.

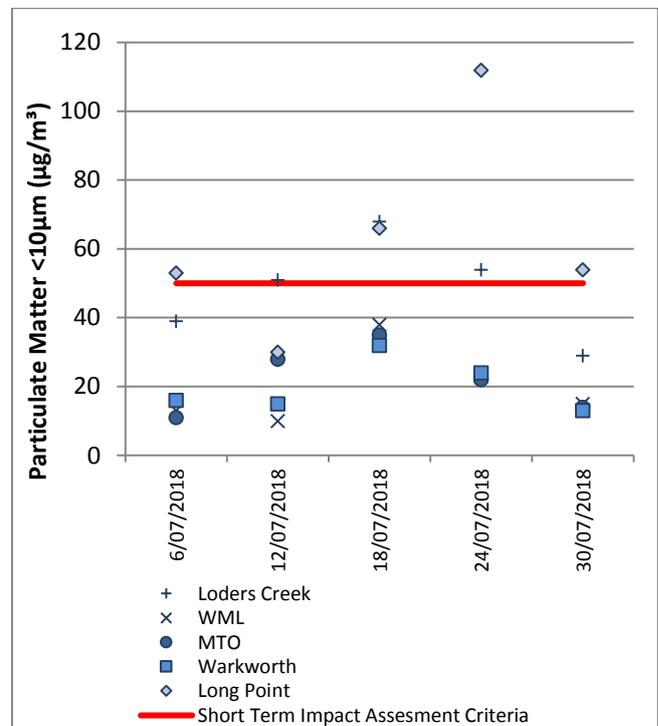
Figure 5: Individual PM₁₀ Results – July 2018

Figure 5 shows the individual PM₁₀ results at each monitoring station against the short term impact assessment criteria of 50µg/m³.

On 6th, 18th, 24th and 30th July 2018 the Long Point HVAS PM₁₀ unit recorded results of 53µg/m³, 66µg/m³, 112µg/m³ and 54µg/m³ respectively which are greater than the short term (24hr) PM₁₀ impact assessment criteria.

Investigations determined that the wind direction was generally not from MTW's angle of influence at Long Point on the 6th, 18th, 24th and 30th July 2018. Accordingly, no further action is required.

On 12th, 18th and 24th July 2018 the Loders Creek HVAS unit recorded results of 51µg/m³, 68µg/m³ and 54µg/m³ respectively which are greater than the short term (24hr) PM₁₀ impact assessment criteria.

Investigations indicate that the likely MTW contribution to the results at Long Point on the 12th, 18th and 24th July is less than 66%, 53% and 56% respectively. Accordingly, no further action is required (as per approved Air Quality Monitoring Programme).

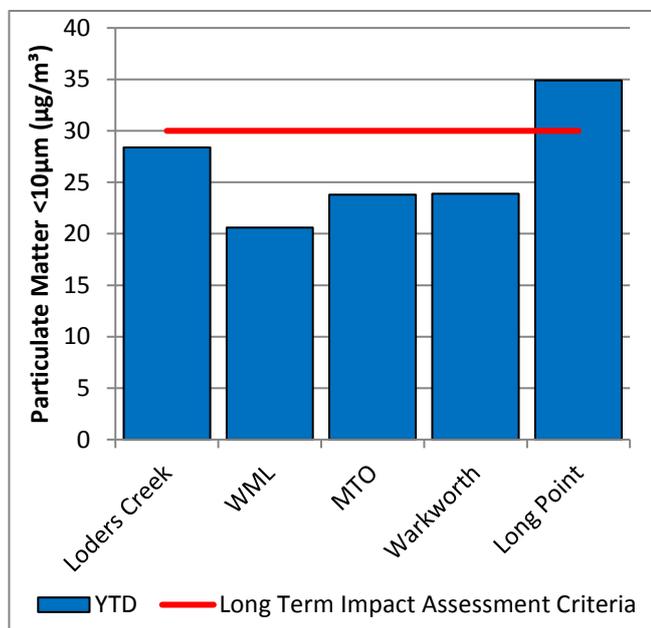
Figure 6: Annual Average PM₁₀ – July 2018

Figure 6 shows the annual average PM10 results against the long term impact assessment criteria.

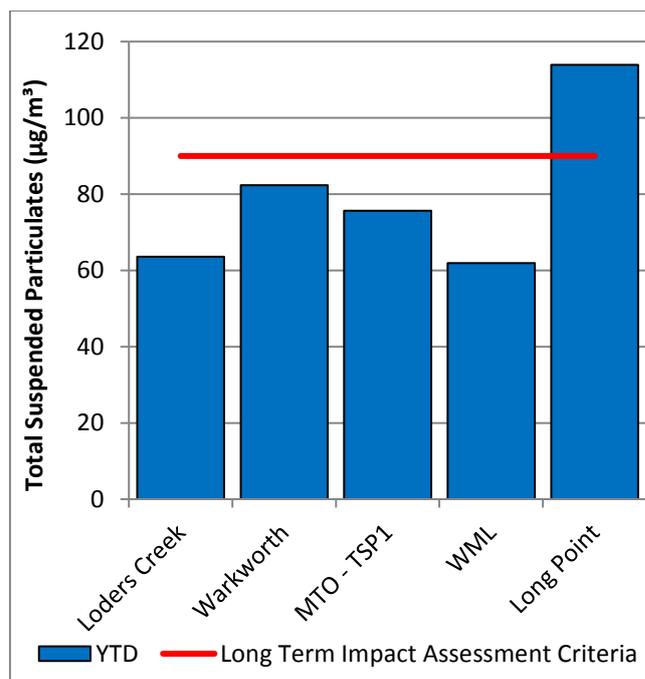
Figure 7: Annual Average Total Suspended Particulates – July 2018

Figure 7 shows the annual average TSP results compared against the long-term impact assessment criteria of 90µg/m³.

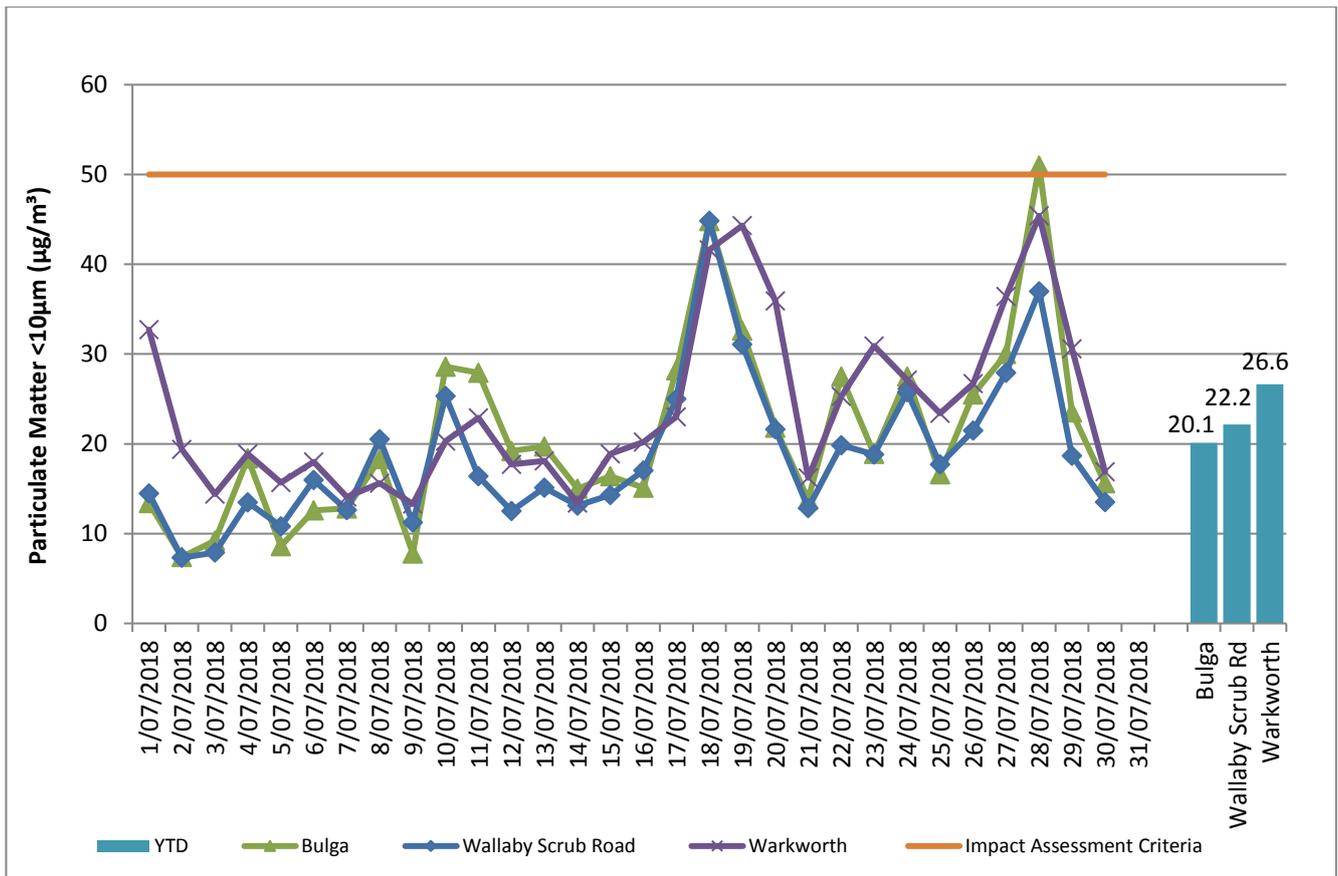
Figure 8: Real Time PM₁₀ daily 24hr average (line graphs) and YTD annual average (column graphs) – July 2018

Results for real time dust sampling are shown in Figure 8, including the daily 24-hour average PM₁₀ result and the annual PM₁₀ average.

One result recorded elevated levels at the Bulga TEOM (51 µg/m³) which exceeded the short term (24hr) criteria on 28th July 2018. This measurement was assessed for MTW’s maximum potential contribution based on meteorological conditions on this day resulting in a maximum estimated contribution of <13µg/m³ from the direction of MTW.

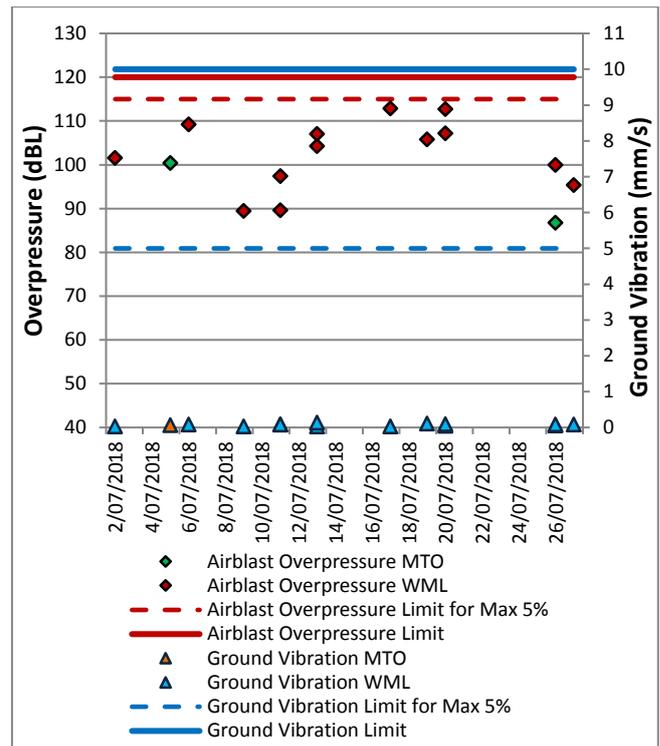
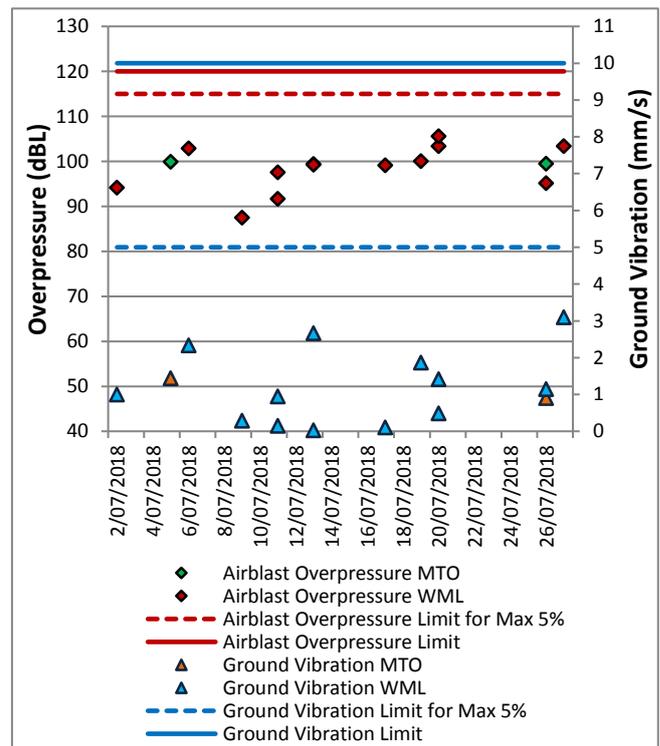
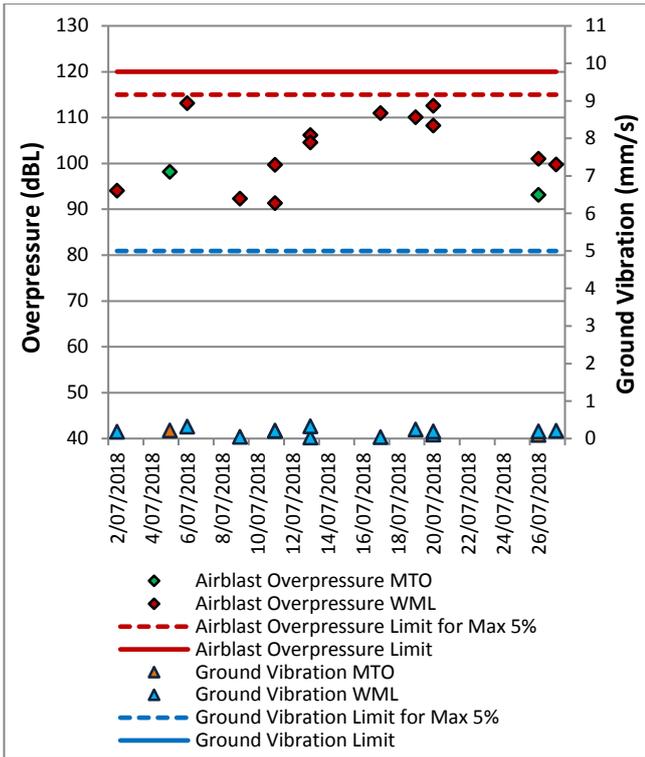
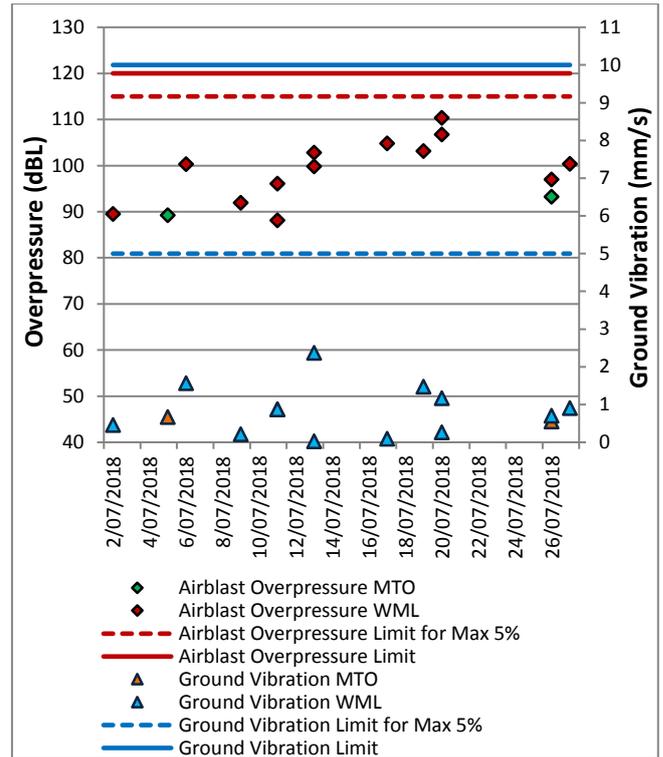
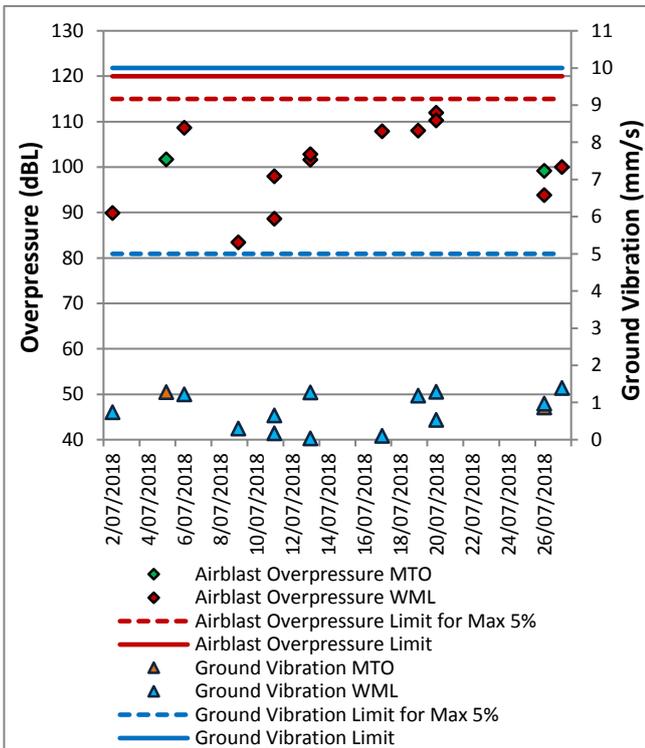
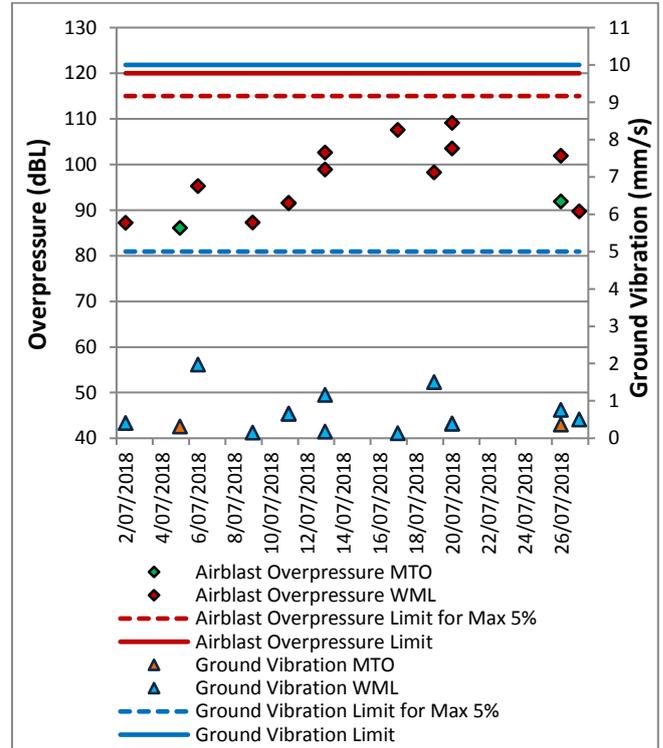
During July 2018, 16 blasts were initiated at MTW. **Figure 9** to **Figure 14** show the blast monitoring results for the reporting period against the impact assessment criteria. The criteria are summarised in **Table 2**.

During the reporting period no blasts exceeded the 115 dB(L) 5% threshold for airblast overpressure or 5mm/s 5% threshold for ground vibration.

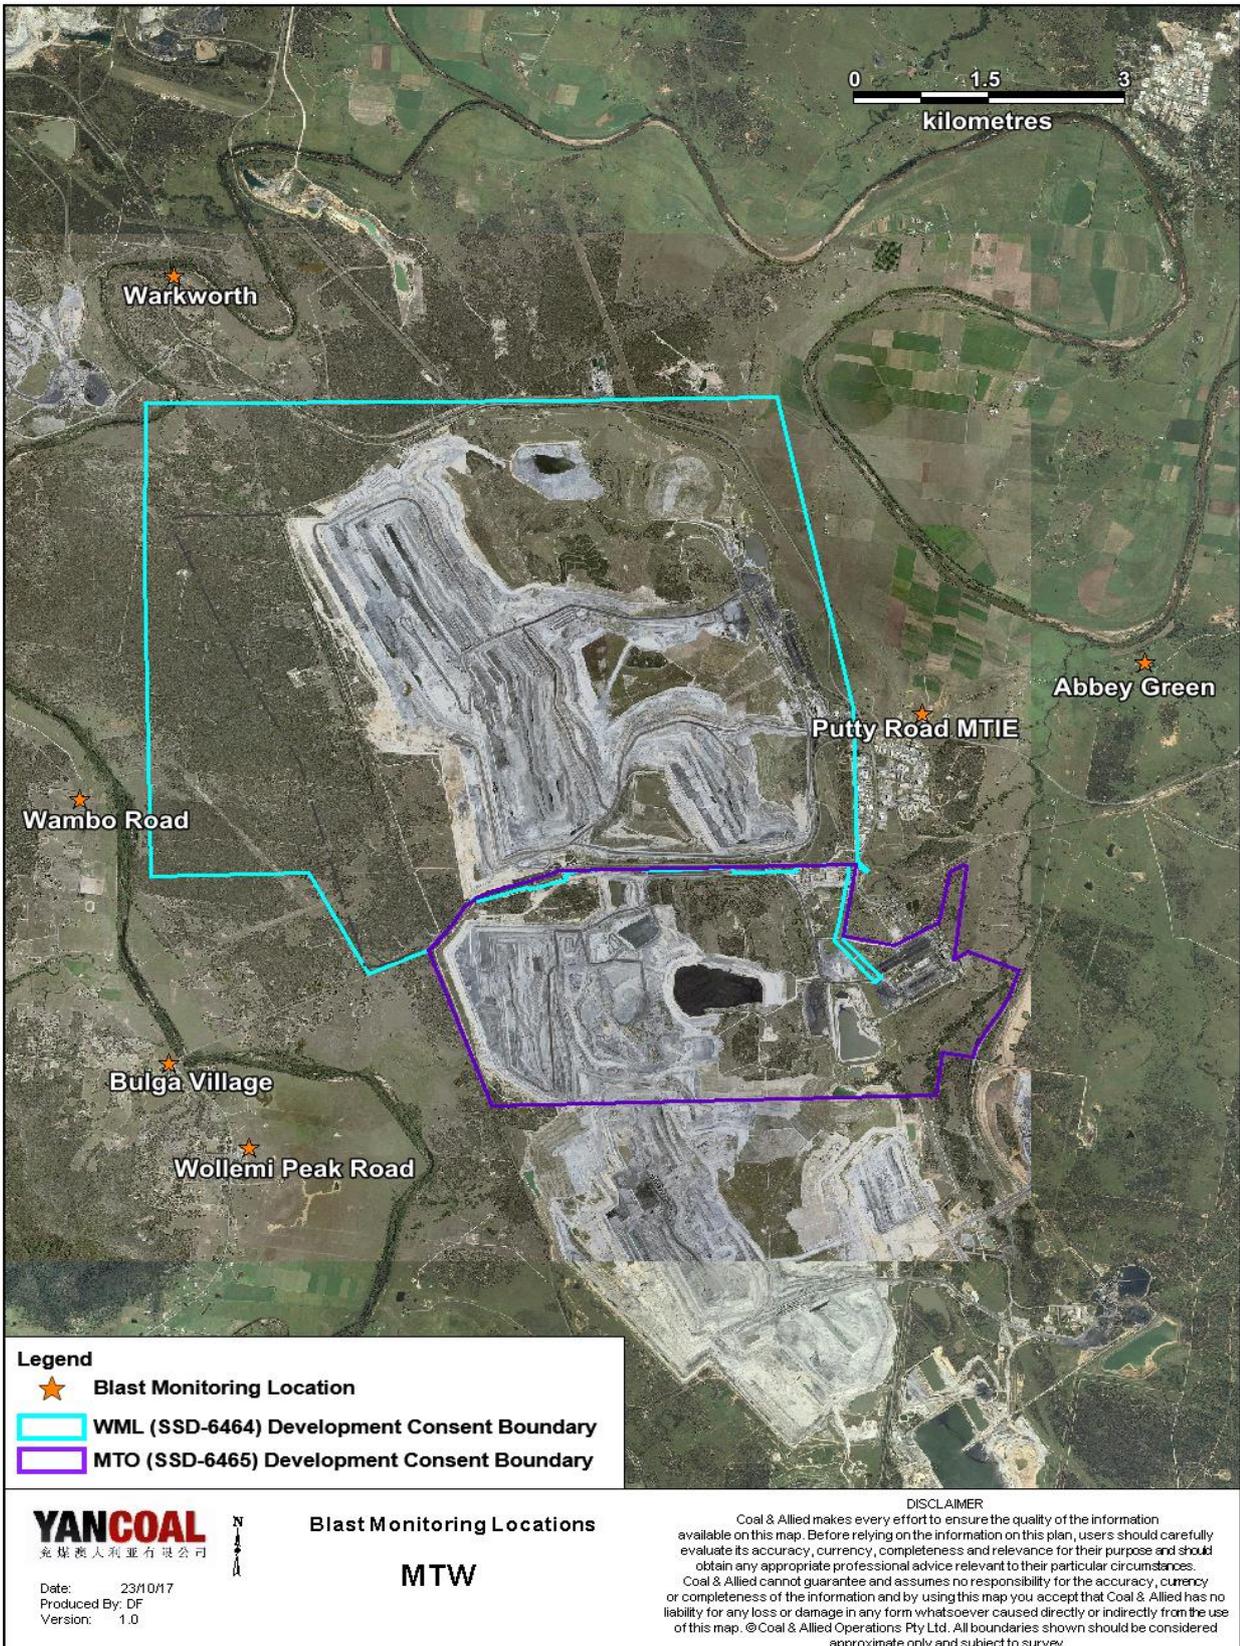
Figure 15: MTW Blast Monitoring Location Plan

MTW have a network of six blast monitoring units. These are located at nearby privately owned residences and function as regulatory compliance monitors.

The location of these monitors can be found in **Figure 15**.

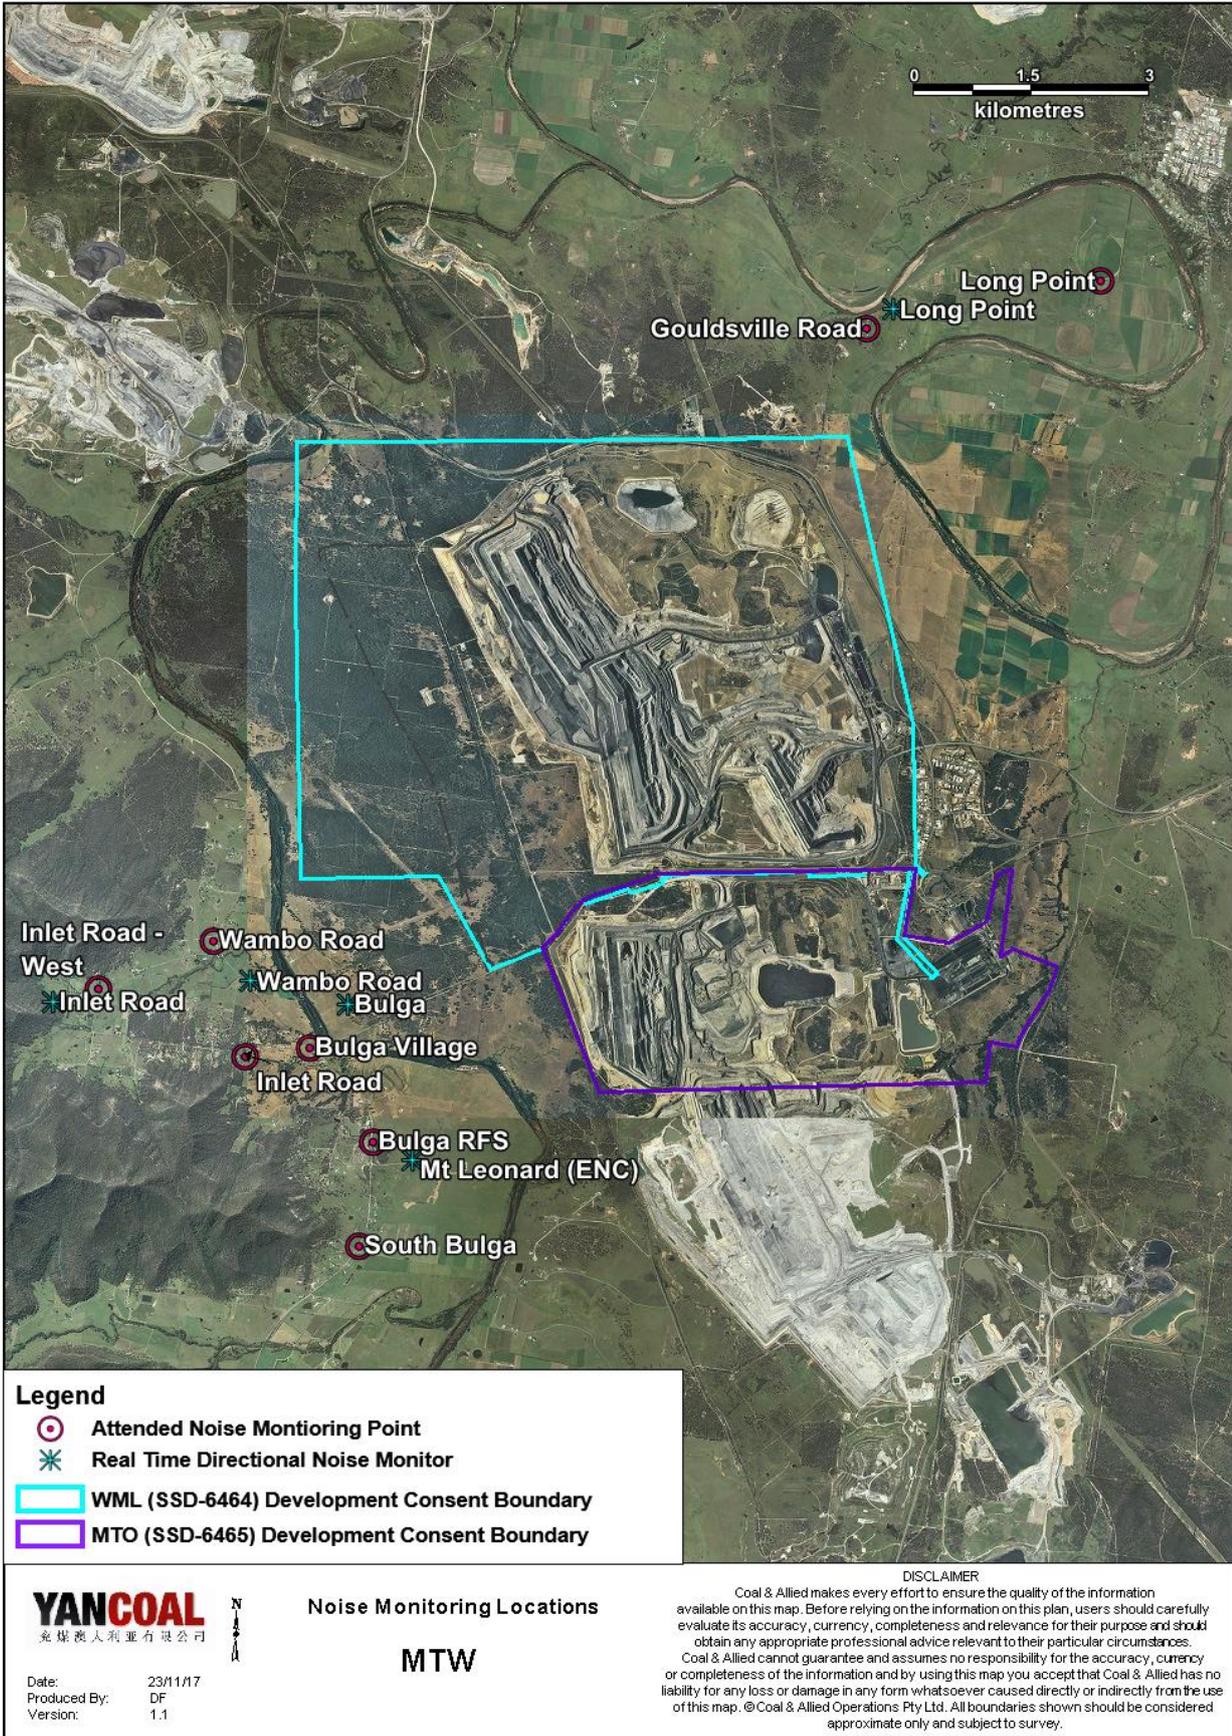
Figure 16: Noise Monitoring Location Plan

Routine attended noise monitoring is carried out in accordance with the MTW Noise Management Plan. A review against EIS predictions will be reported in the Annual Review Report. The purpose of the noise surveys is to quantify and describe the acoustic environment around the site and compare results with specified limits. Real time noise monitoring also occurs at five sites surrounding MTW. Noise monitoring locations are displayed in **Figure 16**.

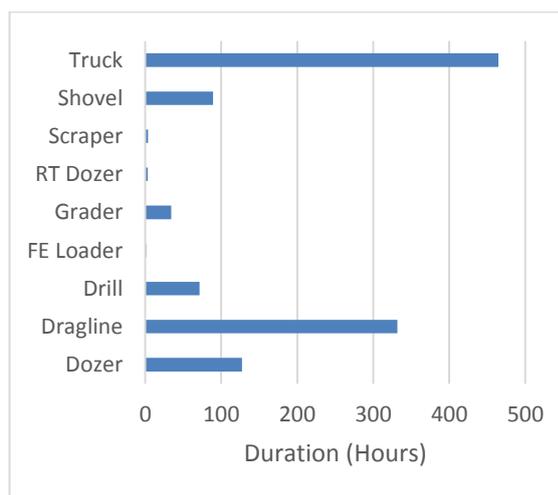
Figure 17: Operational Downtime by Equipment Type – July 2018

During July, a total of 1126 hours of equipment downtime was logged in response to environmental events such as dust, noise and adverse meteorological conditions. Operational downtime by equipment type is shown in **Figure 17**.

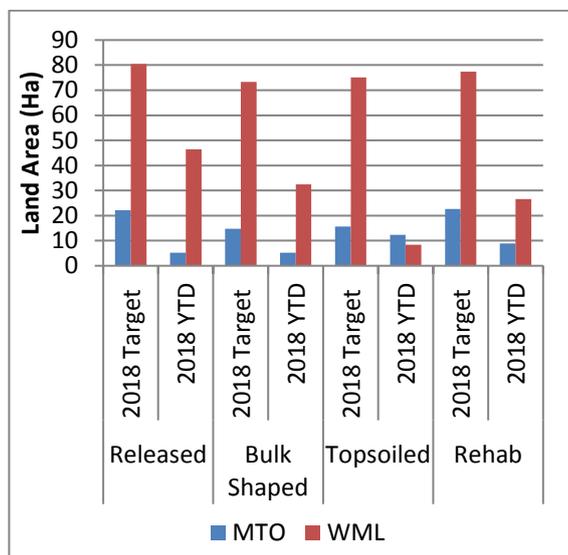
Figure 18: Rehabilitation YTD – July 2018

During July 2018, 1.3 Ha of land was released for rehabilitation, 1.6 Ha of land was bulk shaped, 3.9 Ha of land was topsoiled, 7.5 Ha of land was composted and 9.0 Ha of land was rehabilitated.
