Monthly Environmental Monitoring Report

Yancoal Mt Thorley Warkworth

June 2021

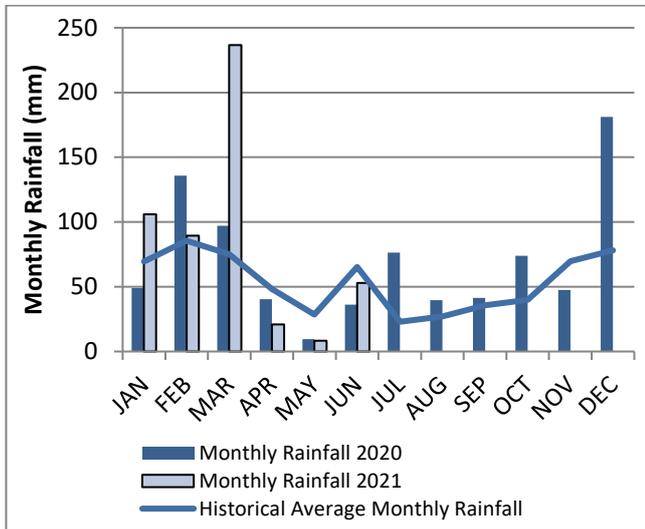
Rainfall for the period is summarised in **Table 1**, the year-to-date trend and historical trend are shown in **Figure 1**.

Note: The historical average monthly rainfall is calculated from 2007 to 2020 monthly totals

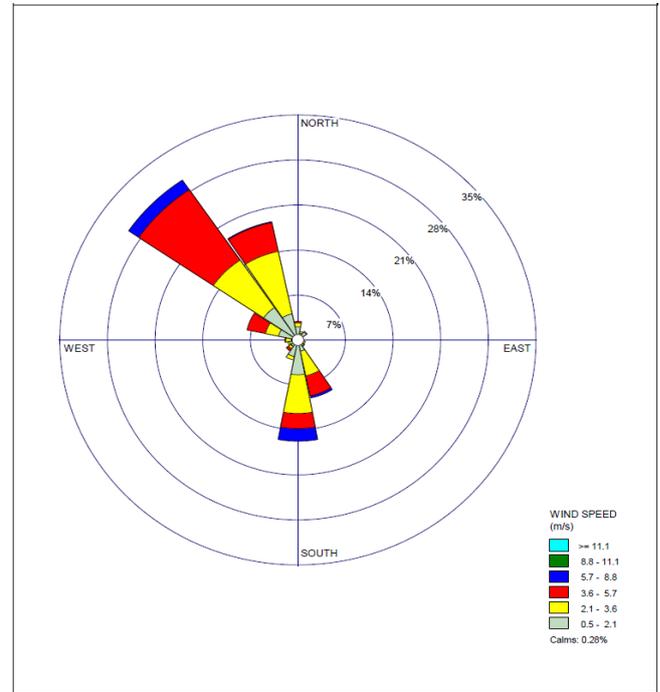
Figure 2: Charlton Ridge Wind Rose – June 2021

Winds from the north west were dominant throughout the reporting period as shown in **Figure 2**.

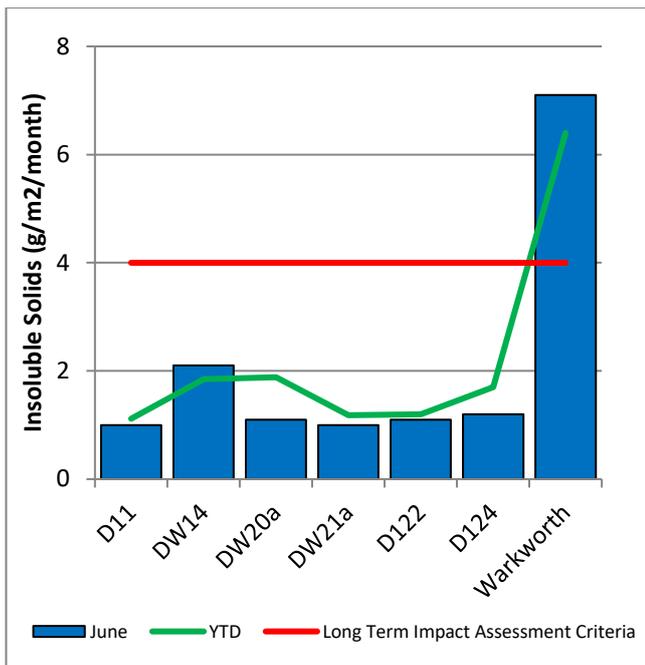
Figure 4: Depositional Dust – June 2021

Figure 4 displays insoluble solids results from depositional dust gauges during the reporting period compared against the year-to-date average and the annual impact assessment criteria.

During the reporting period the Warkworth monitor recorded a monthly result above the long-term impact assessment criteria of 4.0 g/m² per month. There is no evidence to suggest that the Warkworth result is contaminated. Accordingly, the result will be included in the annual average calculation.

An annual assessment of MTW’s compliance with the Long-Term Impact Assessment Criteria will be provided in the 2021 Annual Review Report.

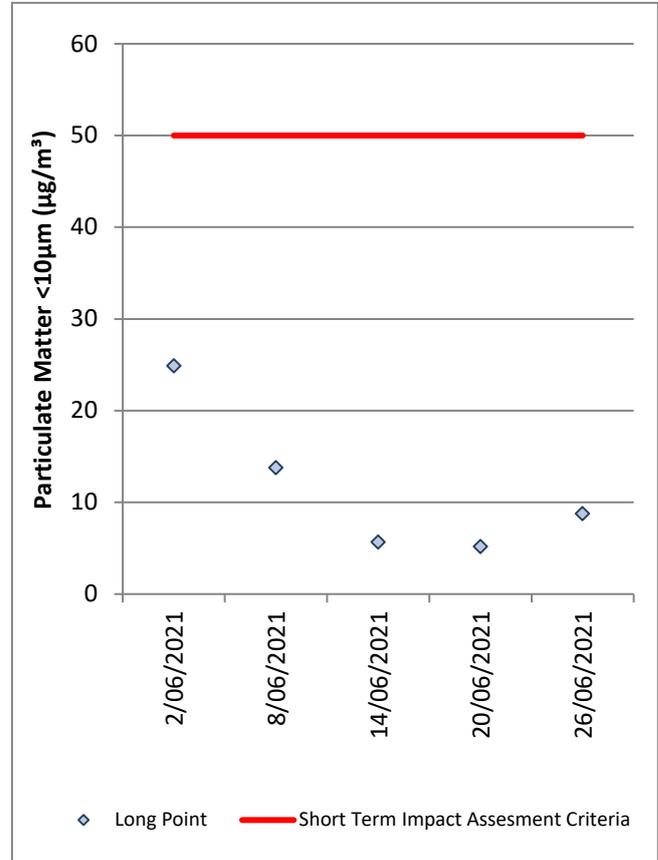
Figure 5: Individual PM₁₀ Results – June 2021

Figure 5 shows the individual PM₁₀ results at the monitoring station against the short-term impact assessment criteria of 50µg/m³.

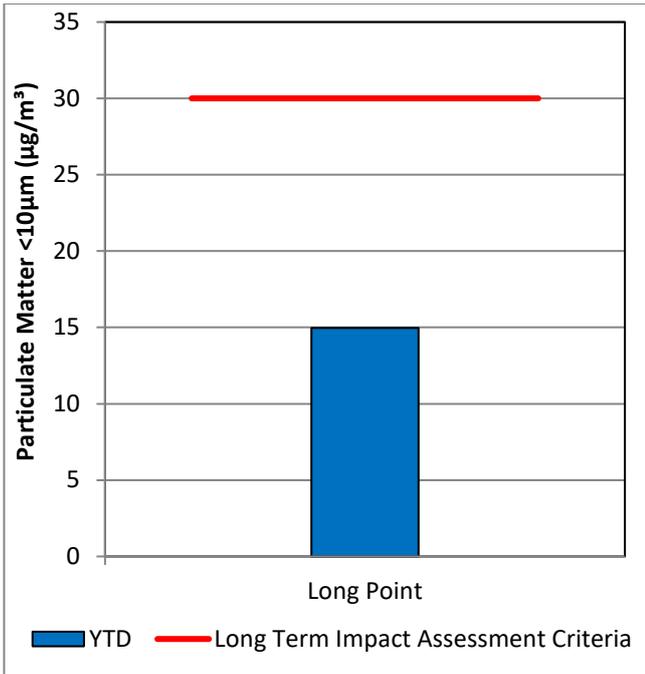
Figure 6: Annual Average PM₁₀ – June 2021

Figure 6 shows the annual average PM₁₀ results against the long-term impact assessment criteria.

An annual assessment of MTW’s compliance with the Long-Term Impact Assessment Criteria will be provided in the 2021 Annual Review Report.

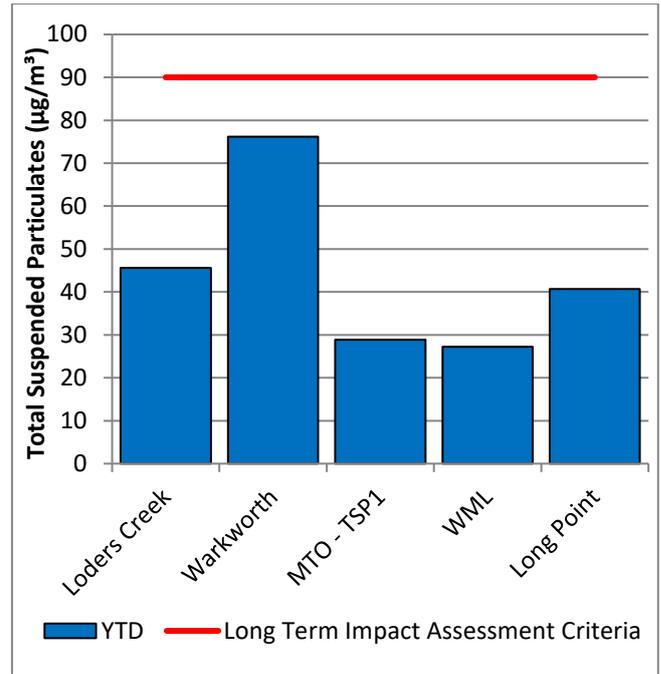
Figure 7: Annual Average Total Suspended Particulates – June 2021

Figure 7 shows the annual average TSP results compared against the long-term impact assessment criteria of 90µg/m³.

An annual assessment of MTW’s compliance with the Long-Term Impact Assessment Criteria will be provided in the 2021 Annual Review Report.

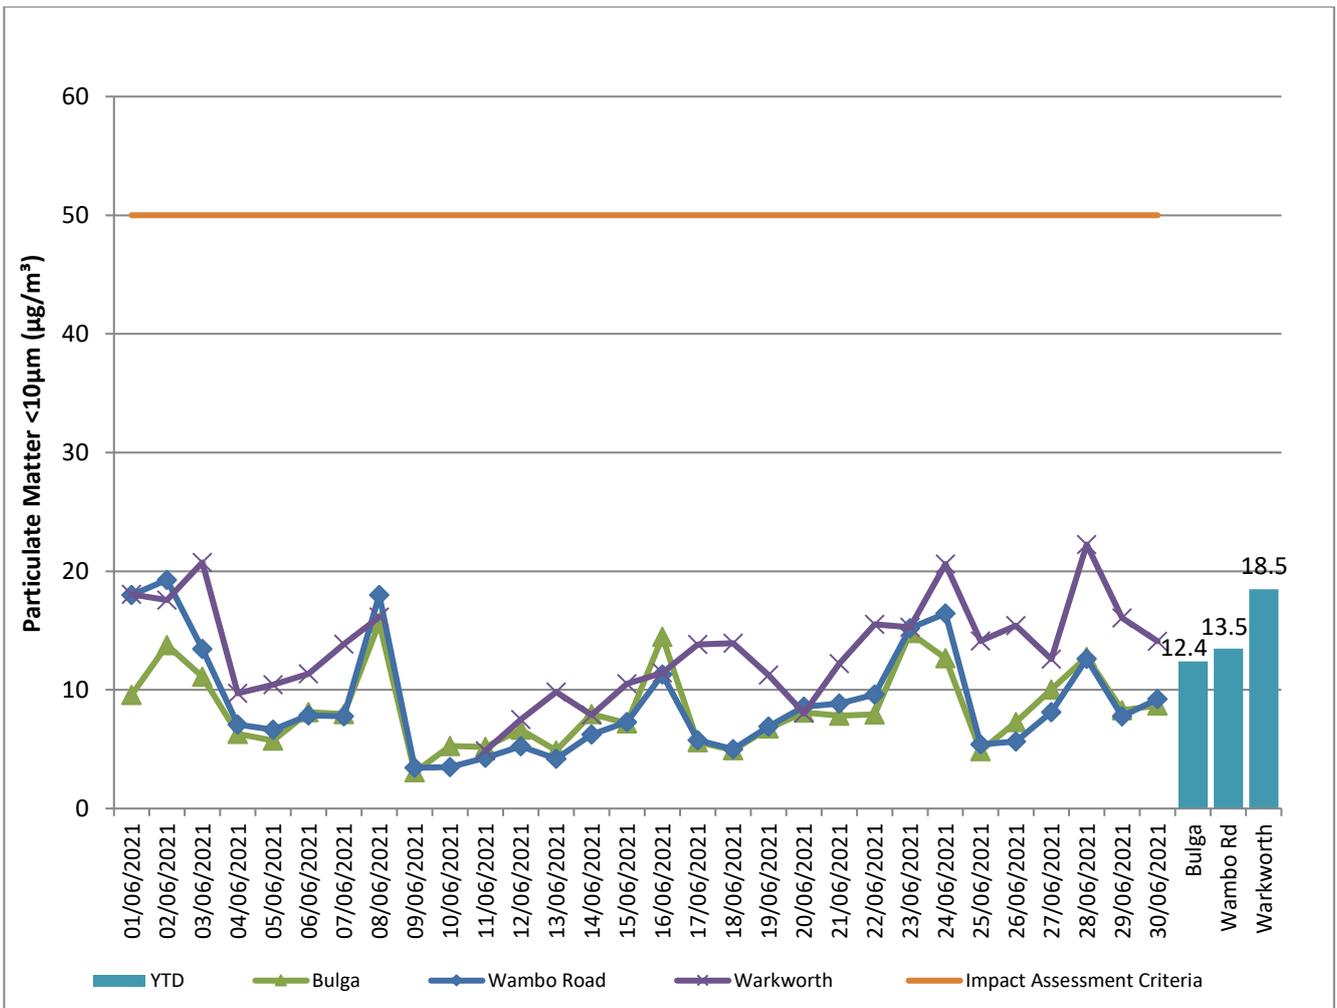
Figure 8: Real Time PM10 24hr average and Year-to-date average – June 2021

Results for real time dust sampling are shown in Figure 8, including the daily 24-hour average PM₁₀ result and the annual PM₁₀ average.

During June, the real-time monitoring system generated 41 automated air quality related alerts, including 24 alerts for adverse meteorological conditions and 17 alerts for elevated PM₁₀ levels.

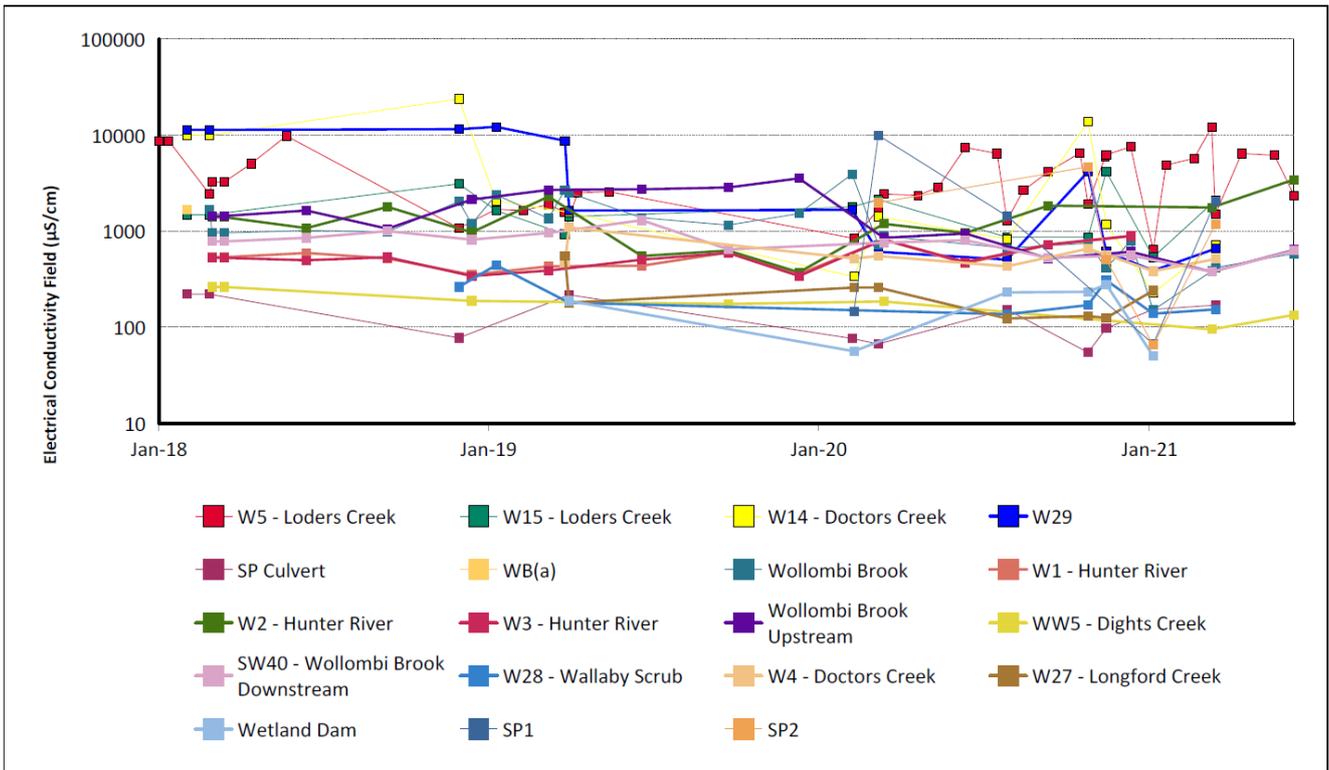
Figure 12: Watercourse Electrical Conductivity Trend – June 2021

Note: Missing data indicates that there was insufficient water to take a sample, or that there was no safe access.

Figure 9 to Figure 11 show the long-term surface water trend (2018 – current) within MTW mine dams. Figure 12 to Figure 14 show the long-term surface water trend (2018 - current) in surrounding watercourses.

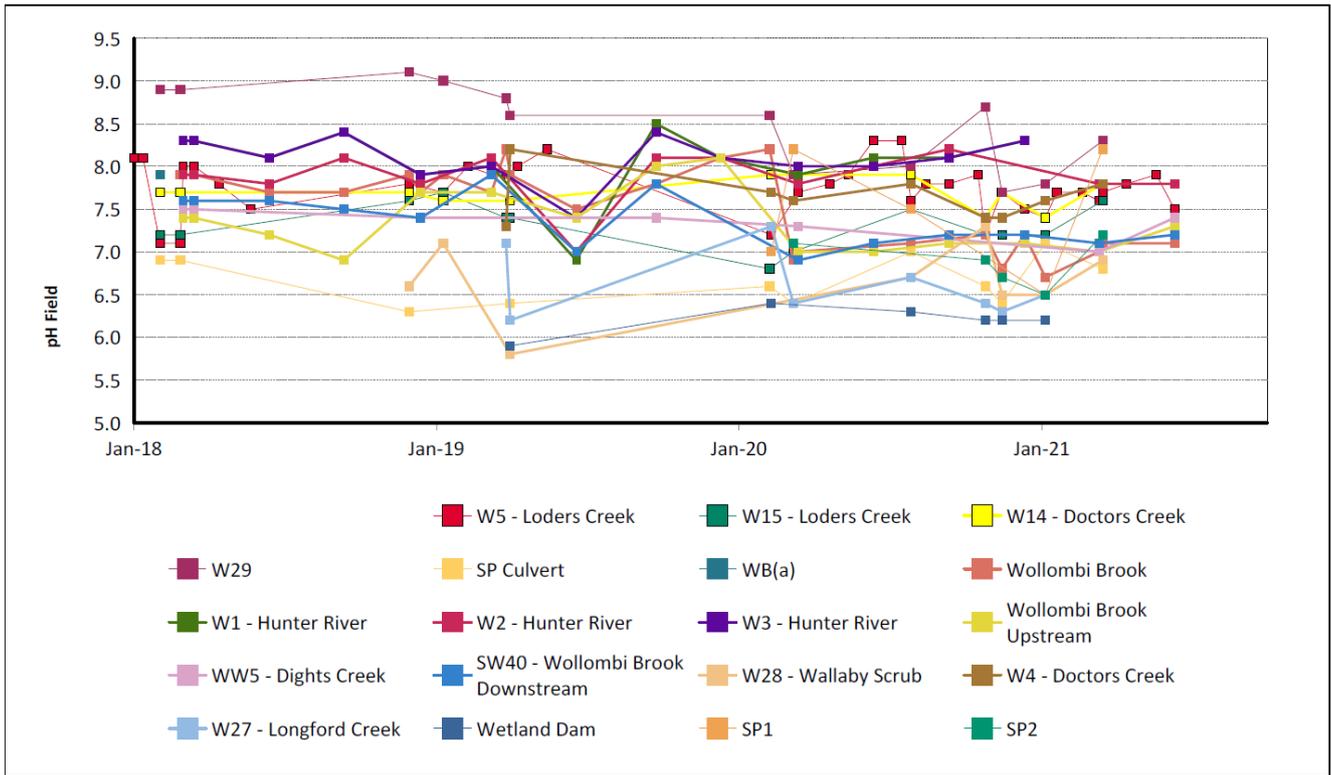
Figure 13: Watercourse pH Trend – June 2021

Note: Missing data indicates that there was insufficient water to take a sample, or that there was no safe access.

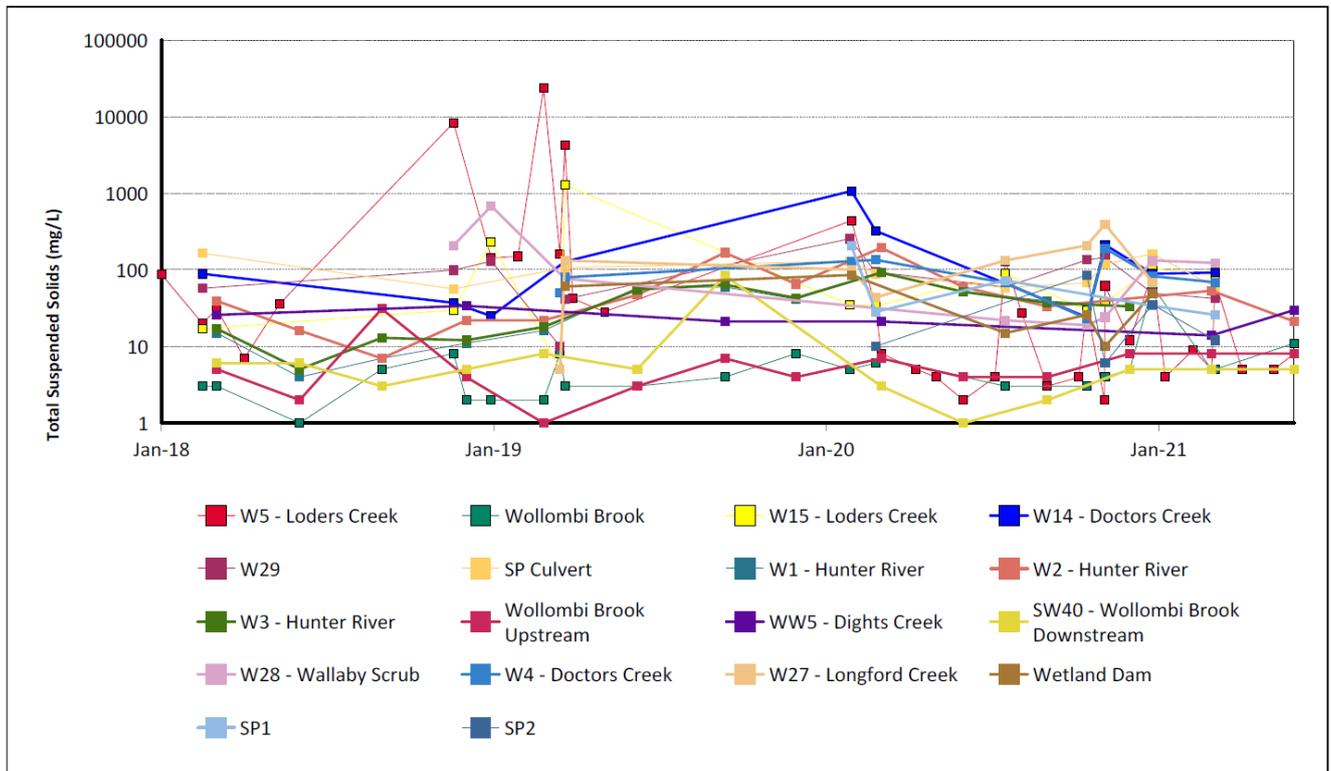
Figure 14: Watercourse Total Suspended Solids Trend – June 2021

Note: Missing data indicates that there was insufficient water to take a sample, or that there was no safe access.

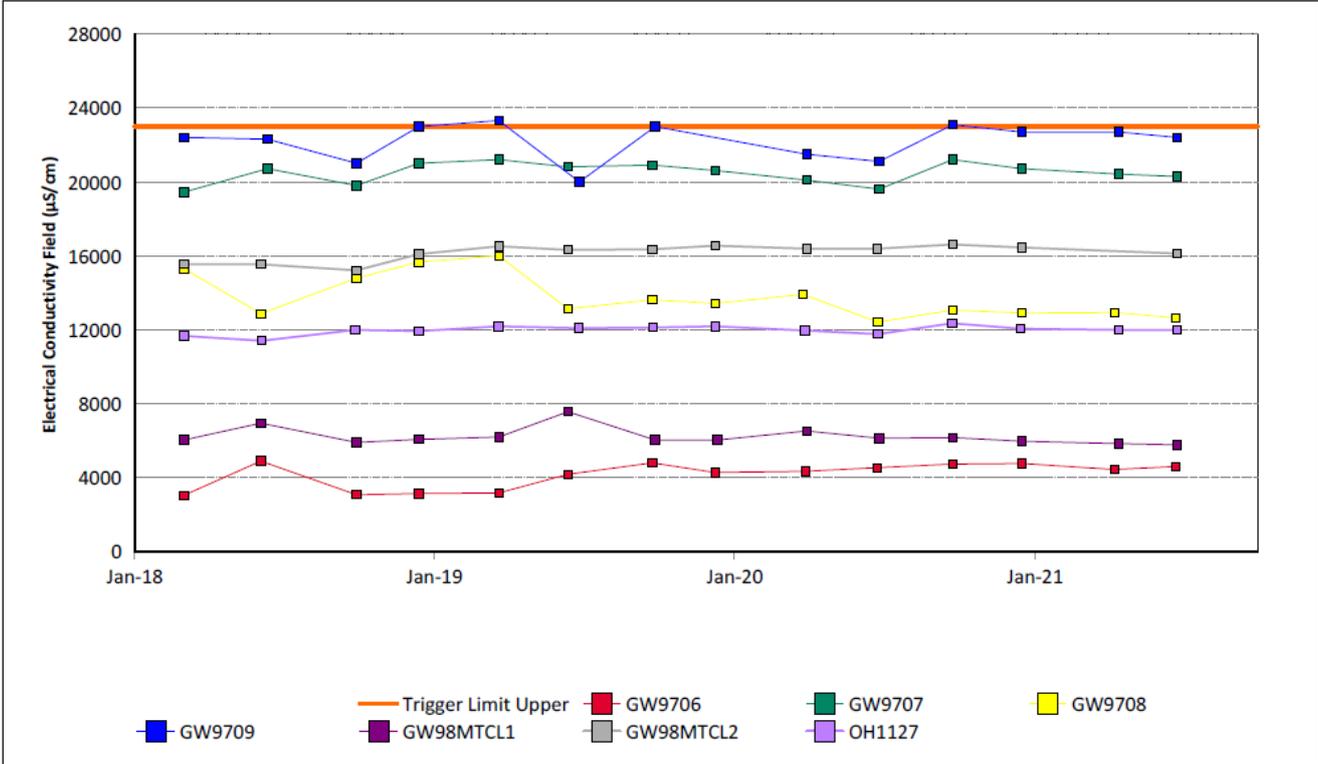
Figure 16: Bayswater Seam Electrical Conductivity Trend – June 2021

Note: Missing data indicates that there was insufficient water to take a sample.

Figure 16 to Figure 61 show the long-term water quality trends (2018 – current) for groundwater bores monitored at MTW.

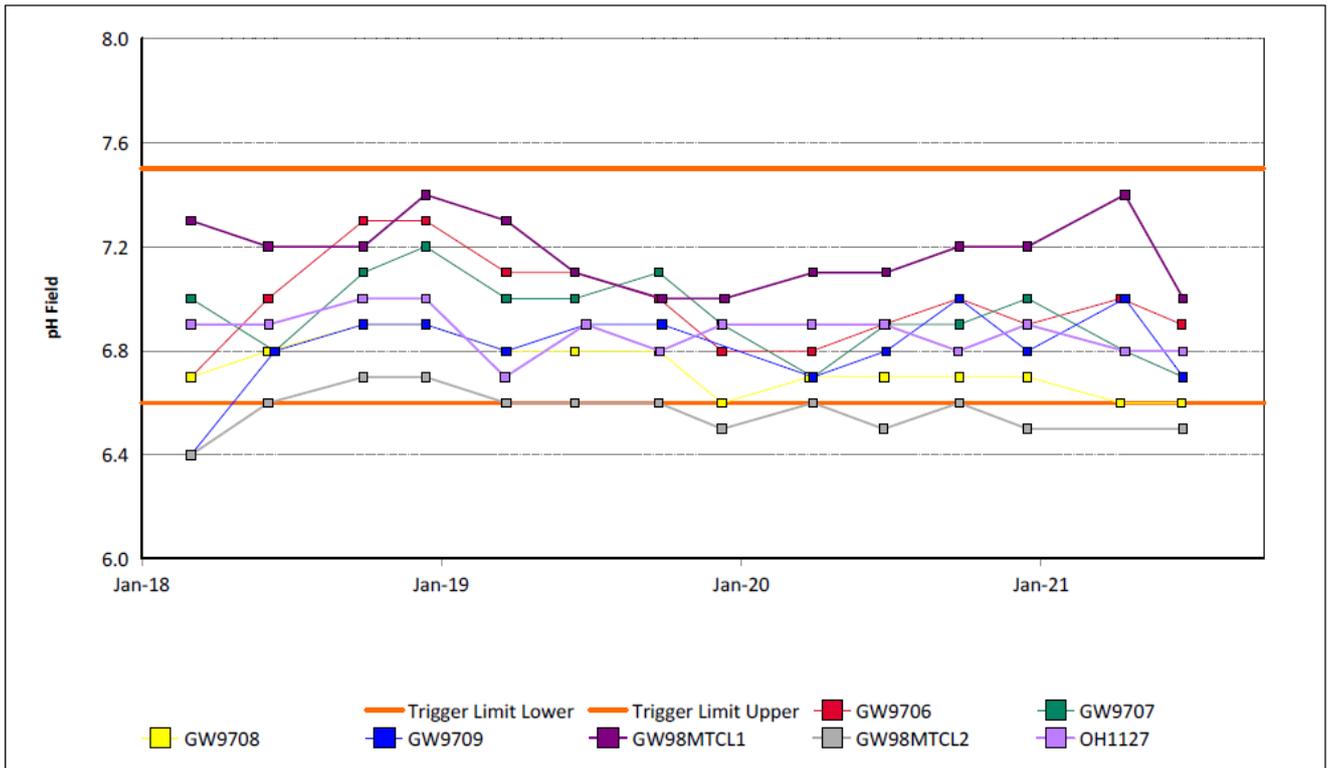
Figure 17: Bayswater Seam pH Trend – June 2021

Note: Missing data indicates that there was insufficient water to take a sample.

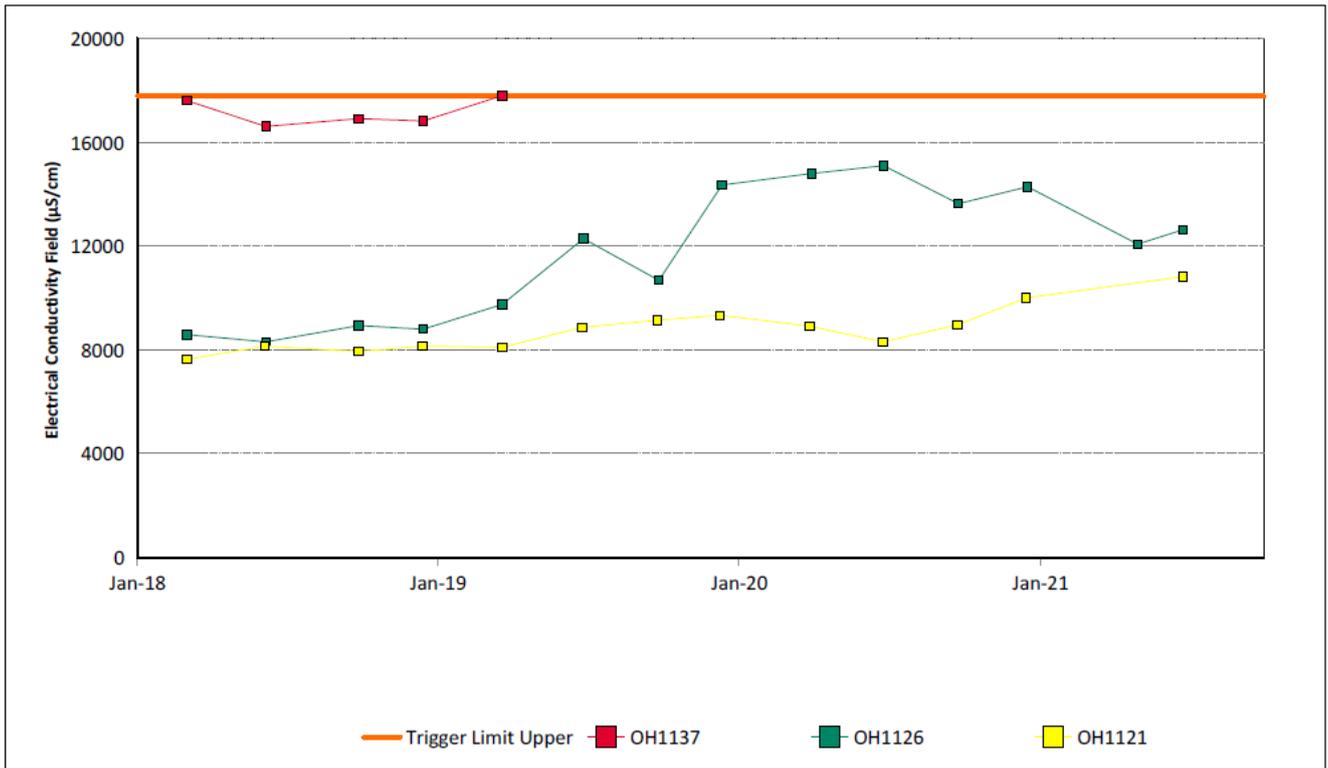
Figure 31: Vaux Seam Electrical Conductivity Trend – June 2021

Note: Missing data indicates that there was insufficient water to take a sample.

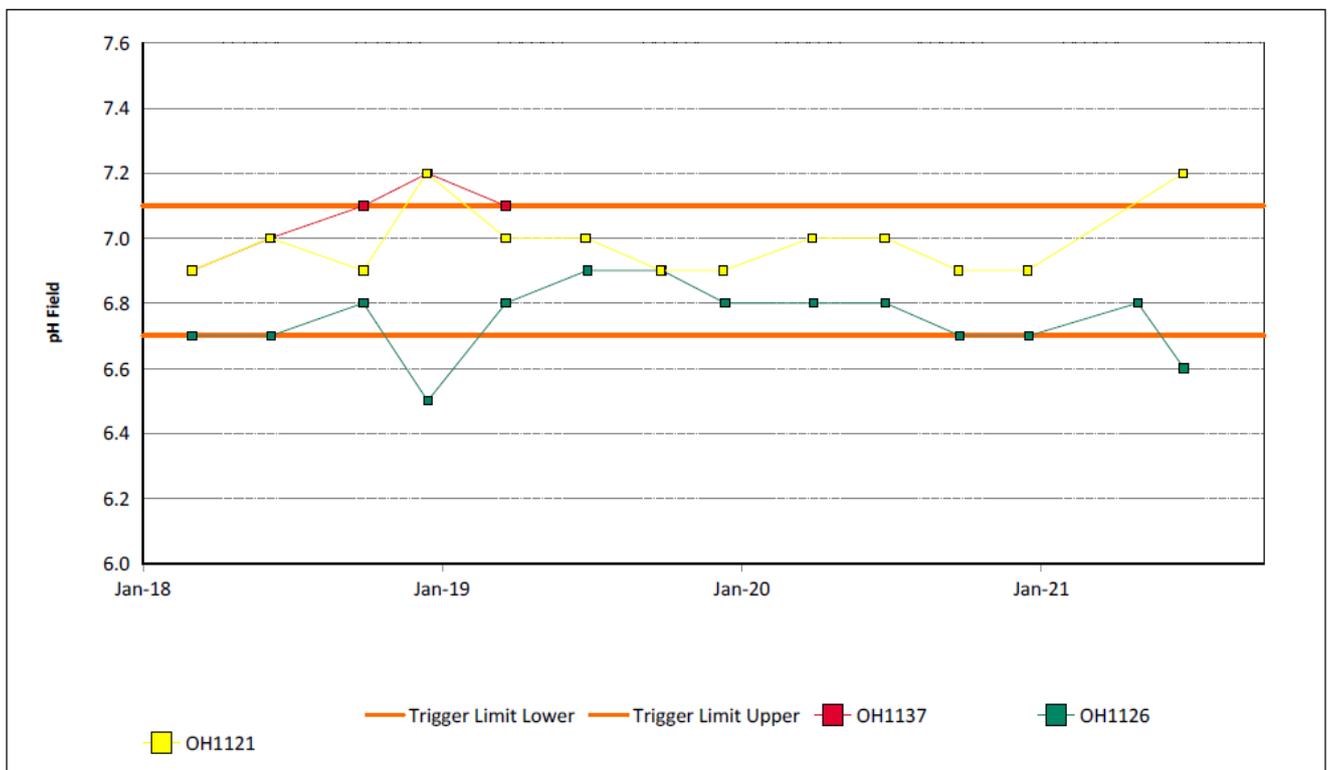
Figure 32: Vaux Seam pH Trend – June 2021

Note: Missing data indicates that there was insufficient water to take a sample.

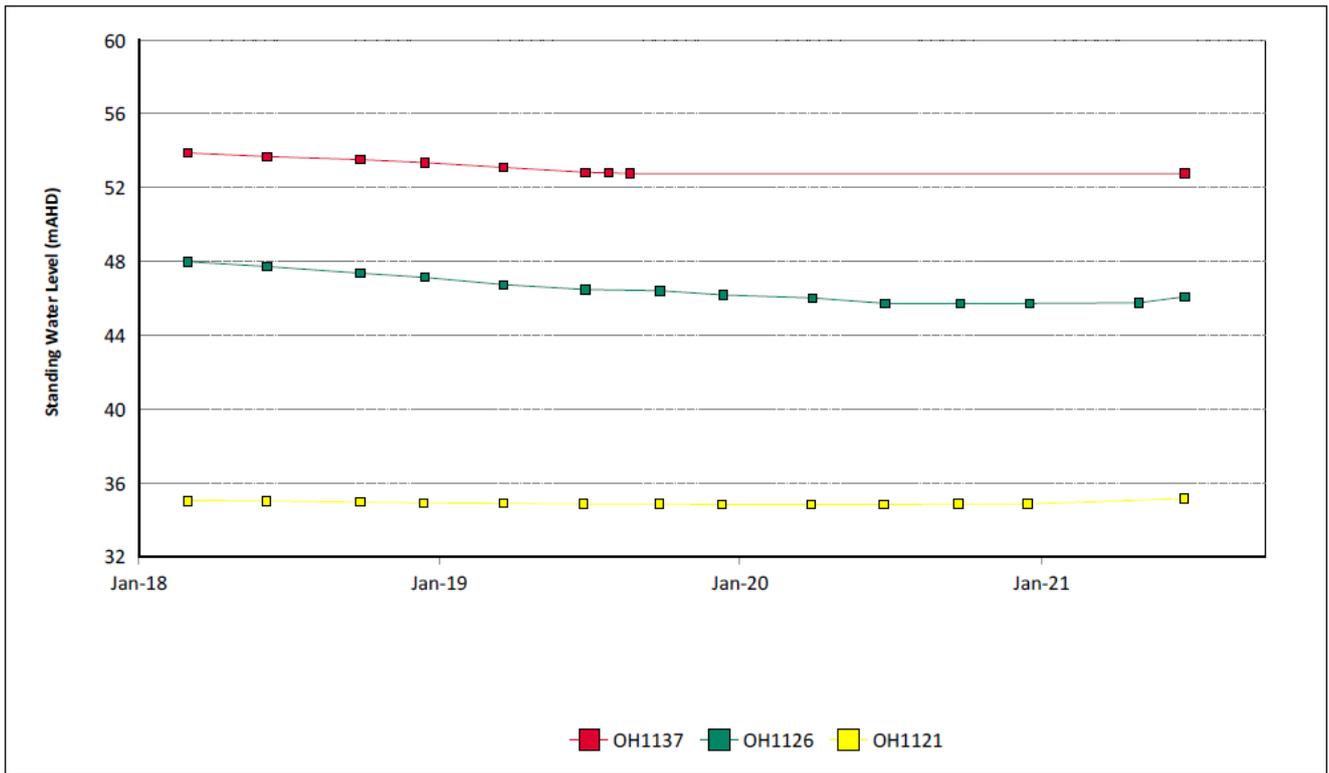
Figure 33: Vaux Seam Standing Water Level Trend – June 2021

Note: Missing data indicates that there was insufficient water to take a sample.

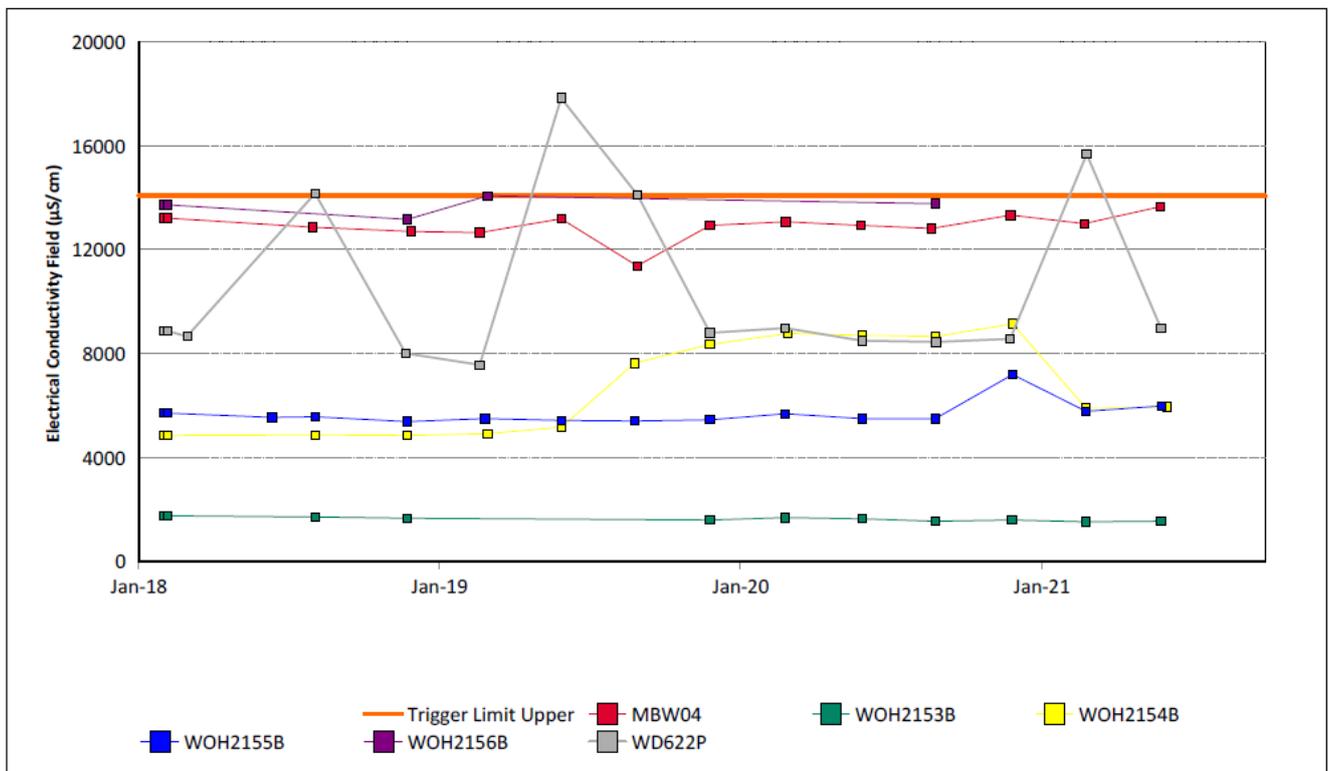
Figure 34: Wambo Seam Electrical Conductivity Trend – June 2021

Note: Missing data indicates that there was insufficient water to take a sample.

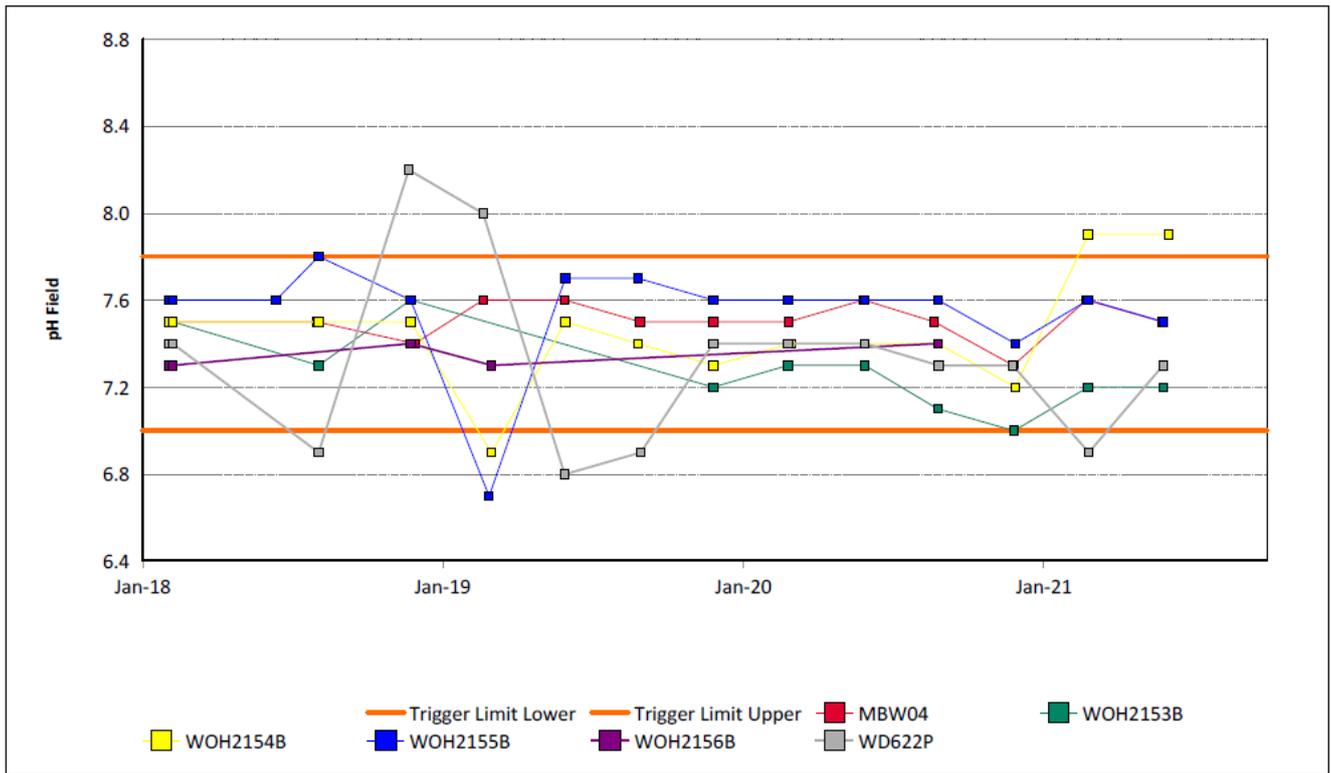
Figure 35: Wambo Seam pH Trend – June 2021

Note: Missing data indicates that there was insufficient water to take a sample.

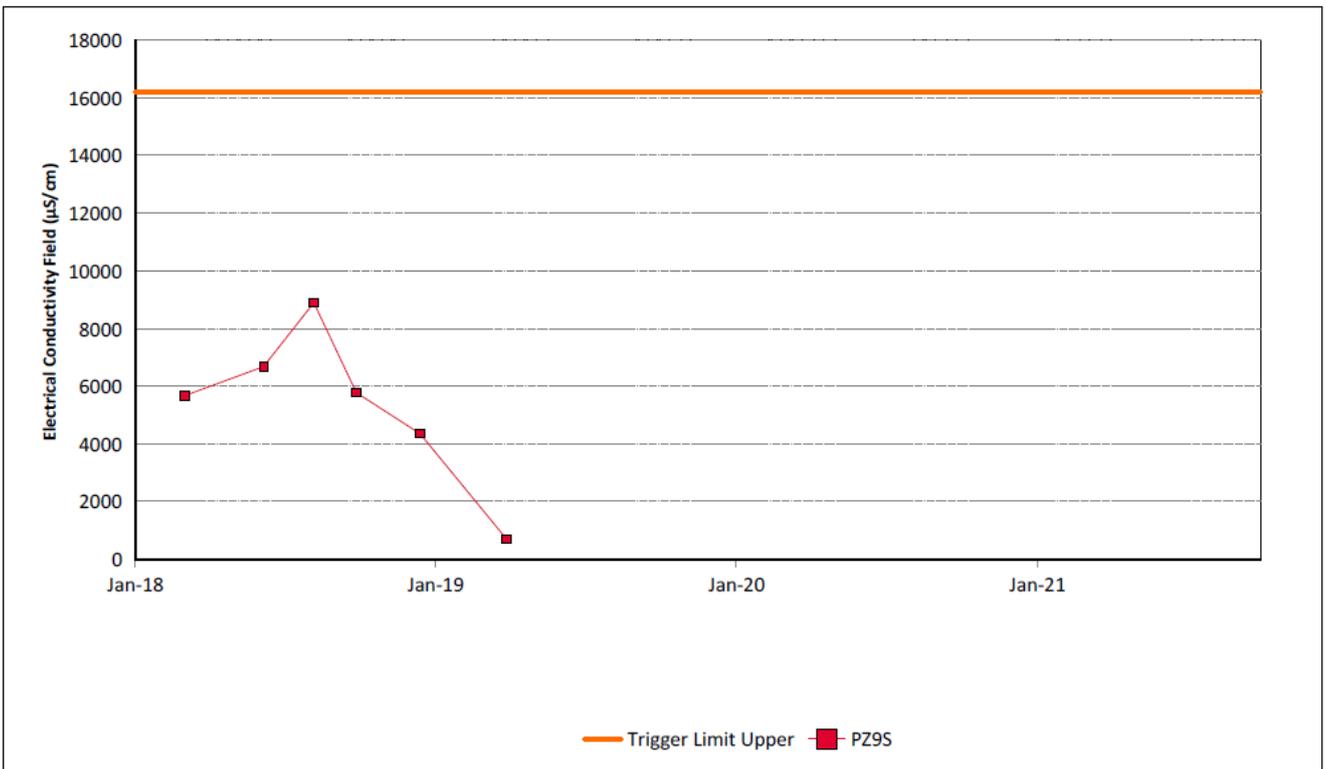
Figure 42: Wollombi Alluvium 2 Electrical Conductivity Trend – June 2021

Note: Missing data indicates that there was insufficient water to take a sample.

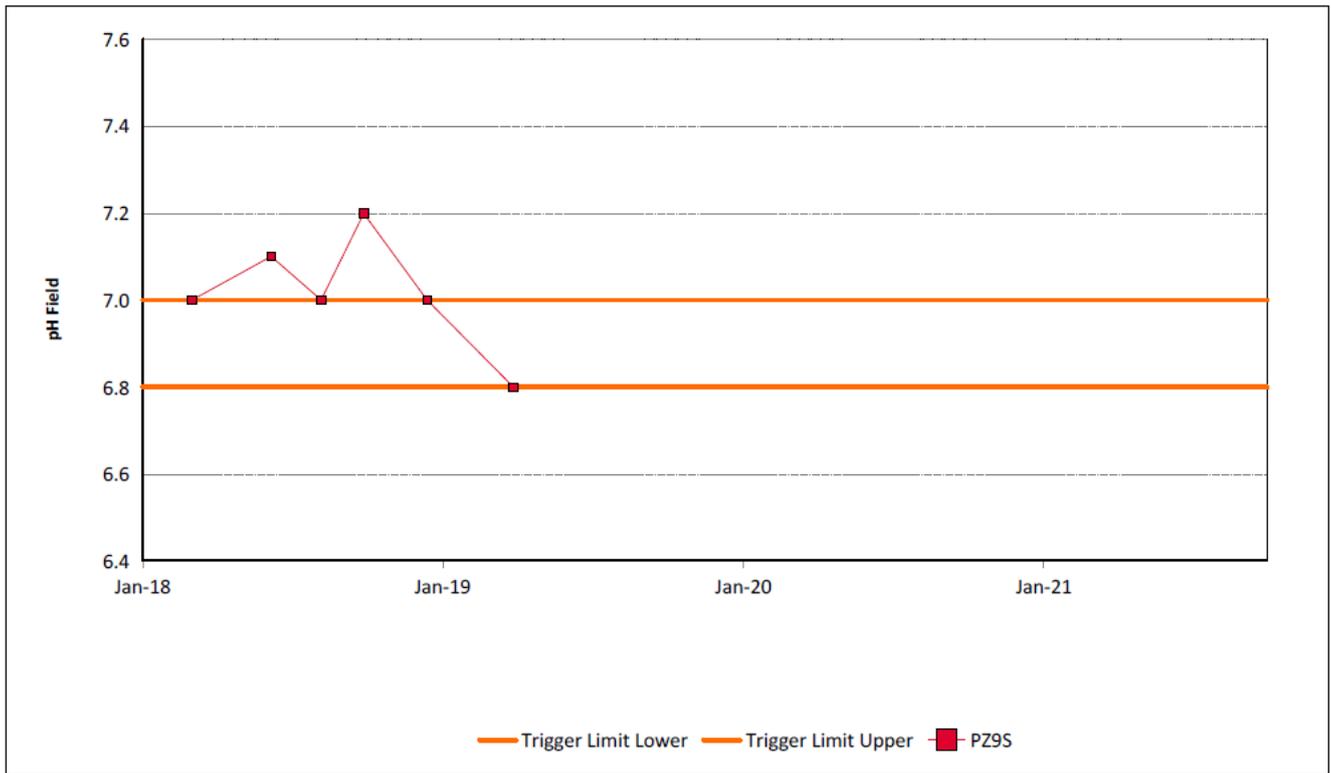
Figure 43: Wollombi Alluvium 2 pH Trend – June 2021

Note: Missing data indicates that there was insufficient water to take a sample.

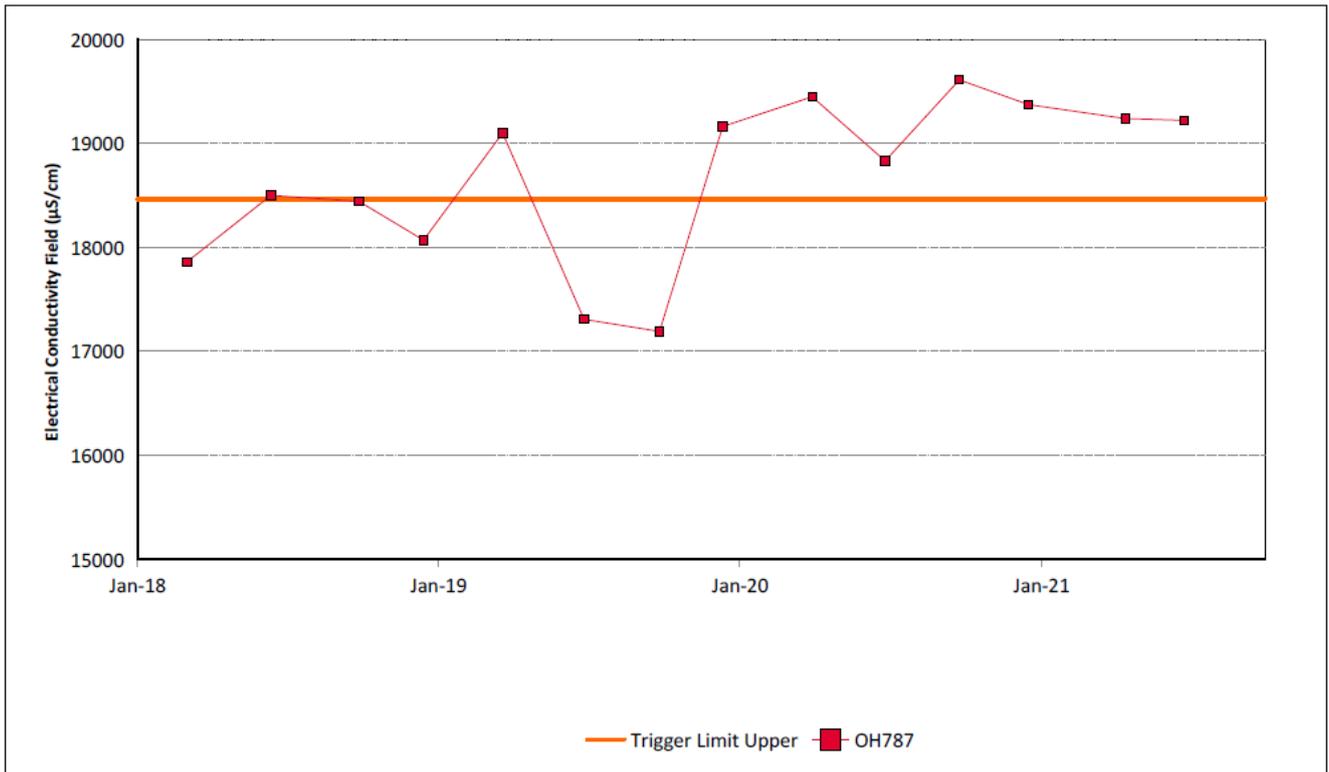
Figure 53: Hunter River Alluvium 2 Electrical Conductivity Trend – June 2021

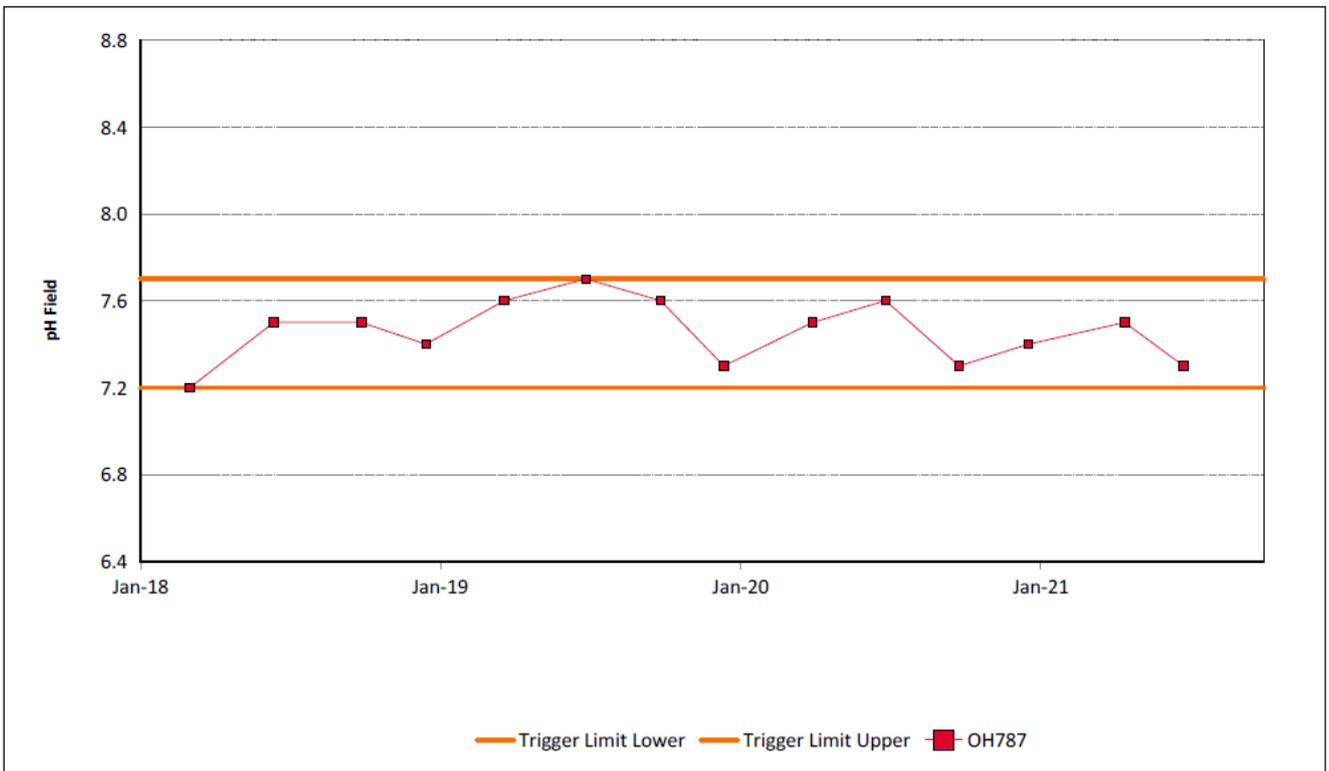
Figure 54: Hunter River Alluvium 2 pH Trend – June 2021

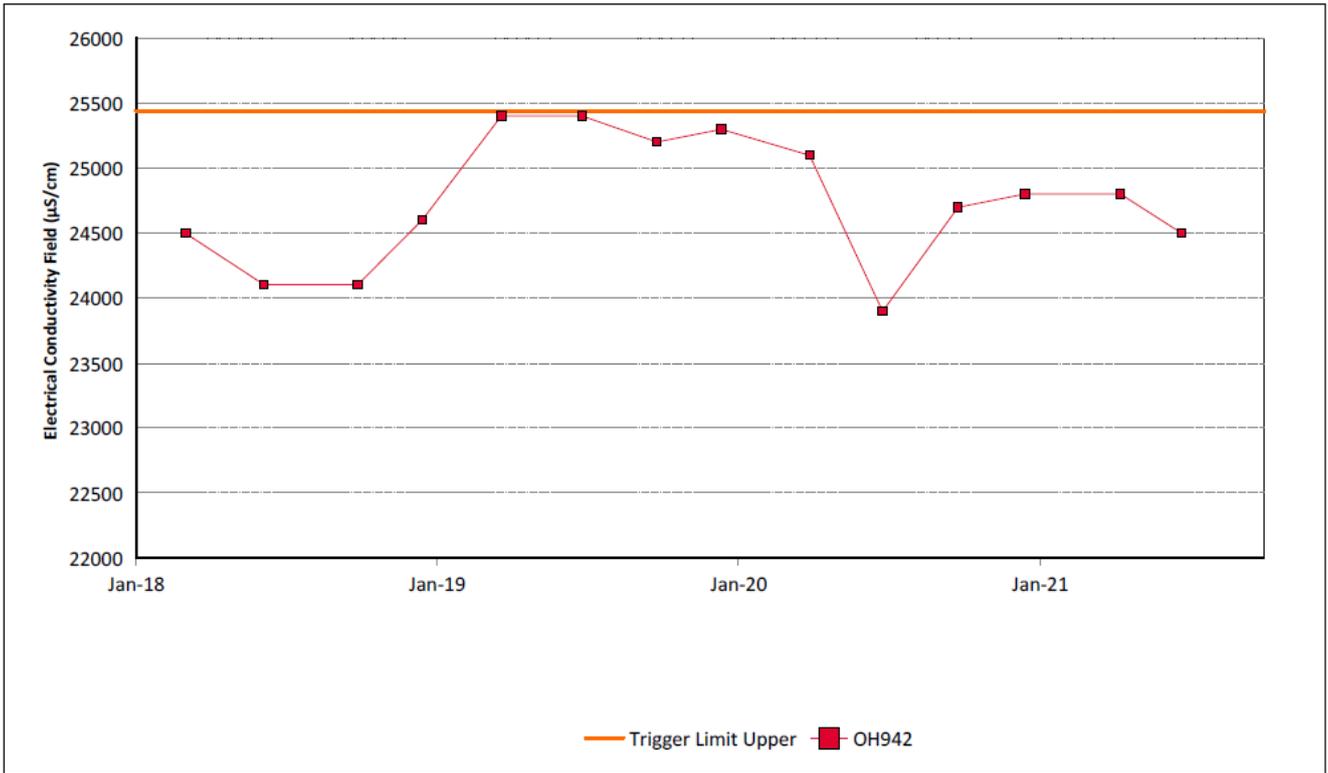
Figure 55: Hunter River Alluvium 3 Electrical Conductivity Trend – June 2021

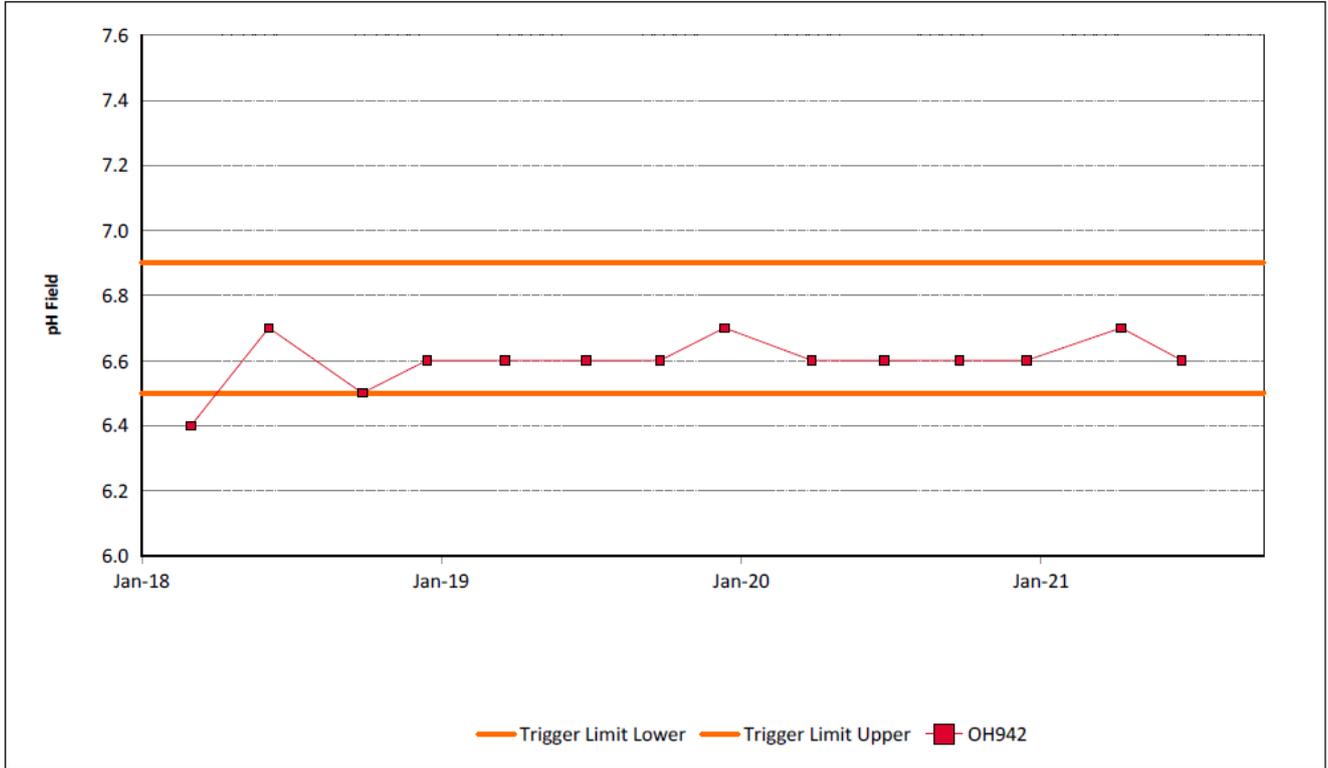
Figure 56: Hunter River Alluvium 3 pH Trend – June 2021

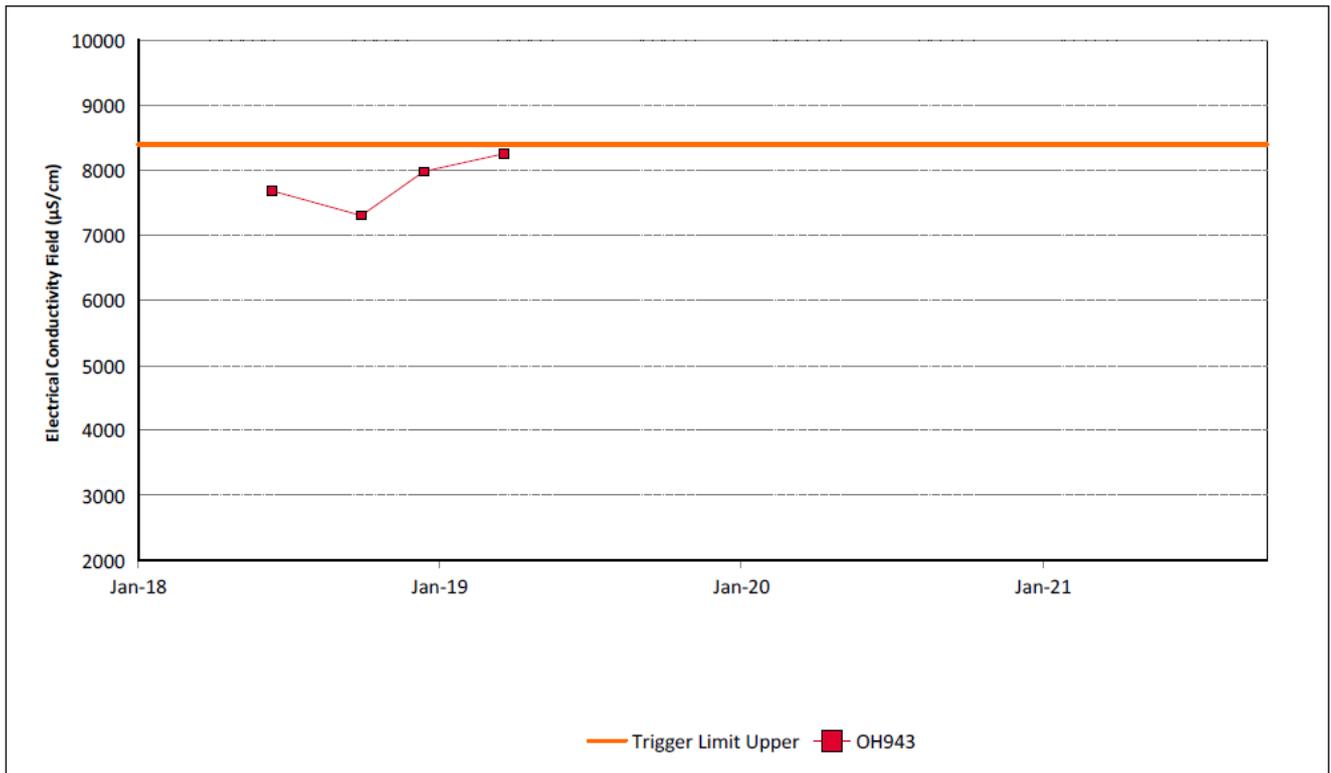
Note: Missing data indicates that there was insufficient water to take a sample.

Figure 57: Hunter River Alluvium 4 Electrical Conductivity Trend – June 2021
