Monthly Environmental Monitoring Report

Yancoal Mt Thorley Warkworth

June 2021

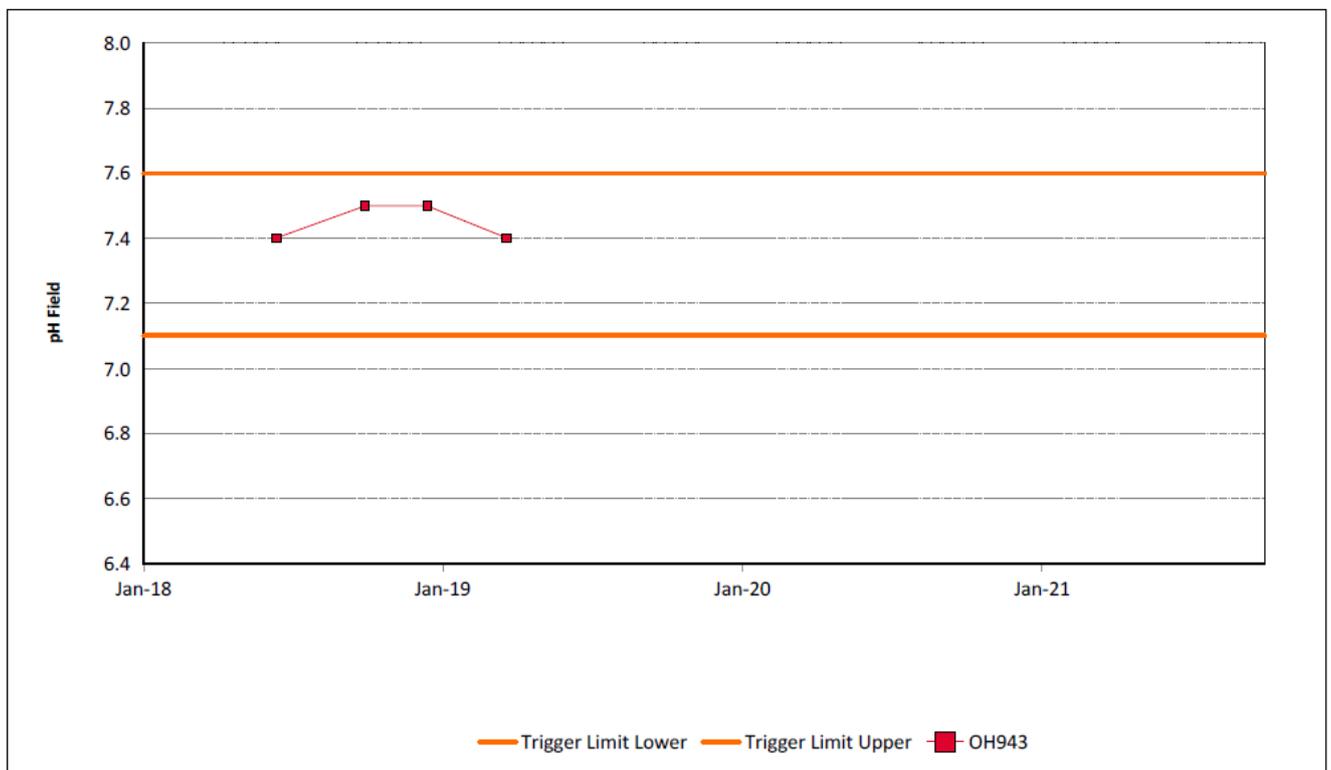
Note: Missing data indicates that there was insufficient water to take a sample.

Figure 58: Hunter River Alluvium 4 pH Trend – June 2021

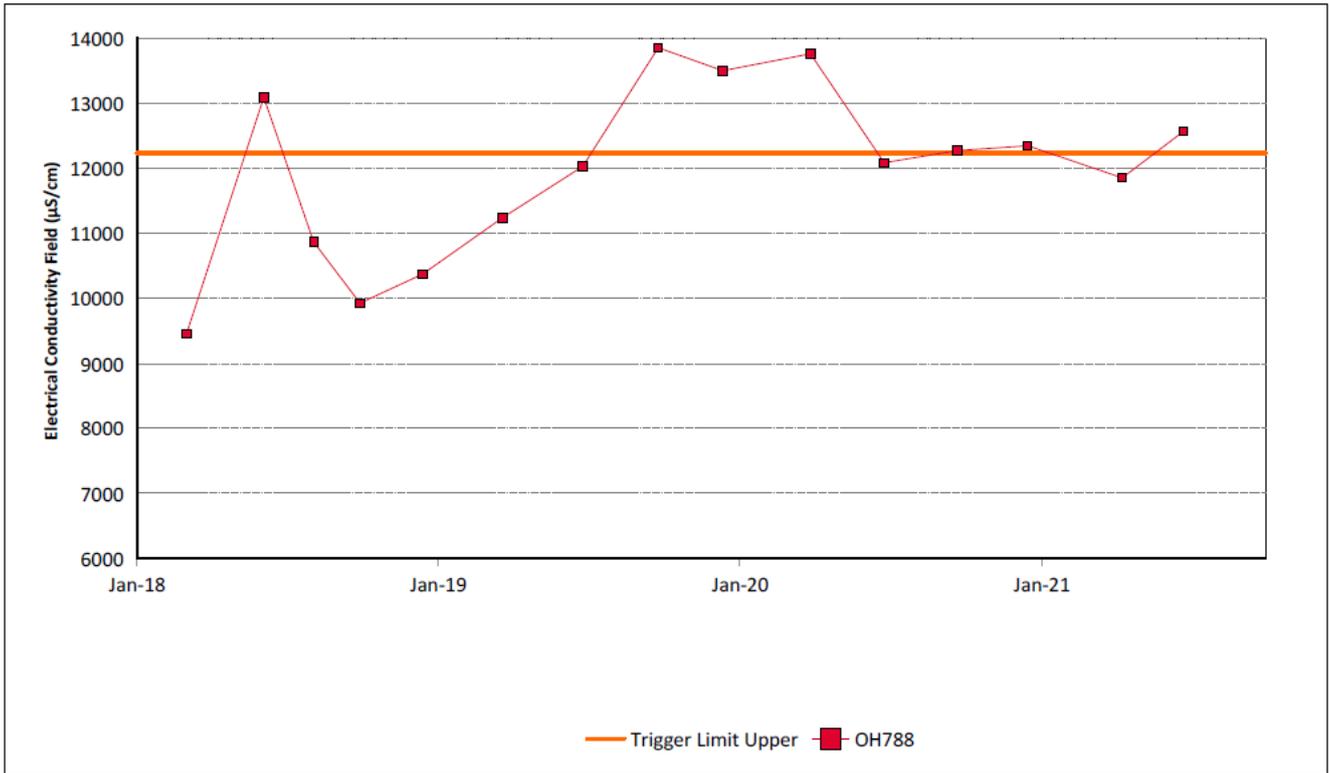
Figure 59: Hunter River Alluvium 5 Electrical Conductivity – June 2021

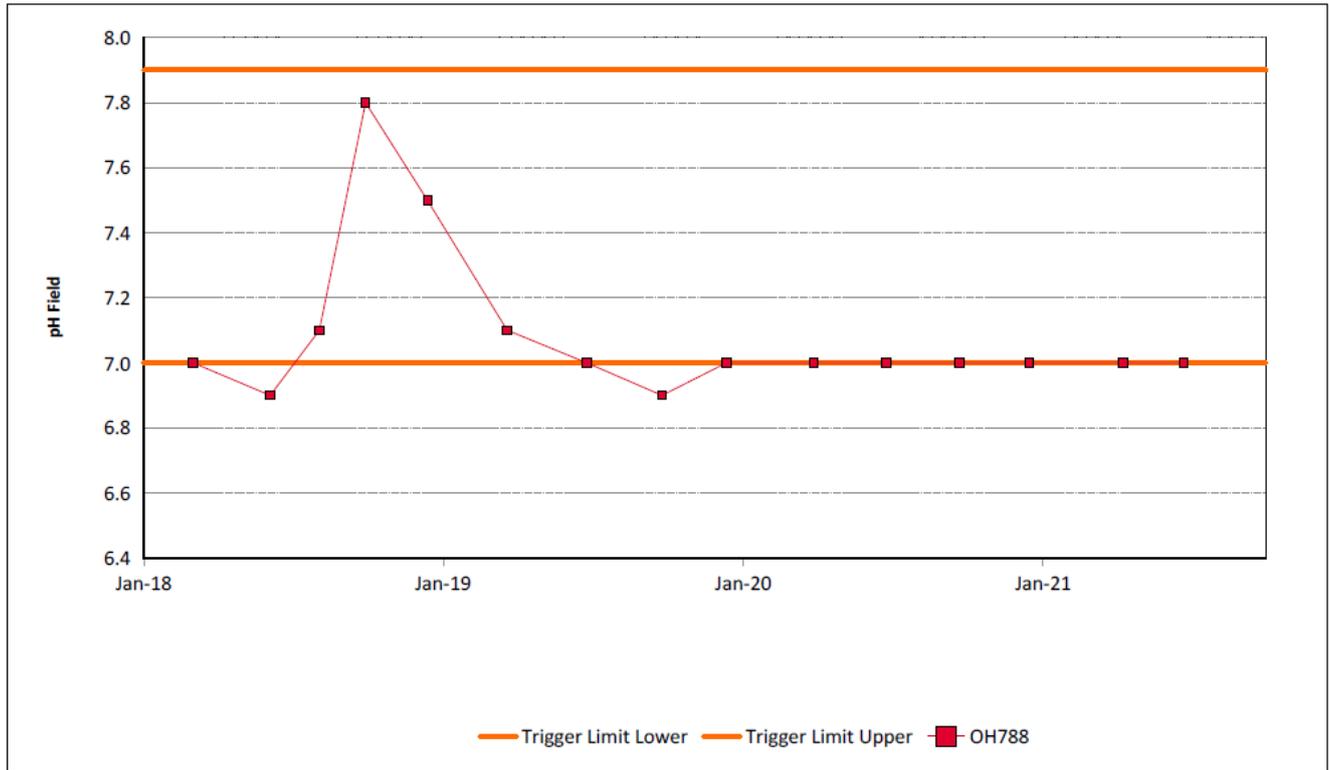
Figure 60: Hunter River Alluvium 5 pH Trend – June 2021

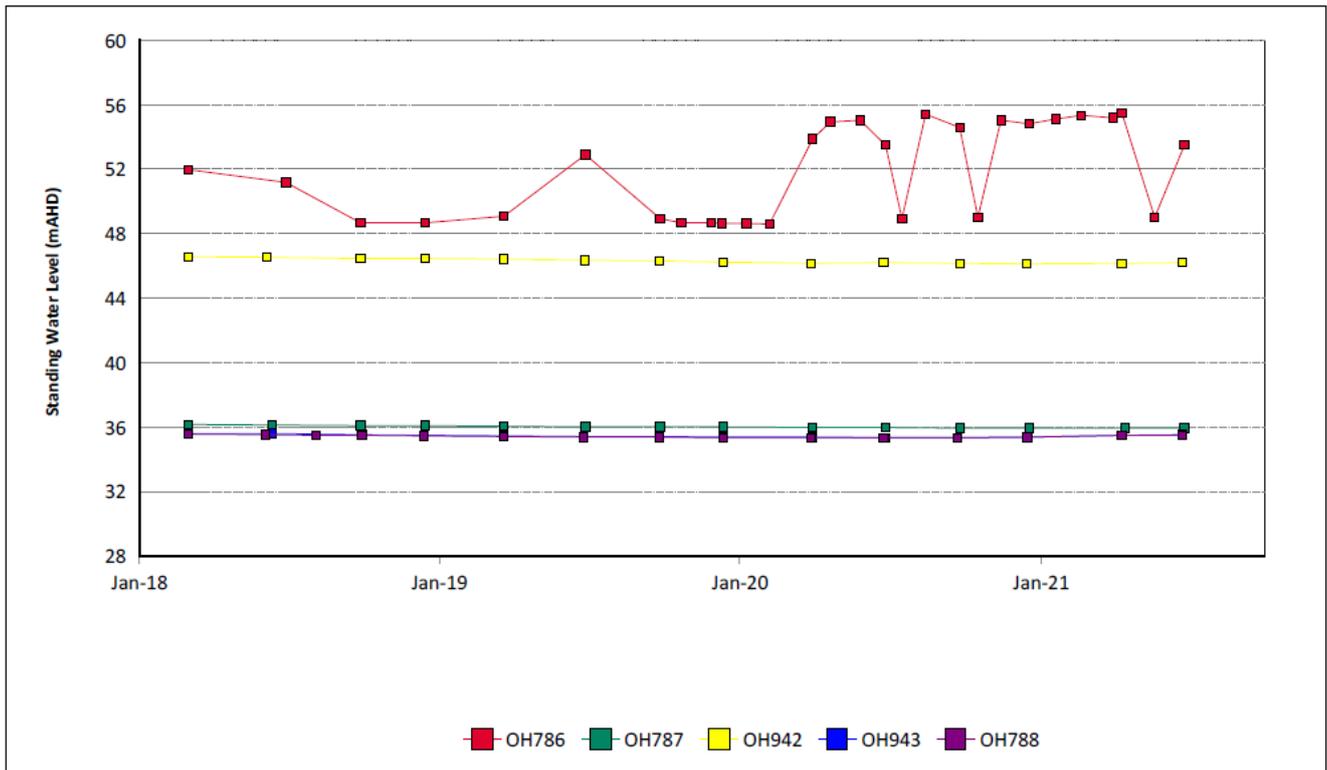
Figure 61: Hunter River Alluvium Standing Water Level Trend – June 2021

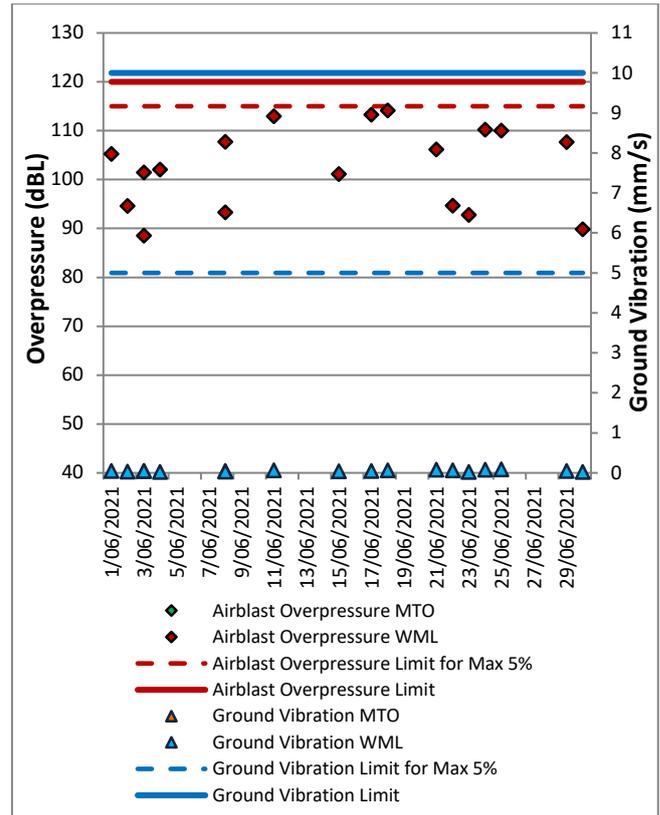
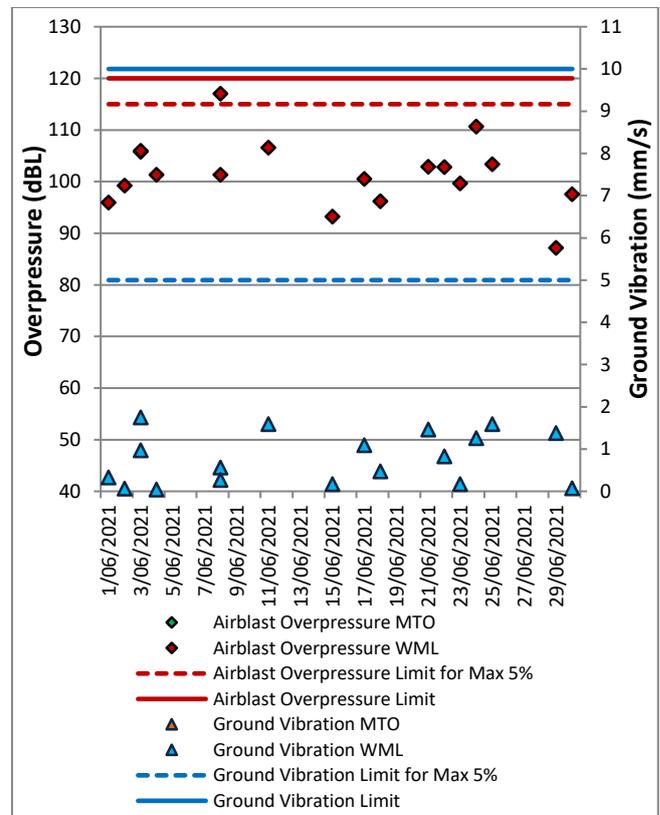
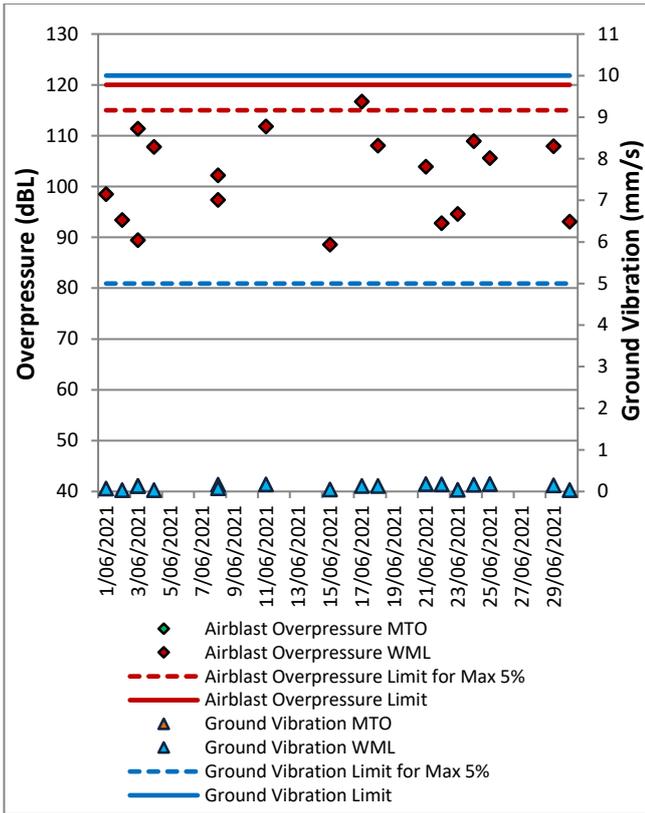
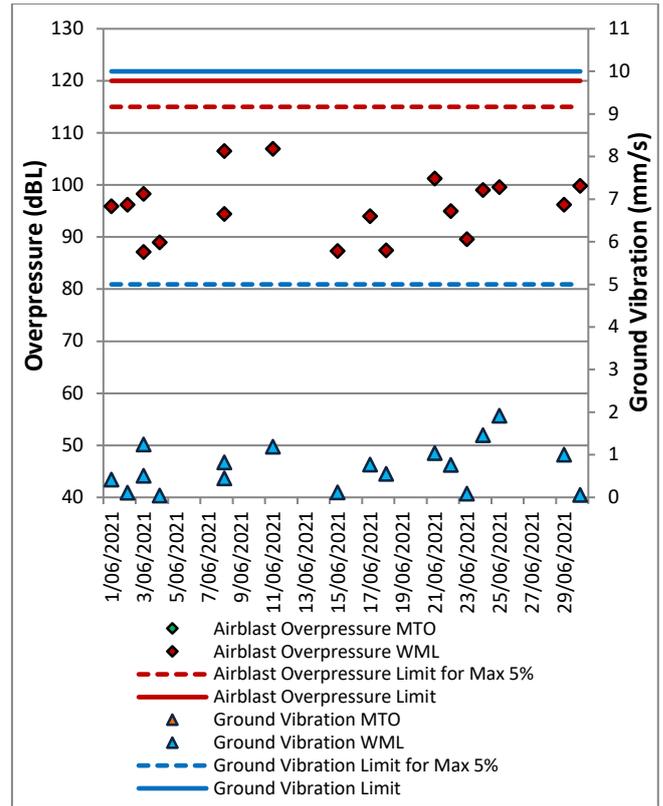
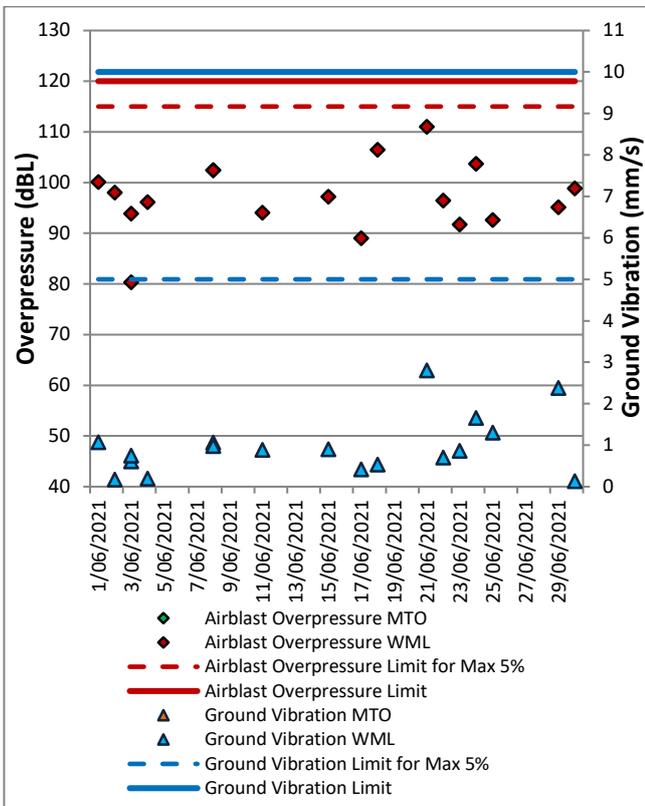
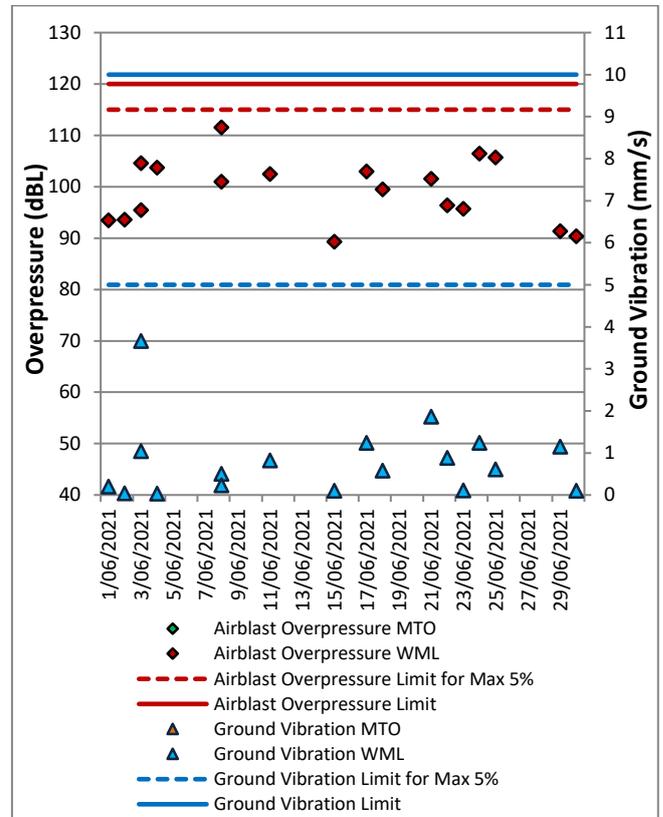
Figure 63 to Figure 68 show the blast monitoring results for the reporting period against the impact assessment criteria. The criteria are summarised in **Table 4**.

During the reporting period two blasts exceeded the 115 dB(L) 5% threshold for airblast overpressure, one at the MTIE blast monitoring location and one at the Bulga blast monitoring location. No blasts exceeded the 5mm/s 5% threshold for ground vibration.

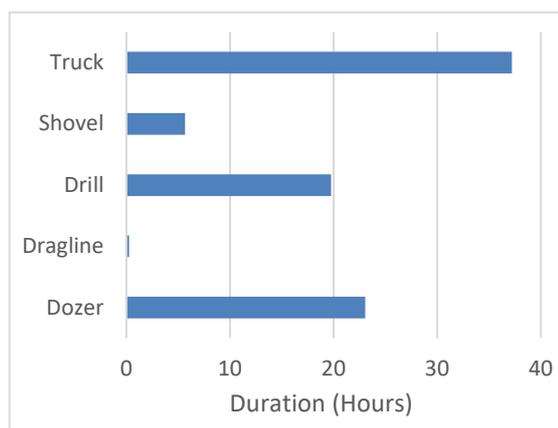
Figure 71: Operational Downtime by Equipment Type – June 2021

During June a total of 86 hours of equipment downtime was logged in response to environmental events such as dust, noise and elevated wind impacts. Operational downtime by equipment type is shown in **Figure 71**.

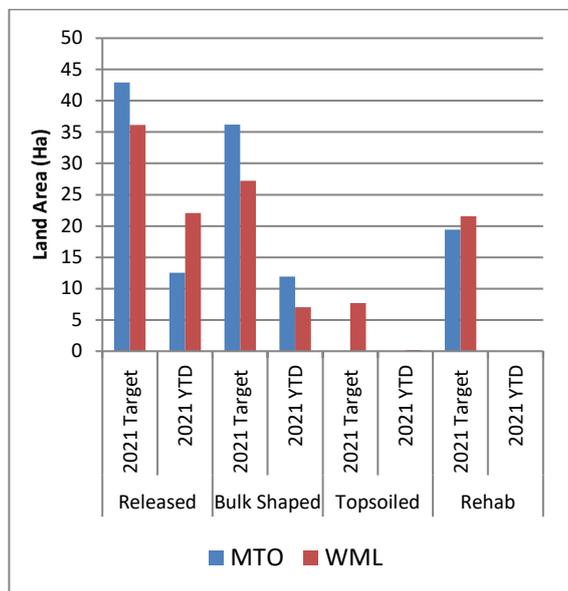
Figure 72: Rehabilitation YTD – June 2021

During June, 2.4 Ha of land was released for rehabilitation and 5.2 Ha was bulk shaped. Year-to-date progress can be viewed in **Figure 72**.
