Monthly Environmental Monitoring Report

Yancoal Mount Thorley Warkworth

September 2023

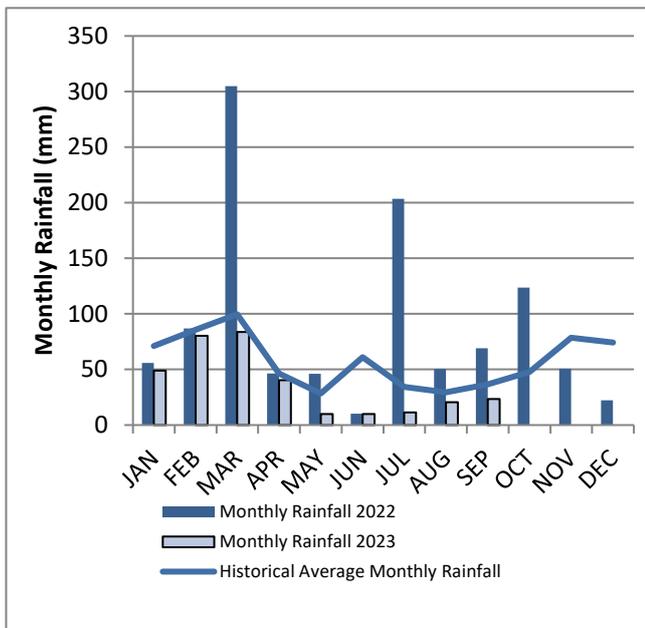
Figure 1: Rainfall Trend YTD

Rainfall for the reporting period is summarised in **Table 1**. The year-to-date monthly rainfall totals, 2023 monthly rainfall totals and historical average monthly rainfall trend are shown in **Figure 1**.

2023	Monthly Rainfall (mm)	Cumulative Rainfall (mm)
September	23.4	328.4

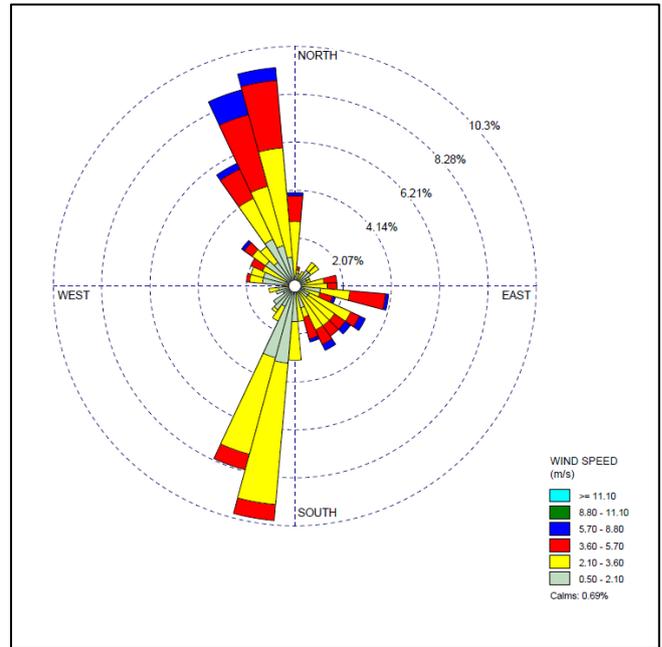
Figure 2: Charlton Ridge Wind Rose – September 2023

Winds from the Northwest and Southwest were dominant during the reporting period as shown in **Figure 2**.

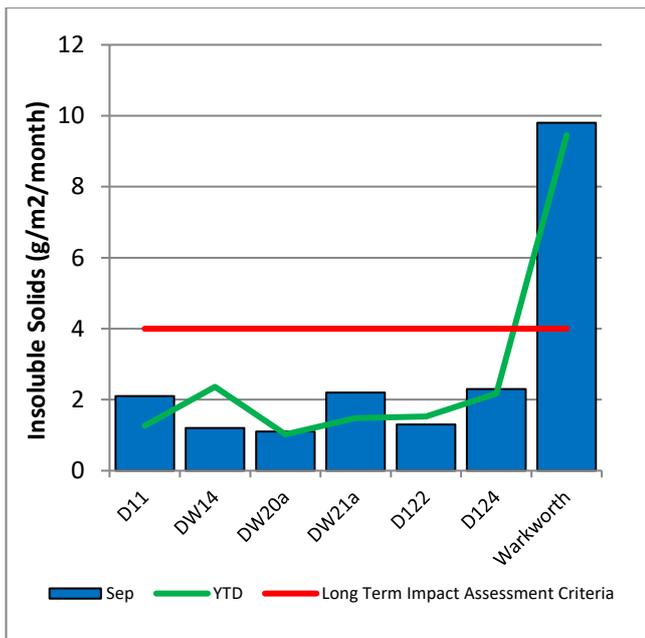
Figure 4: Depositional Dust – September 2023

During the reporting period the Warkworth monitor recorded a monthly result above the long-term impact assessment criteria of 4.0 g/m² per month. There is no evidence to suggest that the result is contaminated. Accordingly, the result will be included in the annual average calculation.

Figure 4 displays insoluble solids results from depositional dust gauges during the reporting period compared against the year-to-date average and the annual impact assessment criteria.

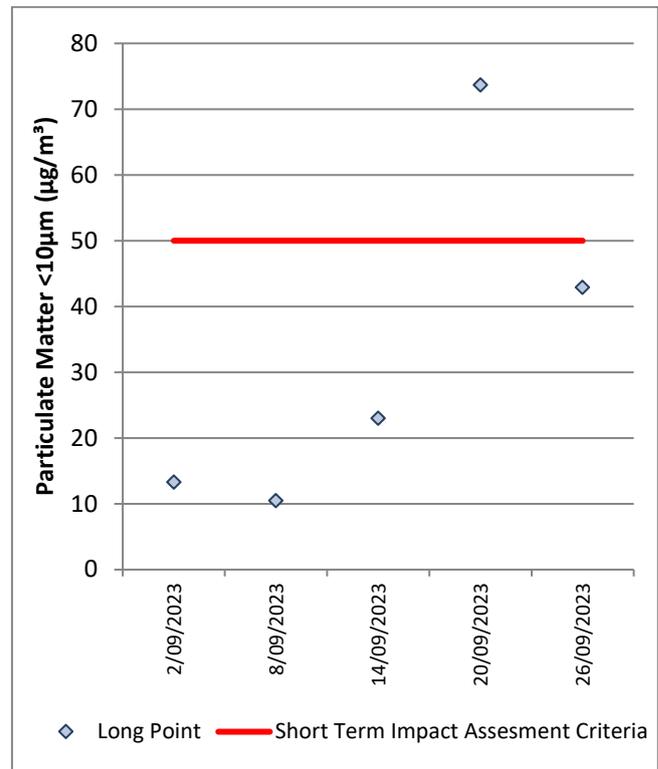
Figure 5: Individual PM₁₀ Results – September 2023

Figure 5 shows the individual PM₁₀ results at each monitoring station against the short-term impact assessment criteria of 50µg/m³.

On 20 September 2023 the Long Point HVAS PM₁₀ unit recorded a result of 73.7 µg/m³, which is greater than the short term (24hr) PM₁₀ impact assessment criteria.

Investigation determined that the wind direction was generally not from MTW’s angle of influence and that the likely MTW contribution to the results is less than 75%. Accordingly, no further action is required (as per approved Air Quality Monitoring Programme).

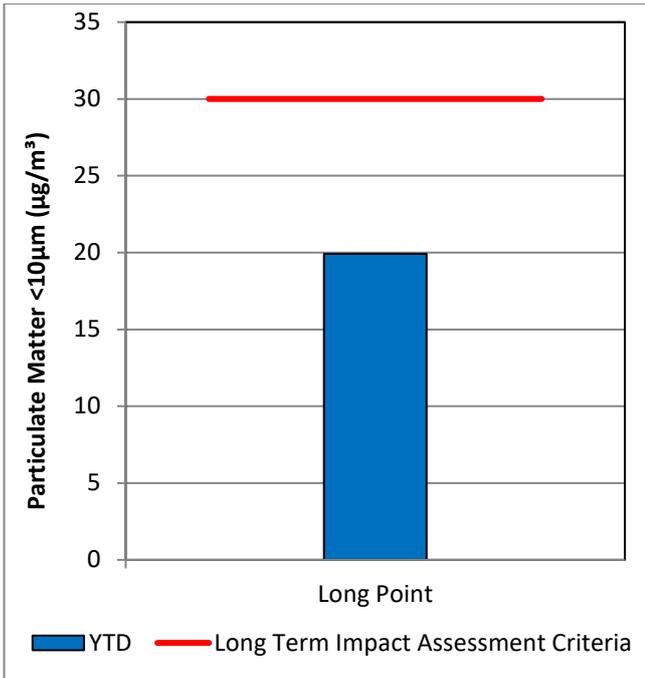
Figure 6: Annual Average PM₁₀ – September 2023

Figure 6 shows the annual average PM₁₀ result against the long term impact assessment criteria.

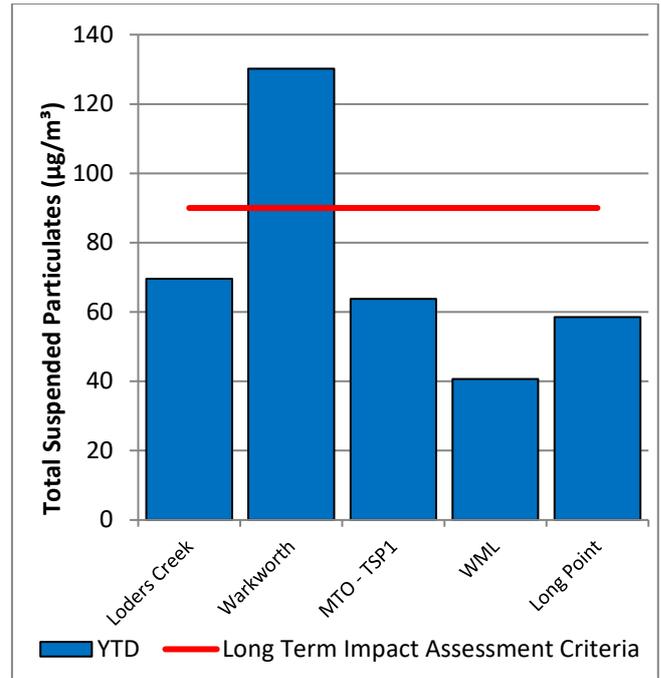
Figure 7: Annual Average Total Suspended Particulates – September 2023

Figure 7 shows the annual average TSP results compared against the long-term impact assessment criteria of 90µg/m³.

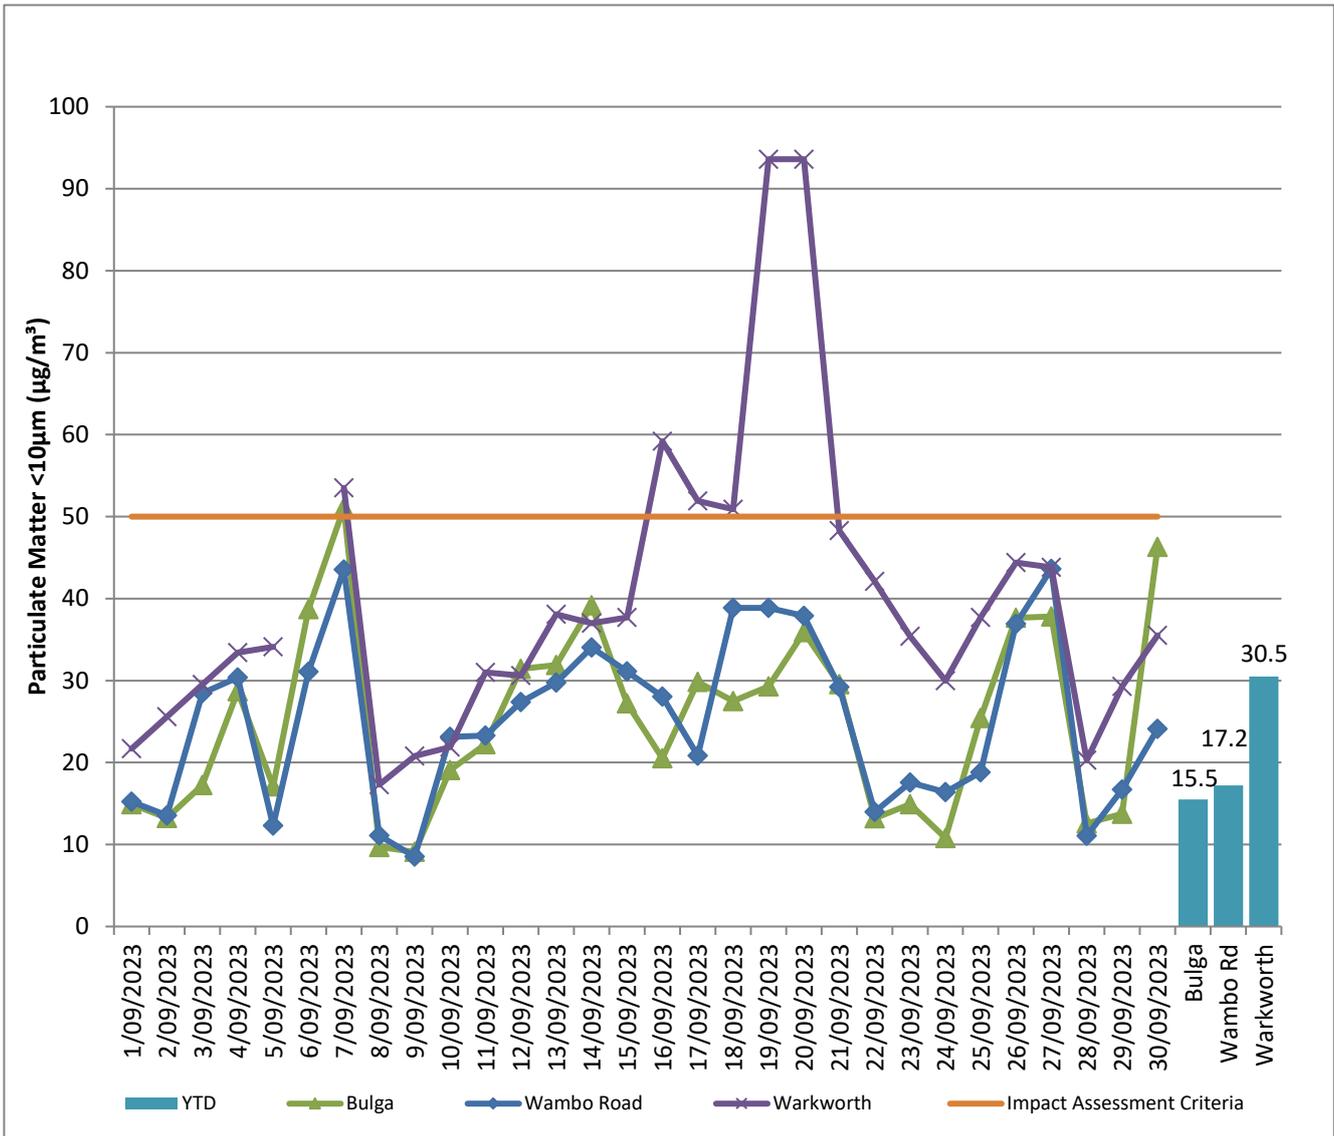
Figure 8: Real Time PM₁₀ daily 24hr average (line graphs) and YTD annual average (column graphs) – September 2023

Results for real time dust sampling are shown in Figure 8, including the daily 24-hour average PM₁₀ result and the annual PM₁₀ average.

On 7 September 2023, the Warkworth OEH TEOM (53.5µg/m³) exceeded the short term (24hr) criteria. The measurement was assessed for MTW’s potential contribution based on meteorological conditions and background PM₁₀ levels on this day resulting in a maximum estimated contribution of 6.2 µg/m³, less than a 12% contribution to the result. Accordingly, no further action is required (as per approved Air Quality Monitoring Programme).

On 7 September 2023, the Bulga OEH TEOM (51.1 µg/m³) exceeded the short term (24hr) criteria. The measurement was assessed for MTW’s potential contribution based on meteorological conditions on this day resulting in a maximum estimated contribution of 26.8 ug/m³, less than a 53% contribution to the result. Accordingly, no further action is required (as per approved Air Quality Monitoring Programme).

On 16 September 2023, the Warkworth OEH TEOM (59.2 $\mu\text{g}/\text{m}^3$) exceeded the short term (24hr) criteria. The measurement was assessed for MTW's potential contribution based on meteorological conditions on this day resulting in a maximum estimated contribution of 1.1 ug/m^3 , less than a 2% contribution to the result. Accordingly, no further action is required (as per approved Air Quality Monitoring Programme).

On 17 September 2023, the Warkworth OEH TEOM (51.9 $\mu\text{g}/\text{m}^3$) exceeded the short term (24hr) criteria. The measurement was assessed for MTW's potential contribution based on meteorological conditions on this day resulting in a maximum estimated contribution of 15.1 ug/m^3 , less than a 30% contribution to the result. Accordingly, no further action is required (as per approved Air Quality Monitoring Programme).

On 18 September 2023, the Warkworth OEH TEOM (50.9 $\mu\text{g}/\text{m}^3$) exceeded the short term (24hr) criteria. The measurement was assessed for MTW's potential contribution based on meteorological conditions on this day resulting in a maximum estimated contribution of 13.1 ug/m^3 , less than a 26% contribution to the result. Accordingly, no further action is required (as per approved Air Quality Monitoring Programme).

On 19 September 2023, the Warkworth OEH TEOM (93.6 $\mu\text{g}/\text{m}^3$) exceeded the short term (24hr) criteria. The measurement was assessed for MTW's potential contribution based on meteorological conditions on this day resulting in a maximum estimated contribution of 1.3 ug/m^3 , less than a 2% contribution to the result. Accordingly, no further action is required (as per approved Air Quality Monitoring Programme).

On 20 September 2023, the Warkworth OEH TEOM (93.6 $\mu\text{g}/\text{m}^3$) exceeded the short term (24hr) criteria. The measurement was assessed for MTW's potential contribution based on meteorological conditions on this day resulting in a maximum estimated contribution of 11.8 ug/m^3 , less than a 13% contribution to the result. Accordingly, no further action is required (as per approved Air Quality Monitoring Programme).

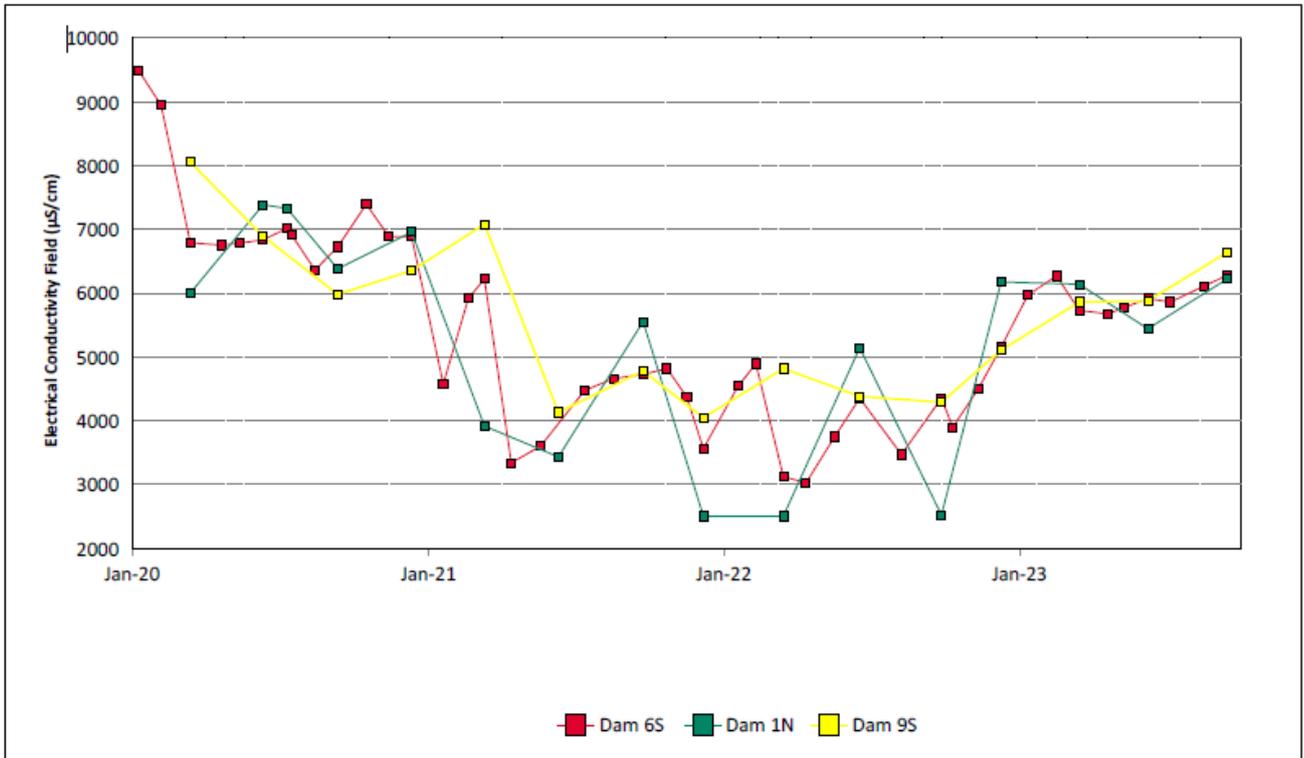
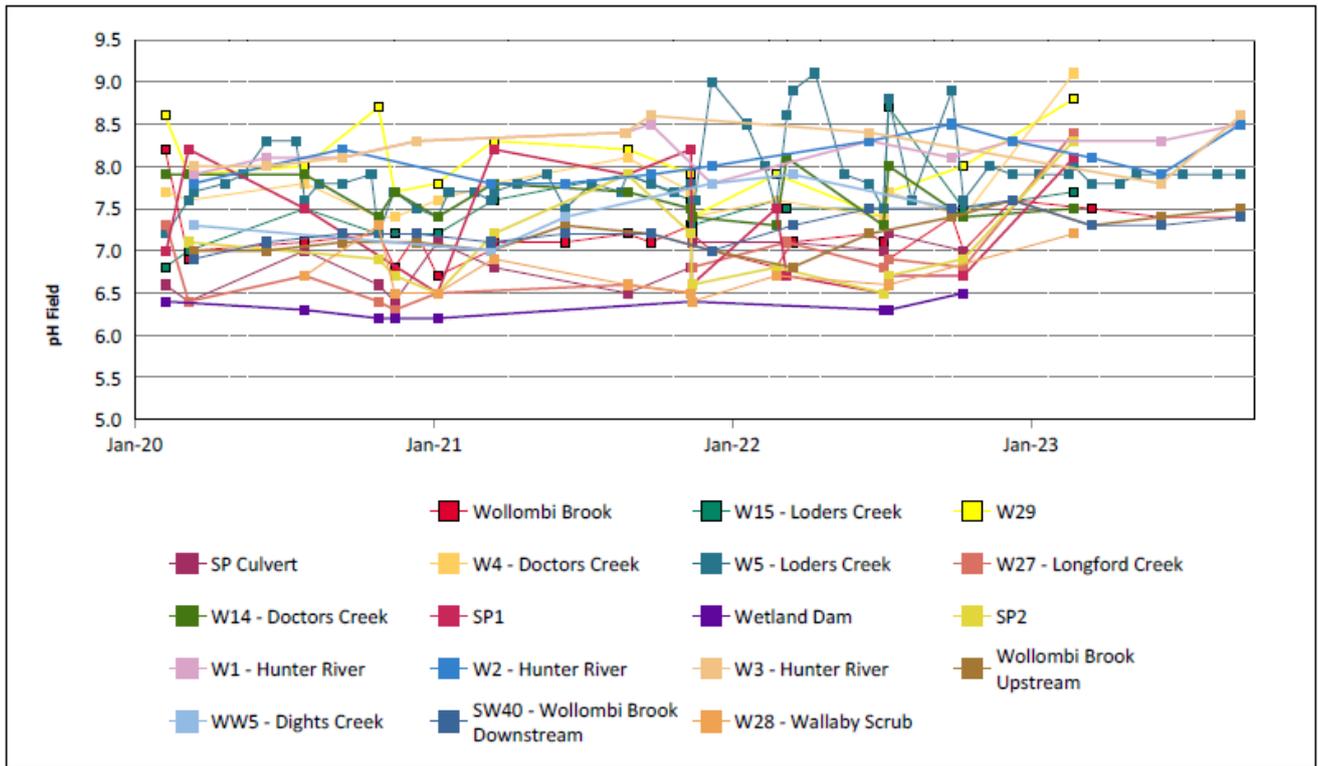
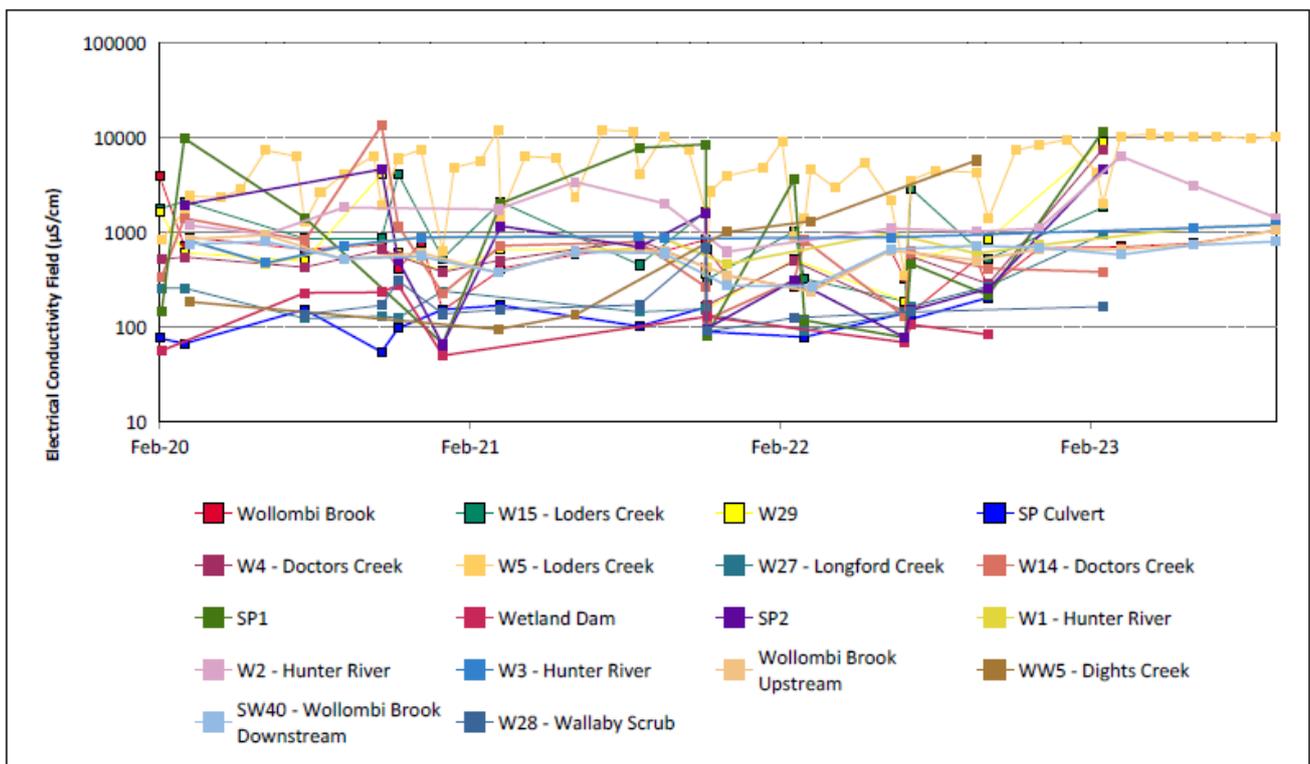
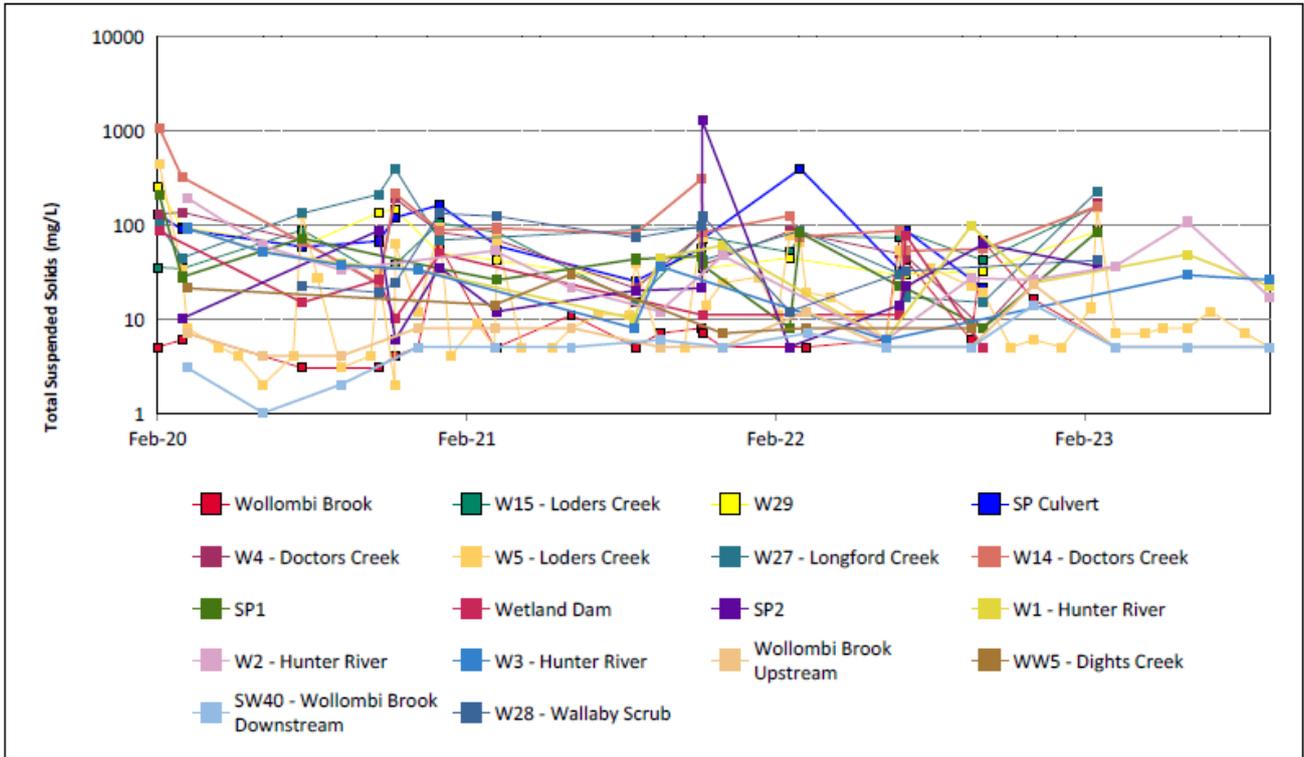
Figure 9 to Figure 11 show the long-term surface waste trend (2020 – current) within MTW mine dams. Figure 12 to Figure 14 show the long-term surface water trend (2020 – current) in surrounding watercourses.

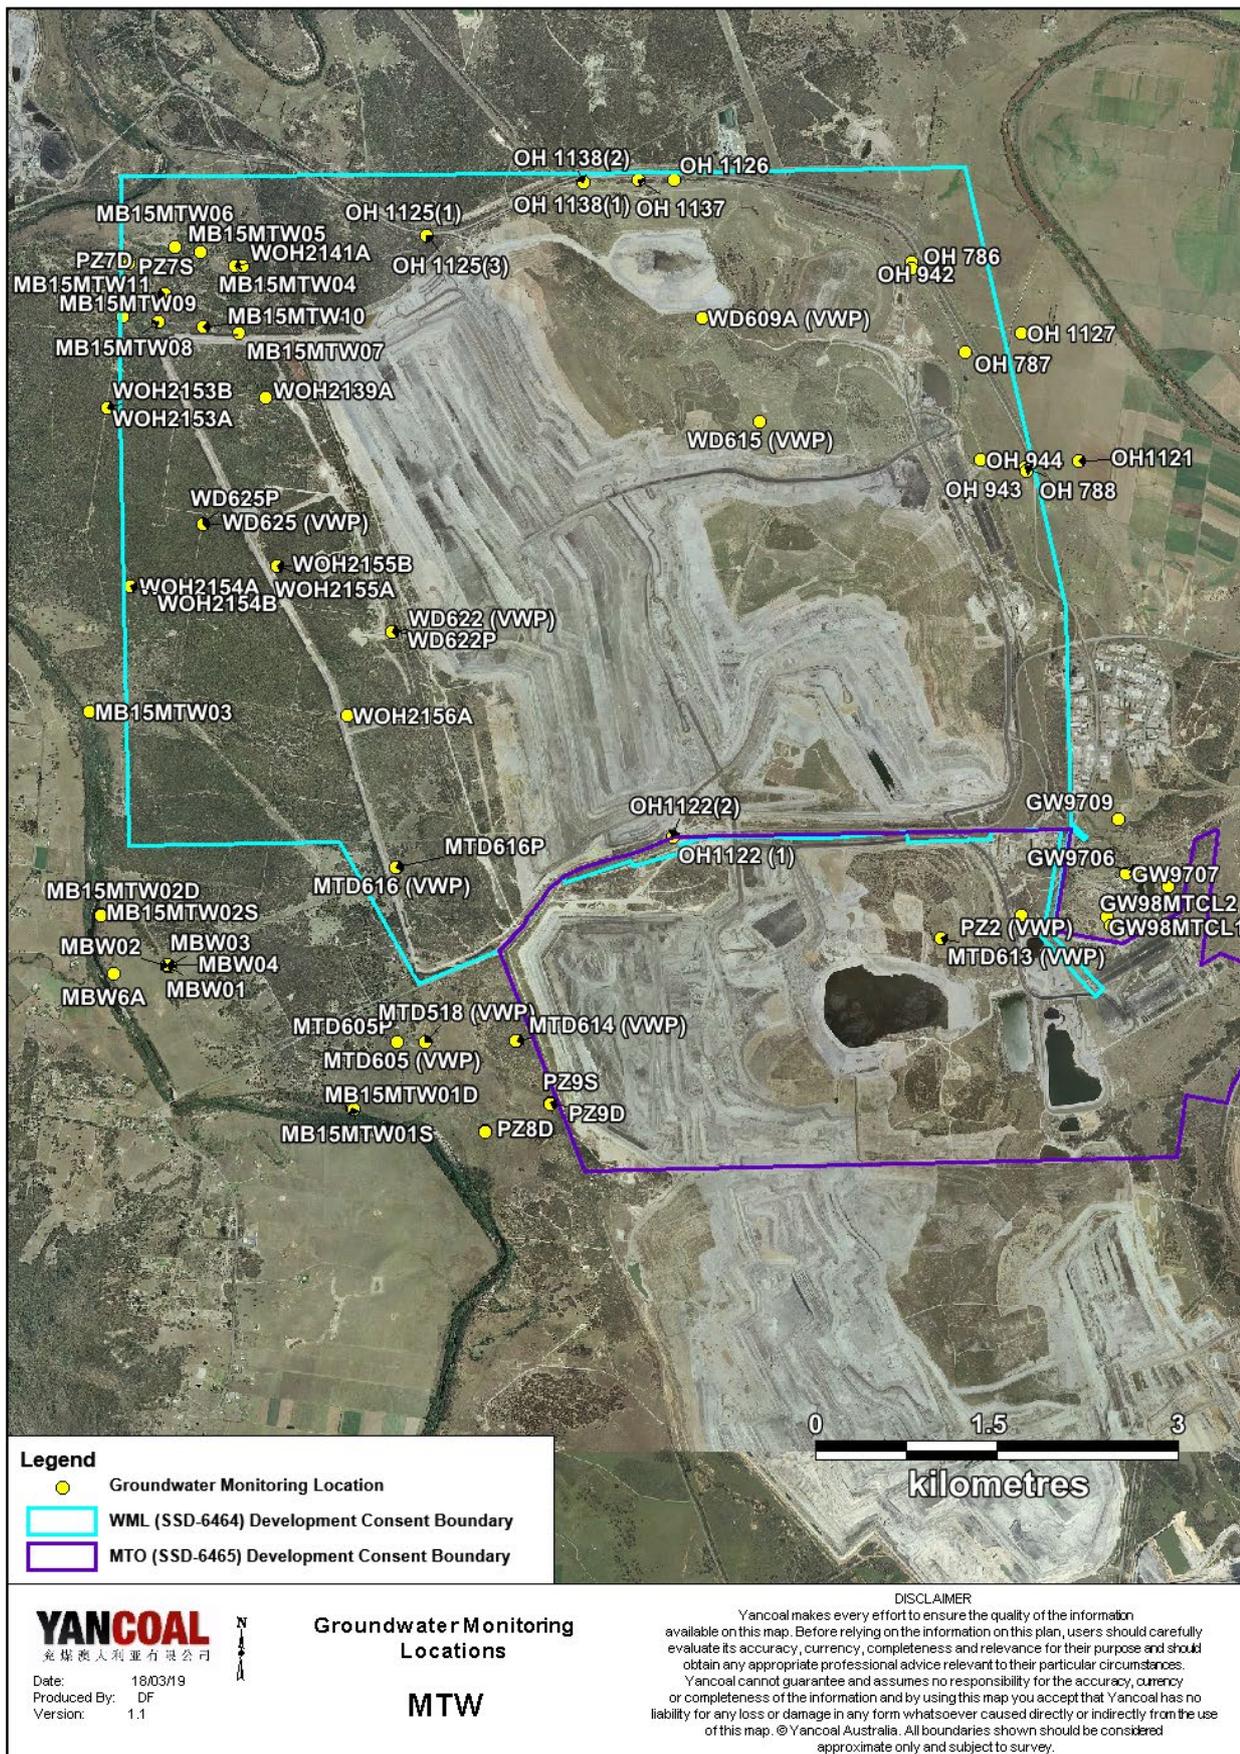
Figure 65: Groundwater Monitoring Location Plan

Internal trigger limits have been developed to assess monitoring data on an on-going basis, and to highlight potentially adverse groundwater impacts. The process for evaluating monitoring results against the internal triggers and subsequent responses are outlined in the MTW Water Management Plan. Locations of groundwater bores are shown in **Figure 56**.

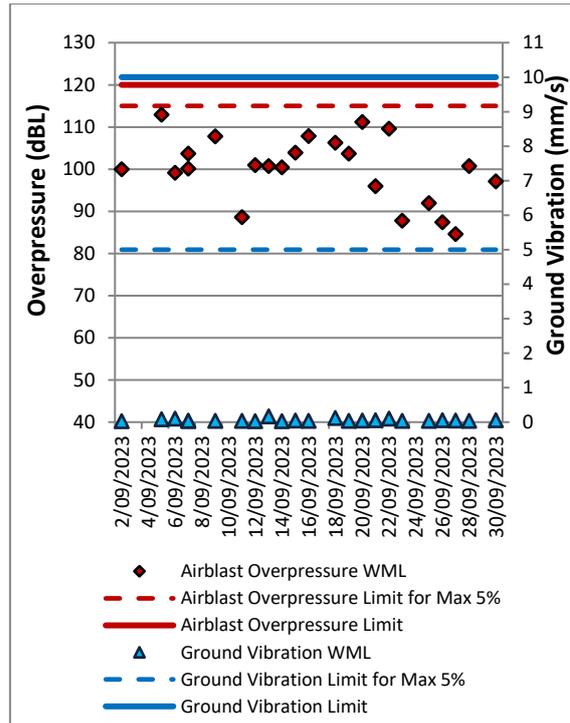
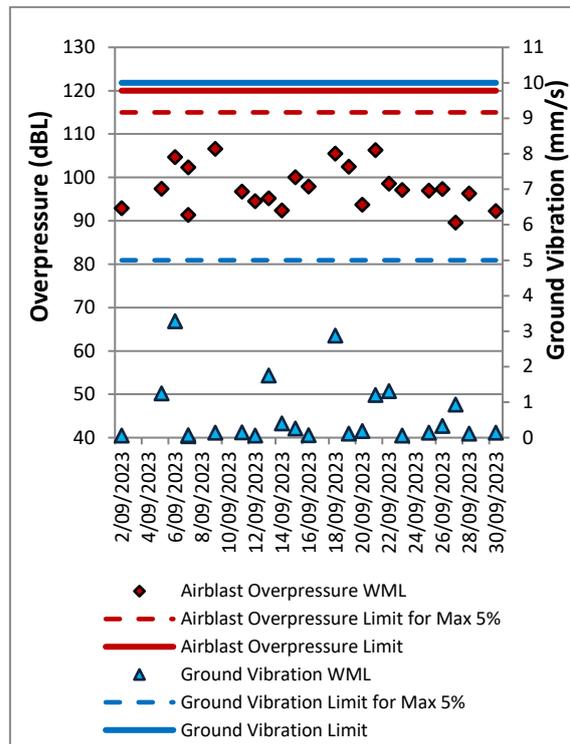
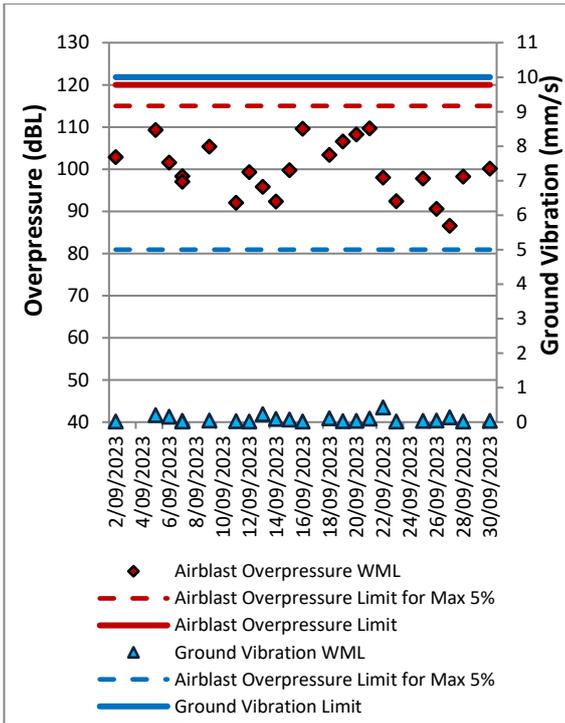
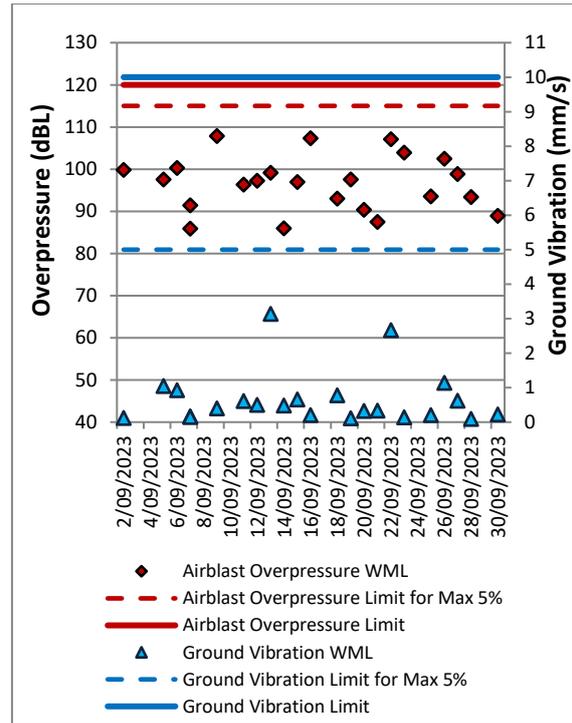
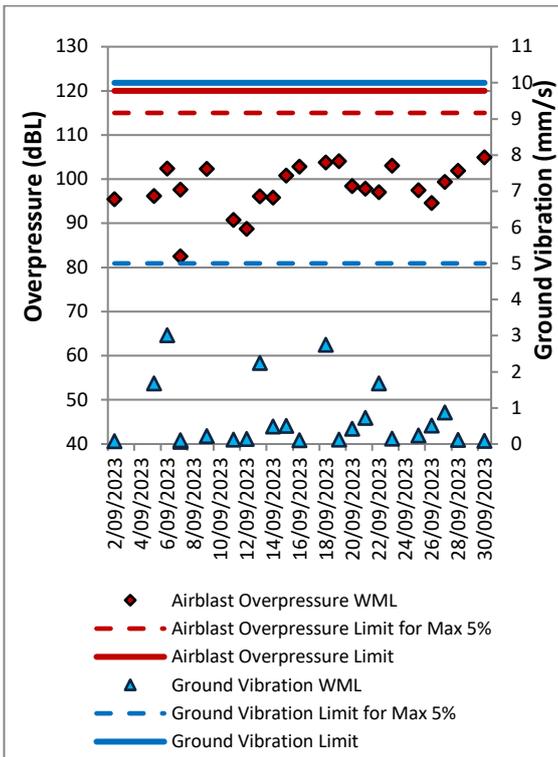
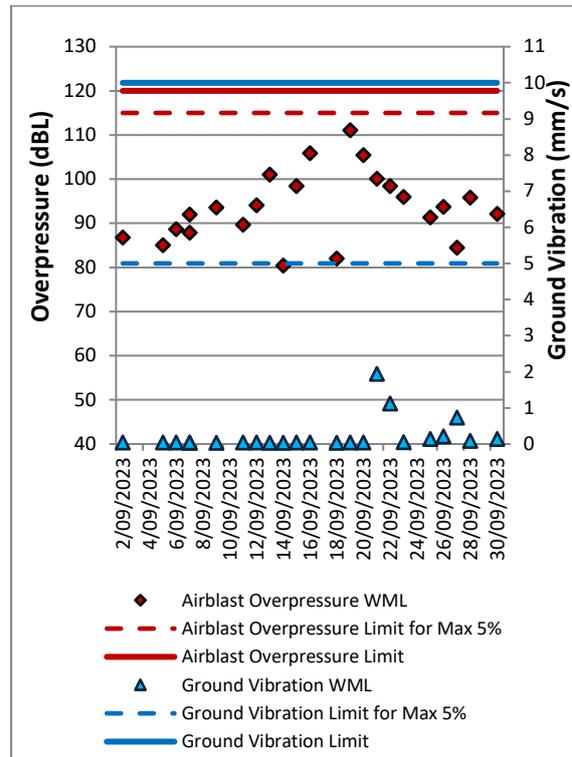
During September 2023, 23 blasts were initiated at MTW. **Figure 9** to **Figure 14** show the blast monitoring results for the reporting period against the impact assessment criteria. The criteria are summarised in **Table 4**.

During the reporting period no blasts exceeded the 5mm/s criteria for ground vibration, or the 115dB(L) threshold for airblast overpressure.

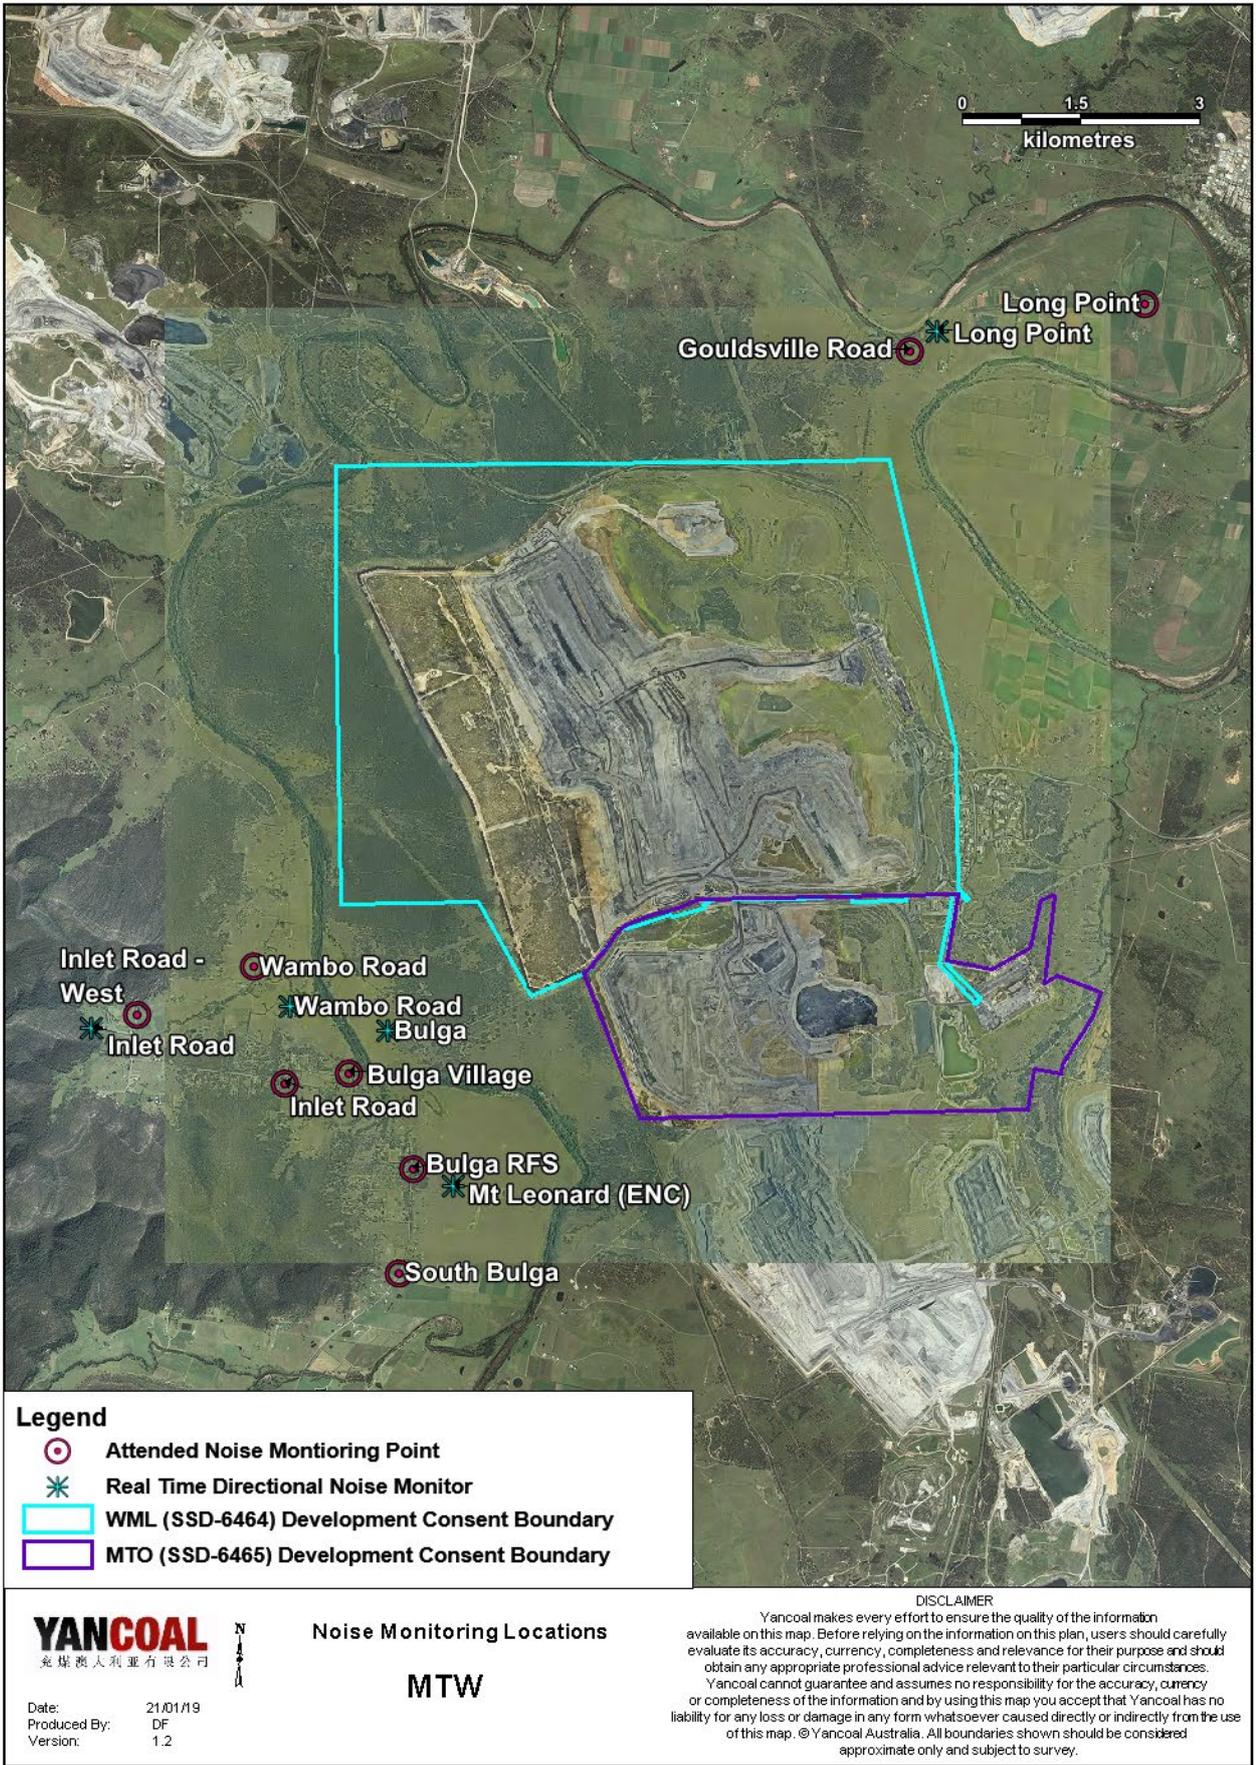
Figure 73: Noise Monitoring Location Plan

Routine attended noise monitoring is carried out in accordance with the MTW Noise Management Plan. A review against EIS predictions will be reported in the Annual Review. The purpose of the noise surveys is to quantify and describe the acoustic environment around the site and compare results with specified limits. Real time noise monitoring also occurs at five sites surrounding MTW. Noise monitoring locations are displayed in **Figure 73**.

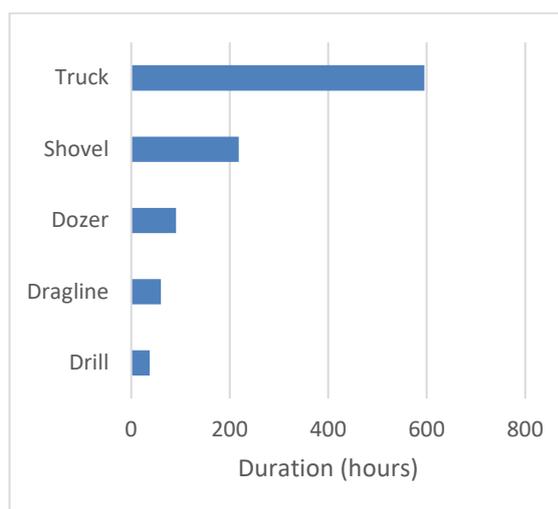
Figure 74: Operational Downtime by Equipment Type – September 2023

During September, a total of 1002 hours of equipment downtime was logged in response to environmental events such as dust, noise and adverse meteorological conditions. Operational downtime by equipment type is shown in **Figure 74**.
