**Minutes of the Mount Thorley Warkworth
Community Consultative Committee Meeting Q1 2022**

Date: Wednesday 23 February 2022

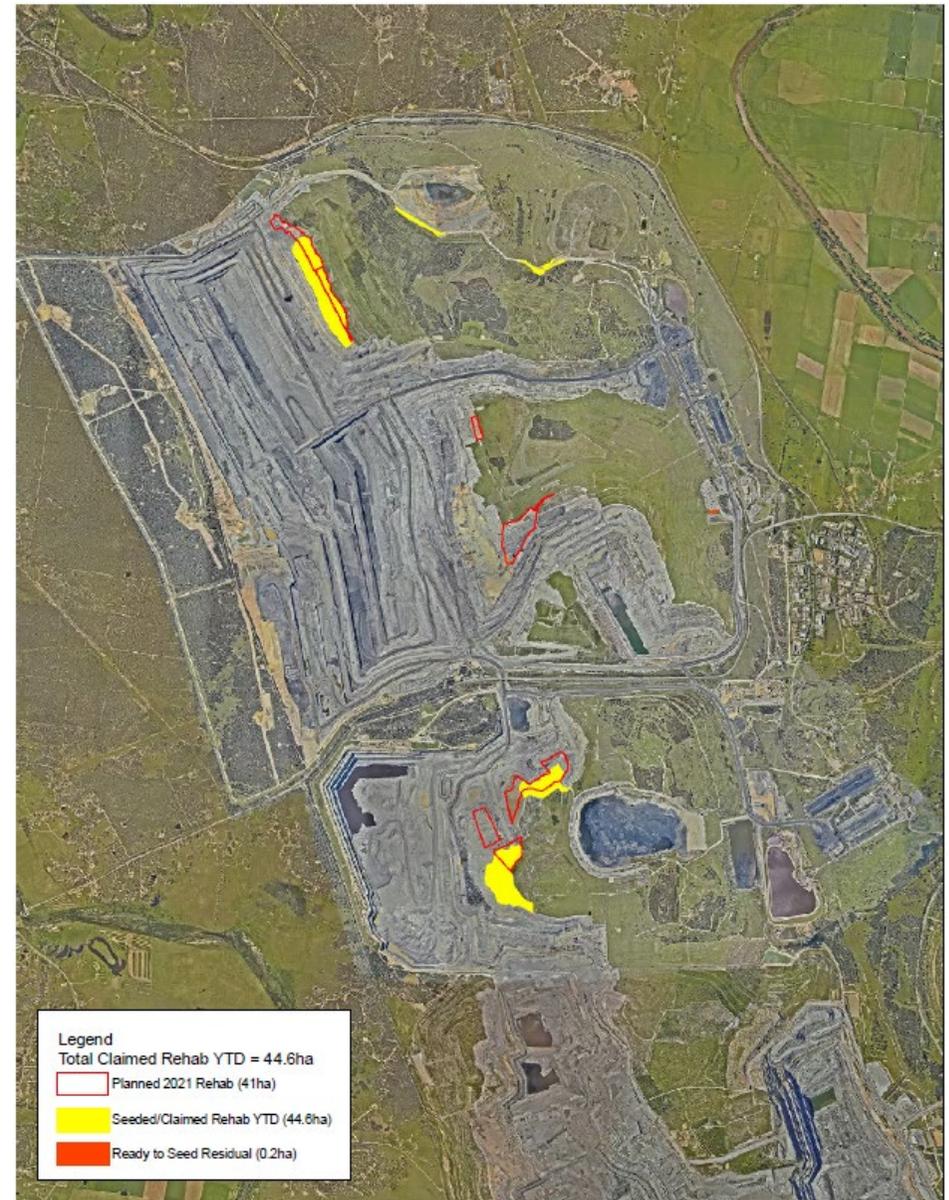
MTW Operations – Rehabilitation/ Disturbance 2021

Disturbance forecast for 2021
– 46.8Ha (New Disturbance
and Rehab Disturbance shown
in red and blue polygons
respectively).

- Progress to end of
December 2021:
 - Disturbed = 45.9ha

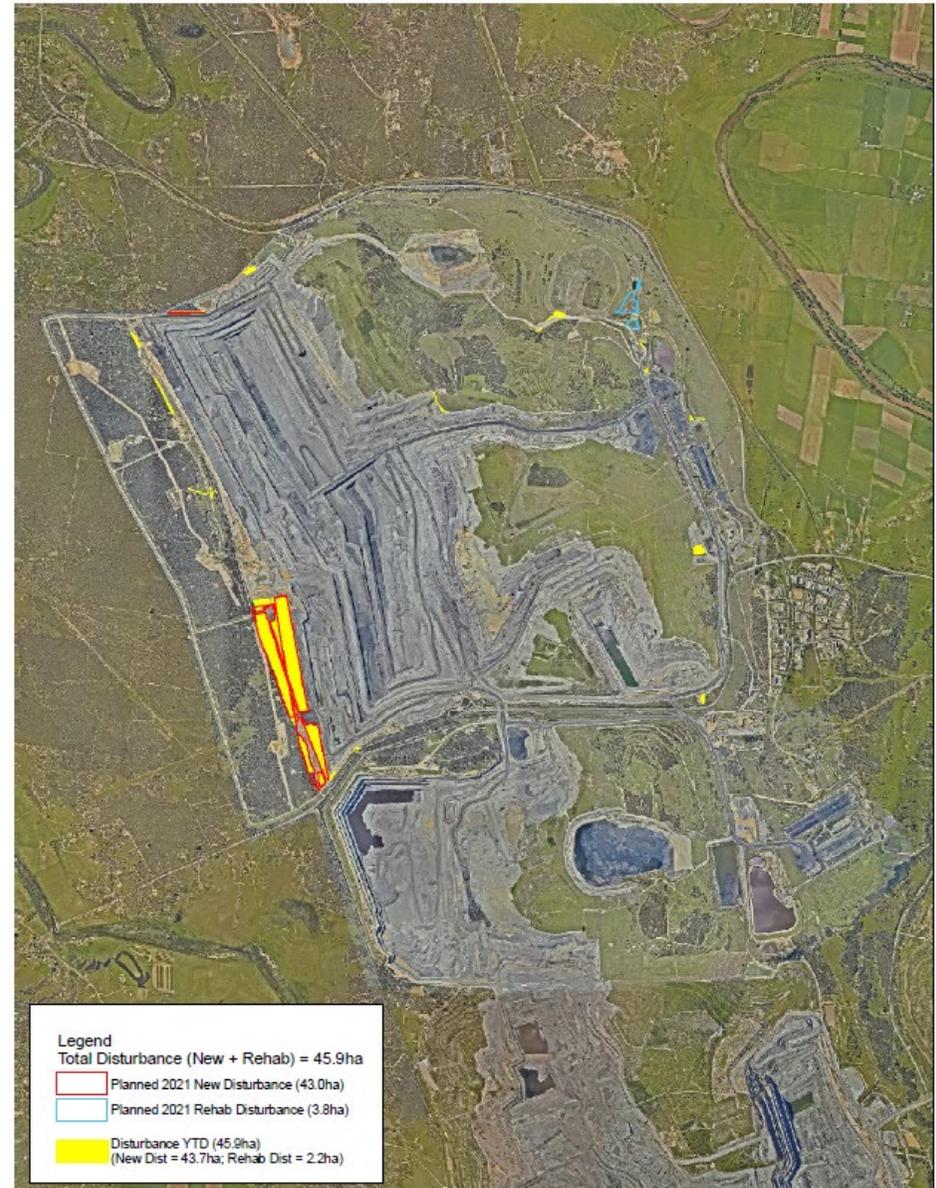
MTW Operations – Rehabilitation/ Disturbance 2022

Disturbance target for 2022 – 80.5Ha (Includes 38ha of rehab disturbance associated with NOOP construction and Tailings Dam 1 dump area)
Rehabilitation target for 2022 – 35ha

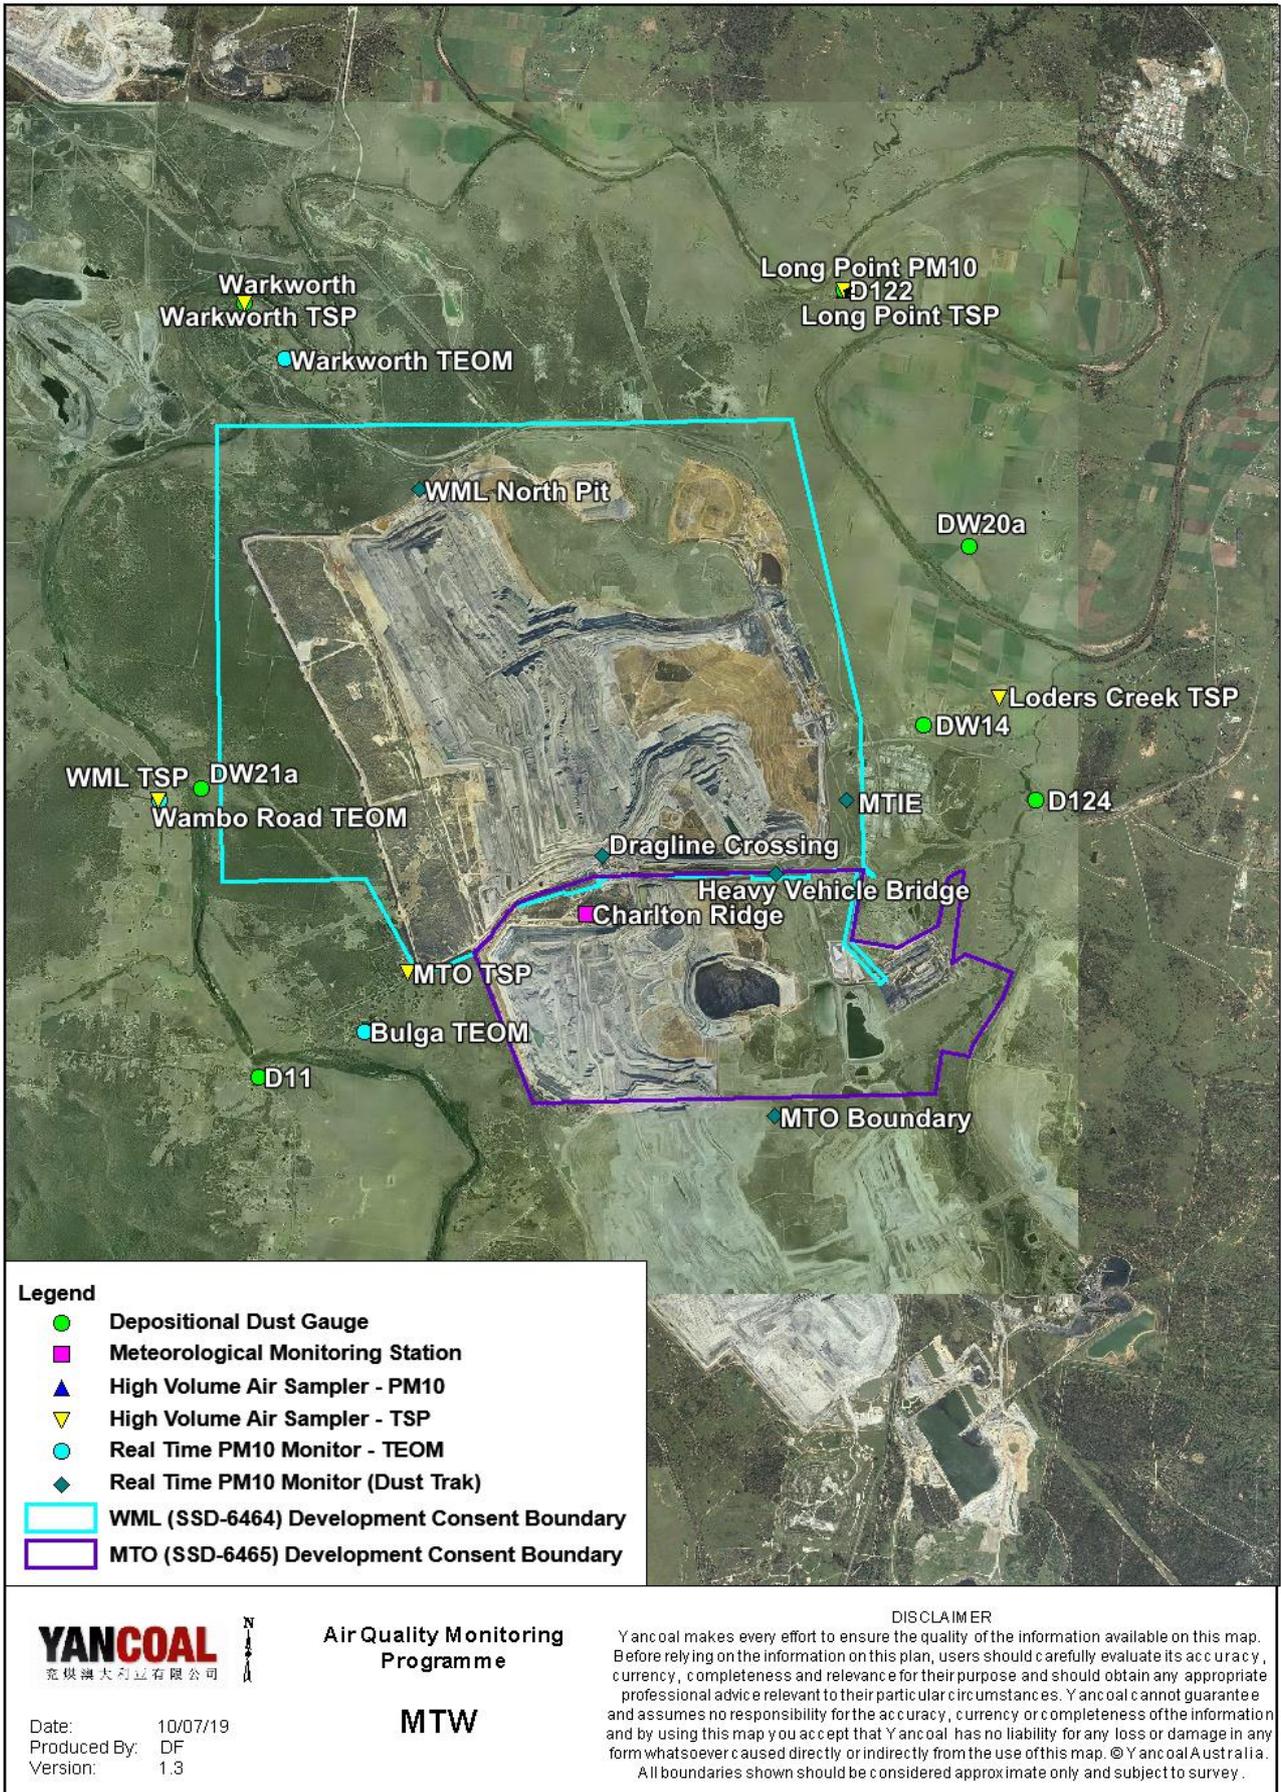
Figure 3: Air Quality Monitoring Locations

Suspended particulates are measured by a network of High Volume Air Samplers (HVAS) measuring Total Suspended Particulates (TSP) and Particulate Matter <10µm (PM₁₀). The location of these monitors can be found in **Figure 3**. Each HVAS was run for 24 hours on a six-day cycle in accordance with EPA requirements.

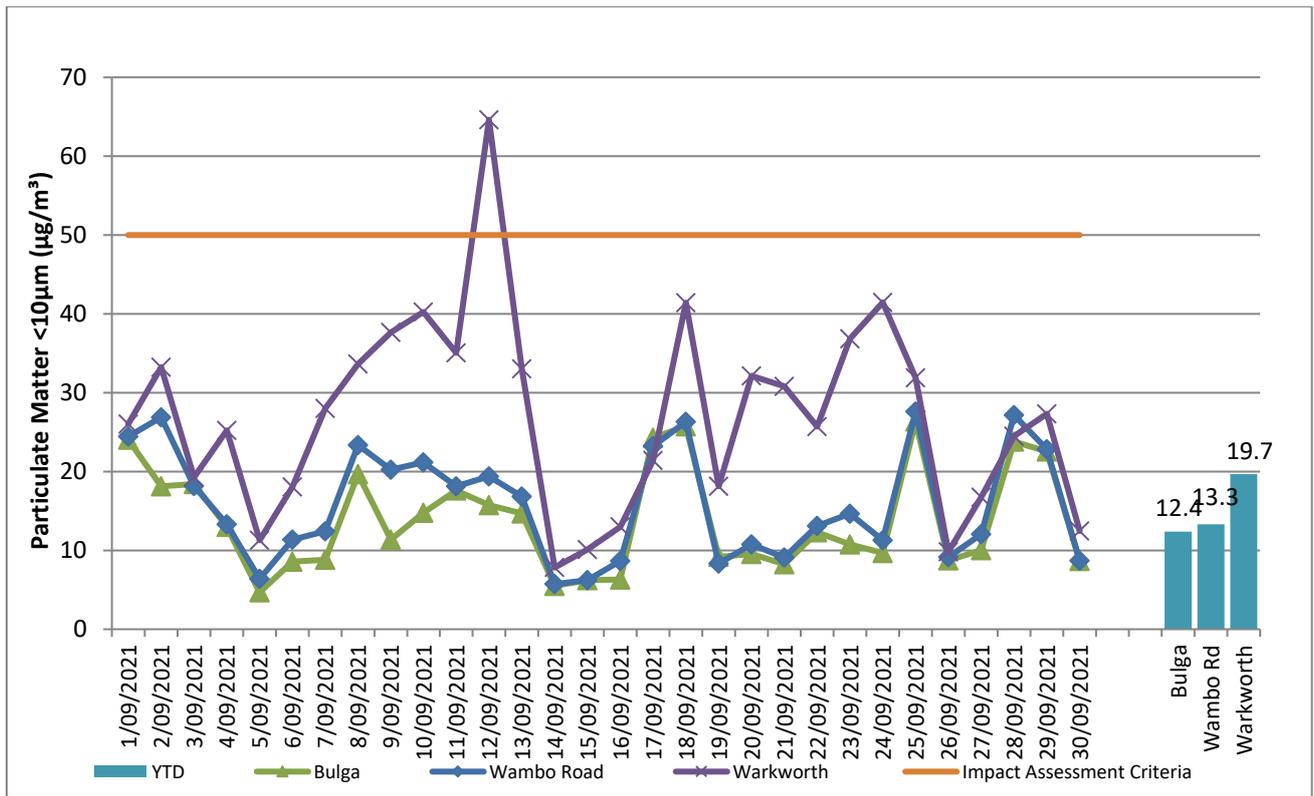
Figure 8: Real Time PM₁₀ 24hr average and Year-to-date average – September 2021

During September, the real-time monitoring system generated 115 automated air quality related alerts, including 16 alerts for adverse meteorological conditions and 99 alerts for elevated PM₁₀ levels.

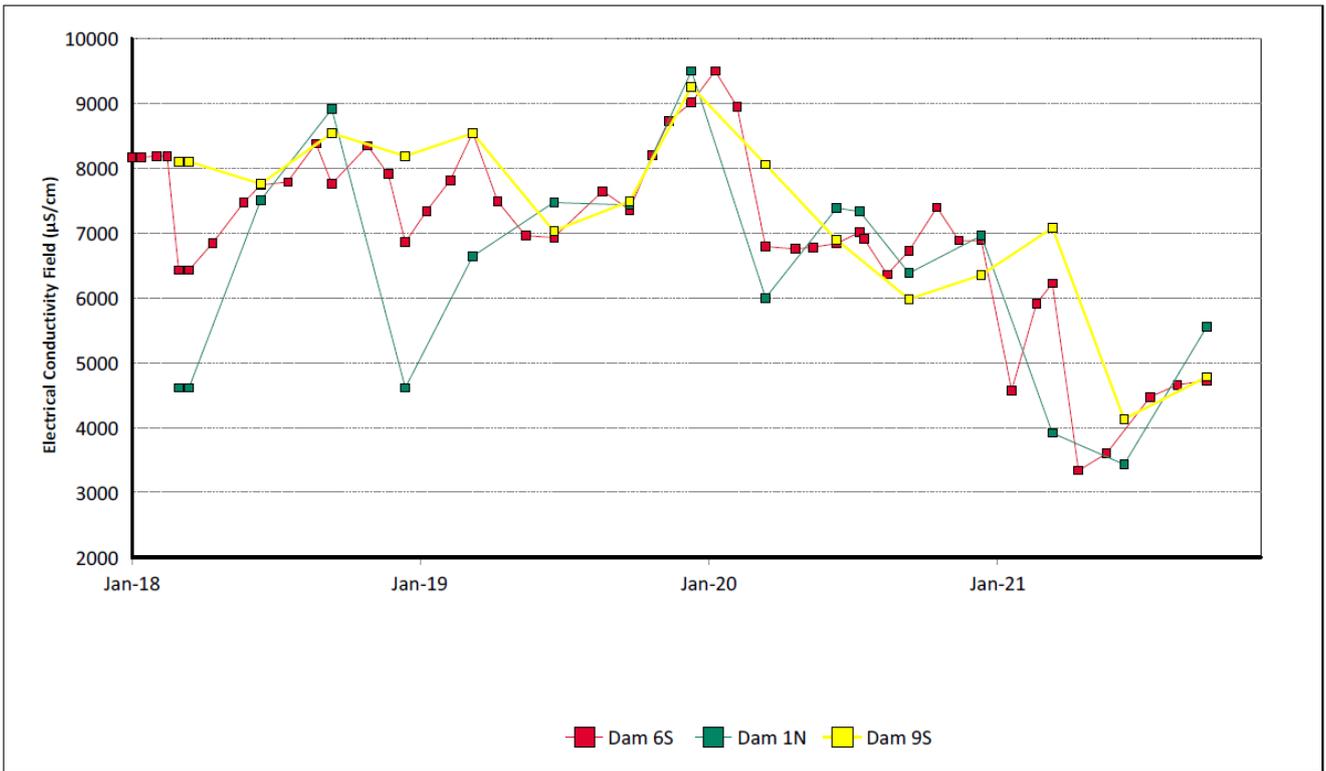
Figure 9: Site Dams Electrical Conductivity Trend – September 2021

Figure 9 to **Figure 11** show the long-term surface water trend (2018 – current) within MTW mine dams. **Figure 12** to **Figure 14** show the long-term surface water trend (2018 - current) in surrounding watercourses.

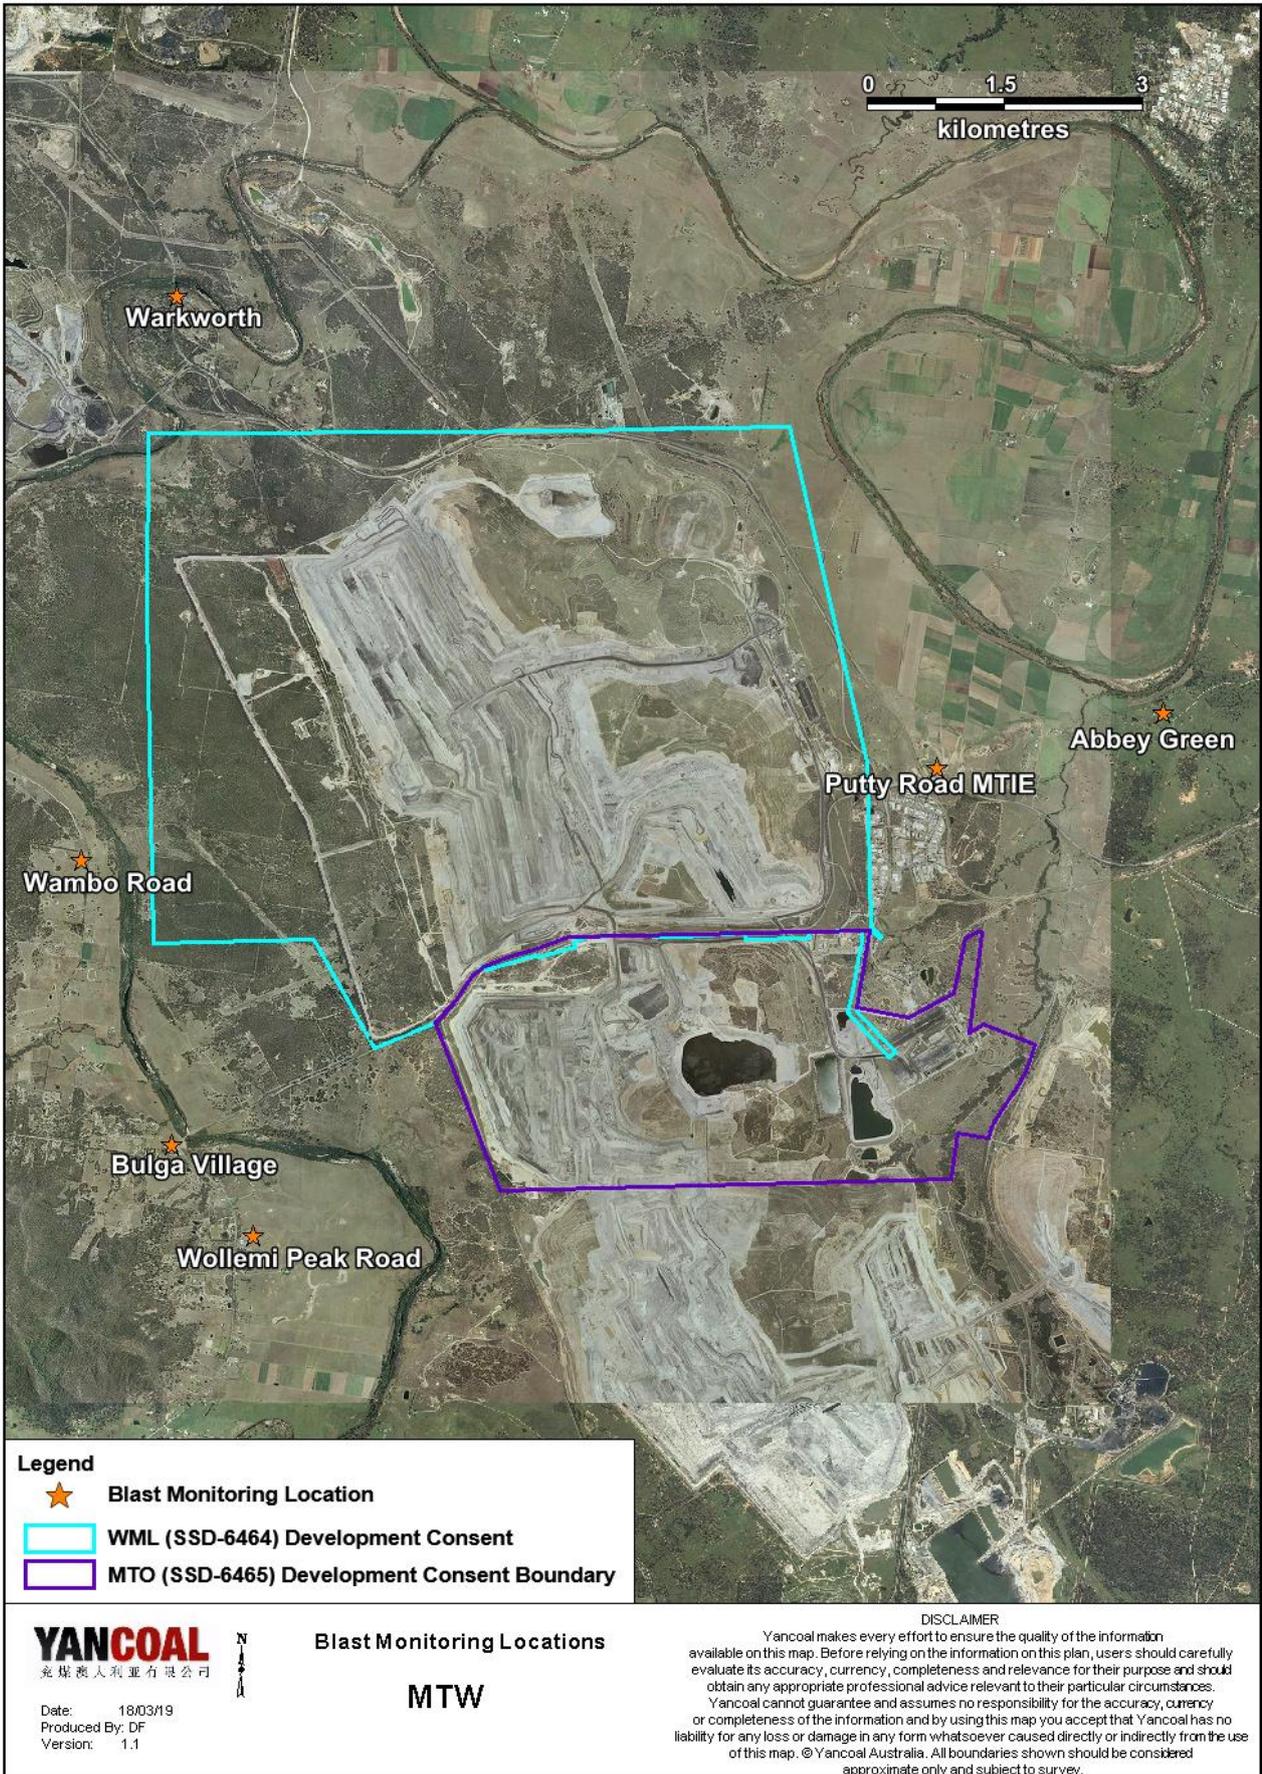
Figure 69: Blast and Vibration Monitoring Location Plan

The location of these monitors can be found in **Figure 69**.

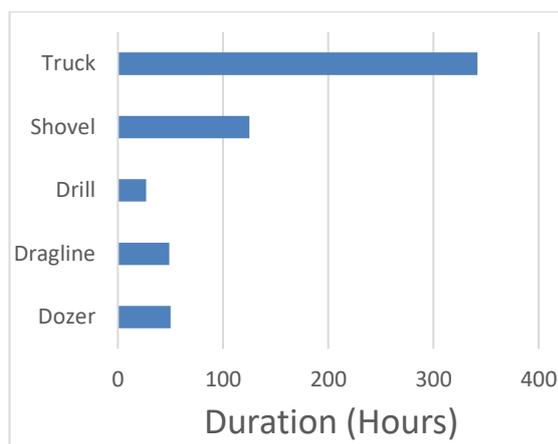
Figure 71: Operational Downtime by Equipment Type – September 2021

During September a total of 596 hours of equipment downtime was logged in response to environmental events such as dust, noise and adverse meteorological conditions. Operational downtime by equipment type is shown in **Figure 71**.

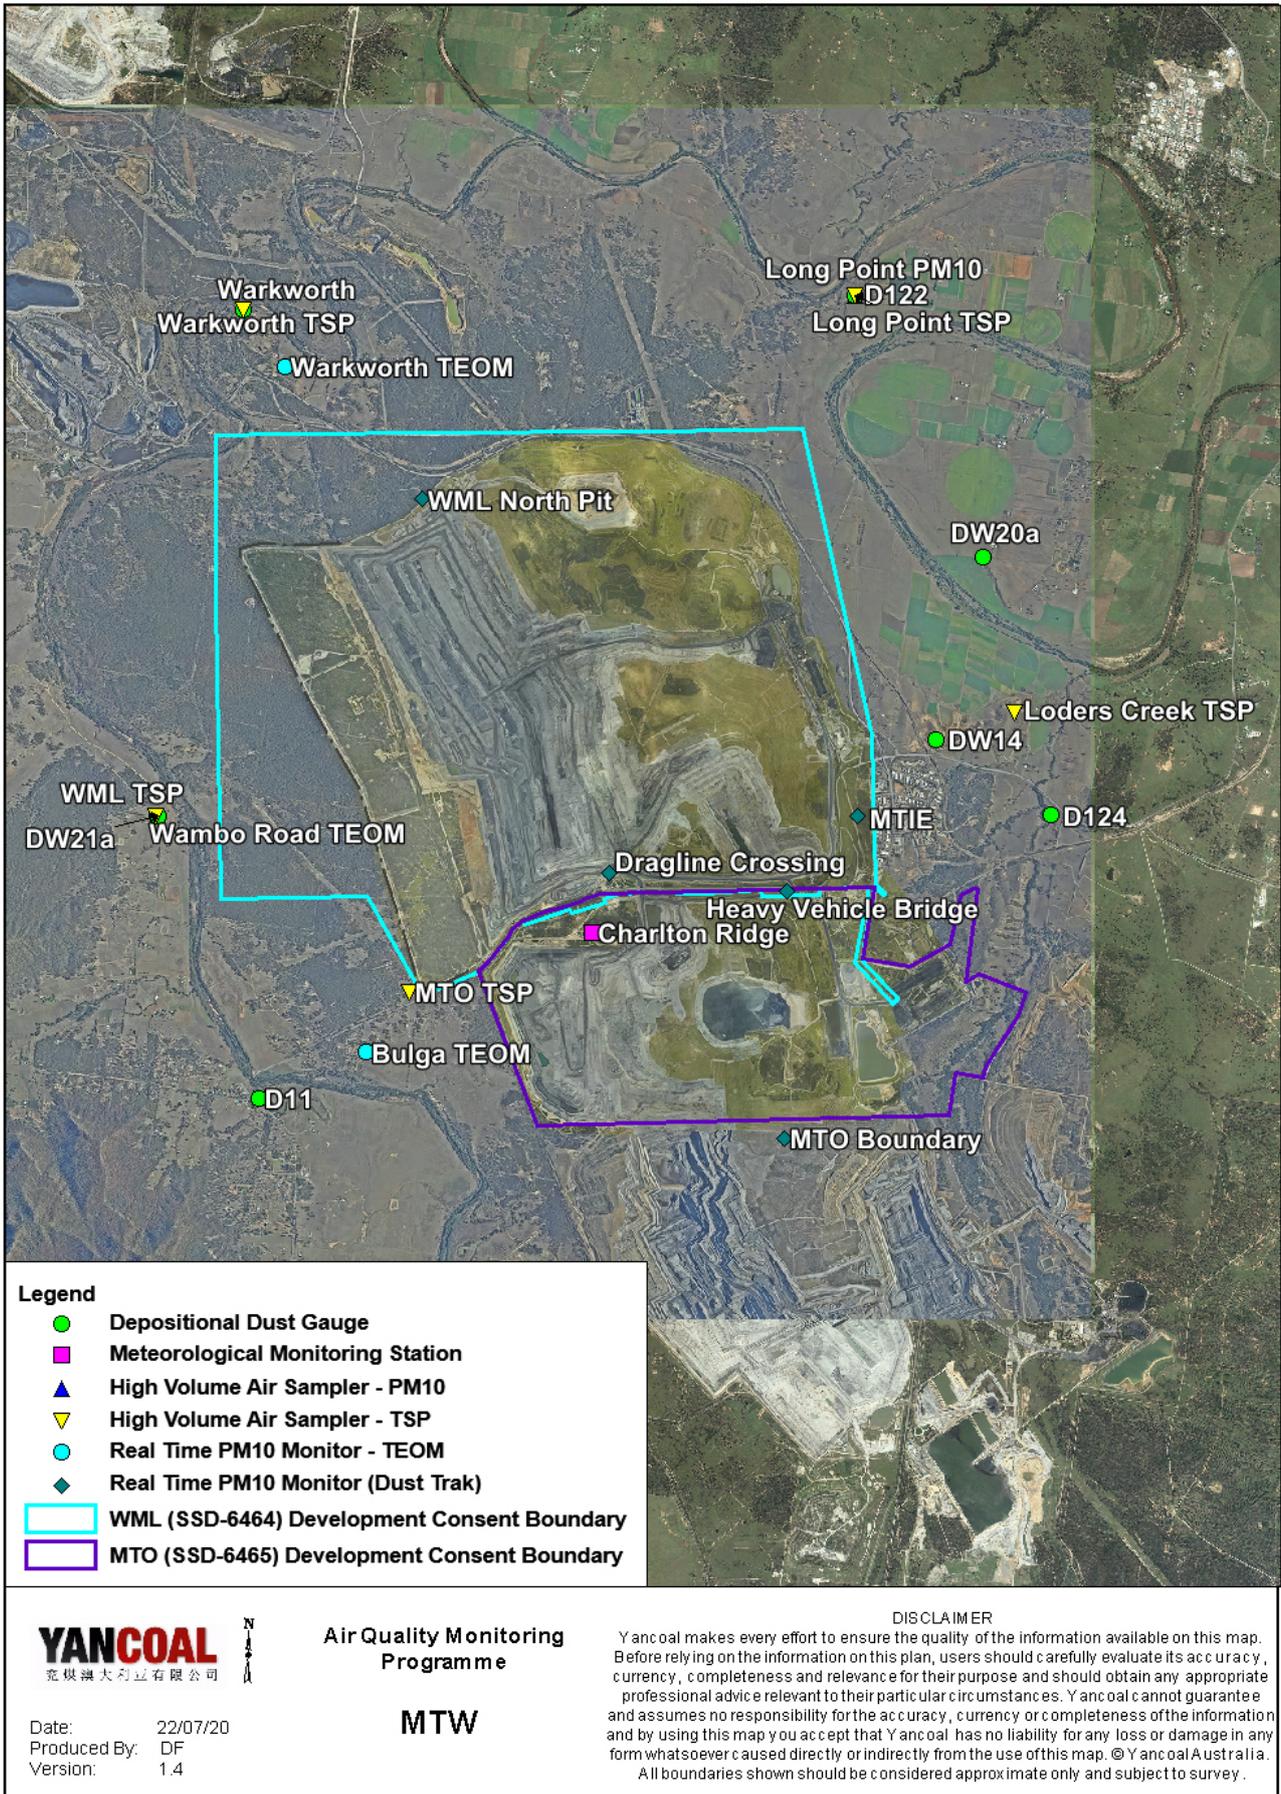
Figure 3: Air Quality Monitoring Locations

Suspended particulates are measured by a network of High Volume Air Samplers (HVAS) measuring Total Suspended Particulates (TSP) and Particulate Matter <10µm (PM₁₀). The location of these monitors can be found in **Figure 3**. Each HVAS was run for 24 hours on a six-day cycle in accordance with EPA requirements.

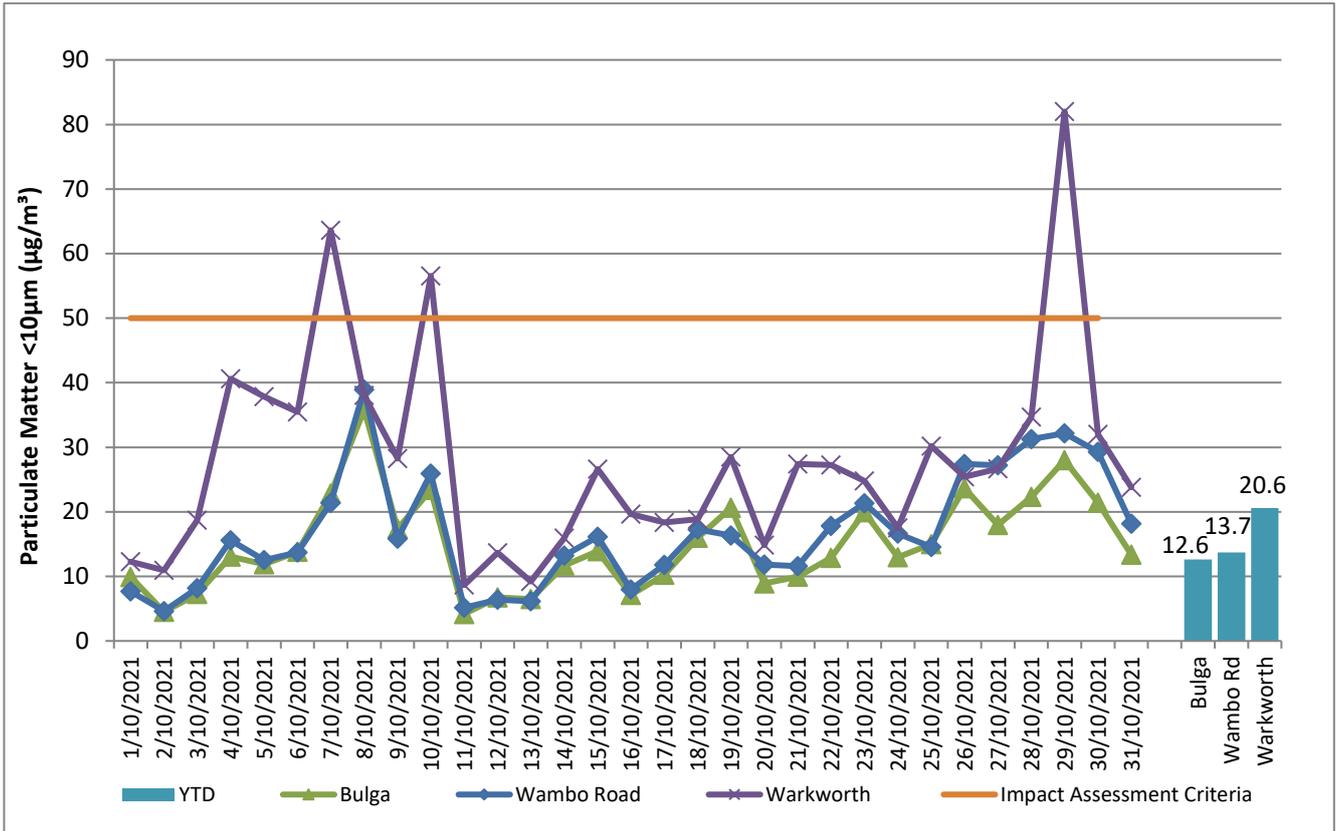
Figure 8: Real Time PM₁₀ daily 24hr average (line graphs) and YTD annual average (column graphs) – October 2021

During October, the real time monitoring system generated 118 automated air quality related alerts, including 13 alerts for adverse meteorological conditions and 105 alerts for elevated PM_{10} levels.

On 7 October 2021, the Warkworth OEH TEOM (63.6 µg/m³) exceeded the short term (24hr) criteria. This measurement was assessed for MTW’s potential contribution based on meteorological conditions on this day resulting in a maximum estimated contribution of 15.5 µg/m³, less than a 25% contribution to the result. Accordingly, no further action is required (as per approved Air Quality Monitoring Programme).

On 10 October 2021, the Warkworth OEH TEOM (56.5 µg/m³) exceeded the short term (24hr) criteria. This measurement was assessed for MTW’s potential contribution based on meteorological conditions on this day resulting in a maximum estimated contribution of 7.5 µg/m³, less than a 14% contribution to the result. Accordingly, no further action is required (as per approved Air Quality Monitoring Programme).

On 29 October 2021, the Warkworth OEH TEOM ($82.0 \mu\text{g}/\text{m}^3$) exceeded the short term (24hr) criteria. This measurement was assessed for MTW's potential contribution based on meteorological conditions on this day resulting in a maximum estimated contribution of $11.6 \mu\text{g}/\text{m}^3$, less than a 17% contribution to the result. Accordingly, no further action is required (as per approved Air Quality Monitoring Programme).

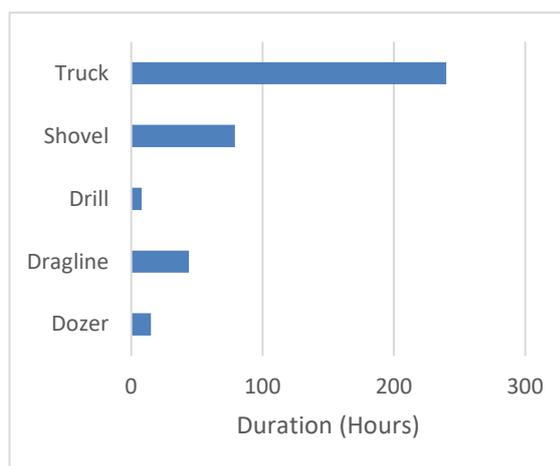
Figure 17: Operational Downtime by Equipment Type – October 2021

During October, a total of 387 hours of equipment downtime was logged in response to environmental events such as dust, noise and adverse meteorological conditions. Operational downtime by equipment type is shown in **Figure 17**.

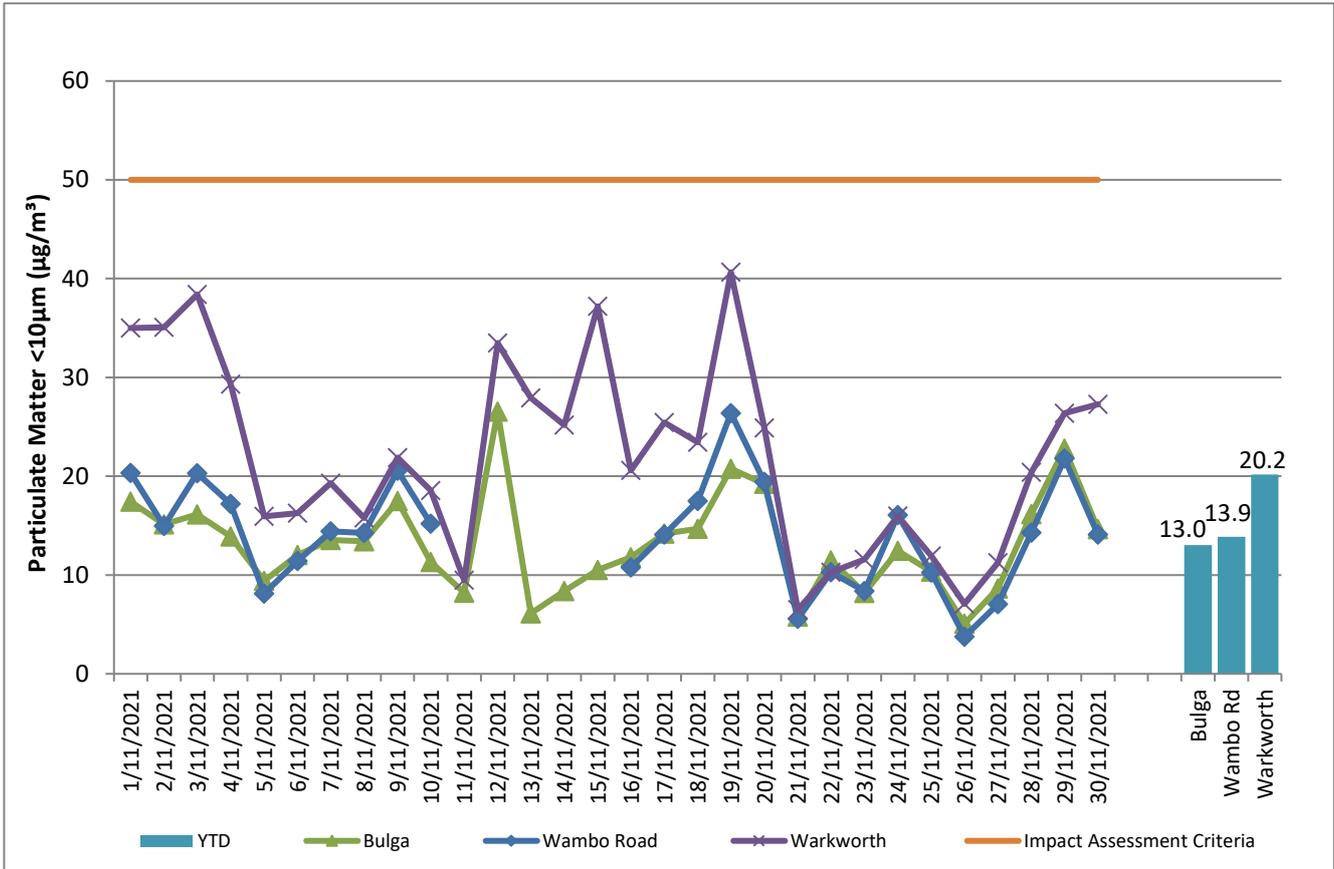
Figure 8: Real Time PM₁₀ daily 24hr average (line graphs) and YTD annual average (column graphs) – November

During November, the real time monitoring system generated 33 automated air quality related alerts, including 10 alerts for adverse meteorological conditions and 23 alerts for elevated PM₁₀ levels.

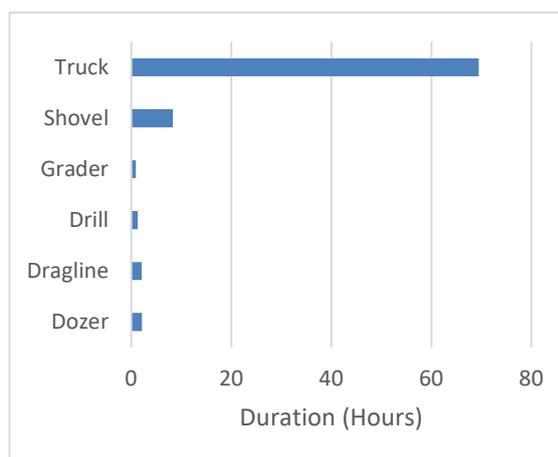
Figure 17: Operational Downtime by Equipment Type – November 2021

During November, a total of 84 hours of equipment downtime was logged in response to environmental events such as dust, noise and adverse meteorological conditions. Operational downtime by equipment type is shown in **Figure 17**.
