# Monthly Environmental Monitoring Report

Yancoal Mount Thorley Warkworth

May 2020

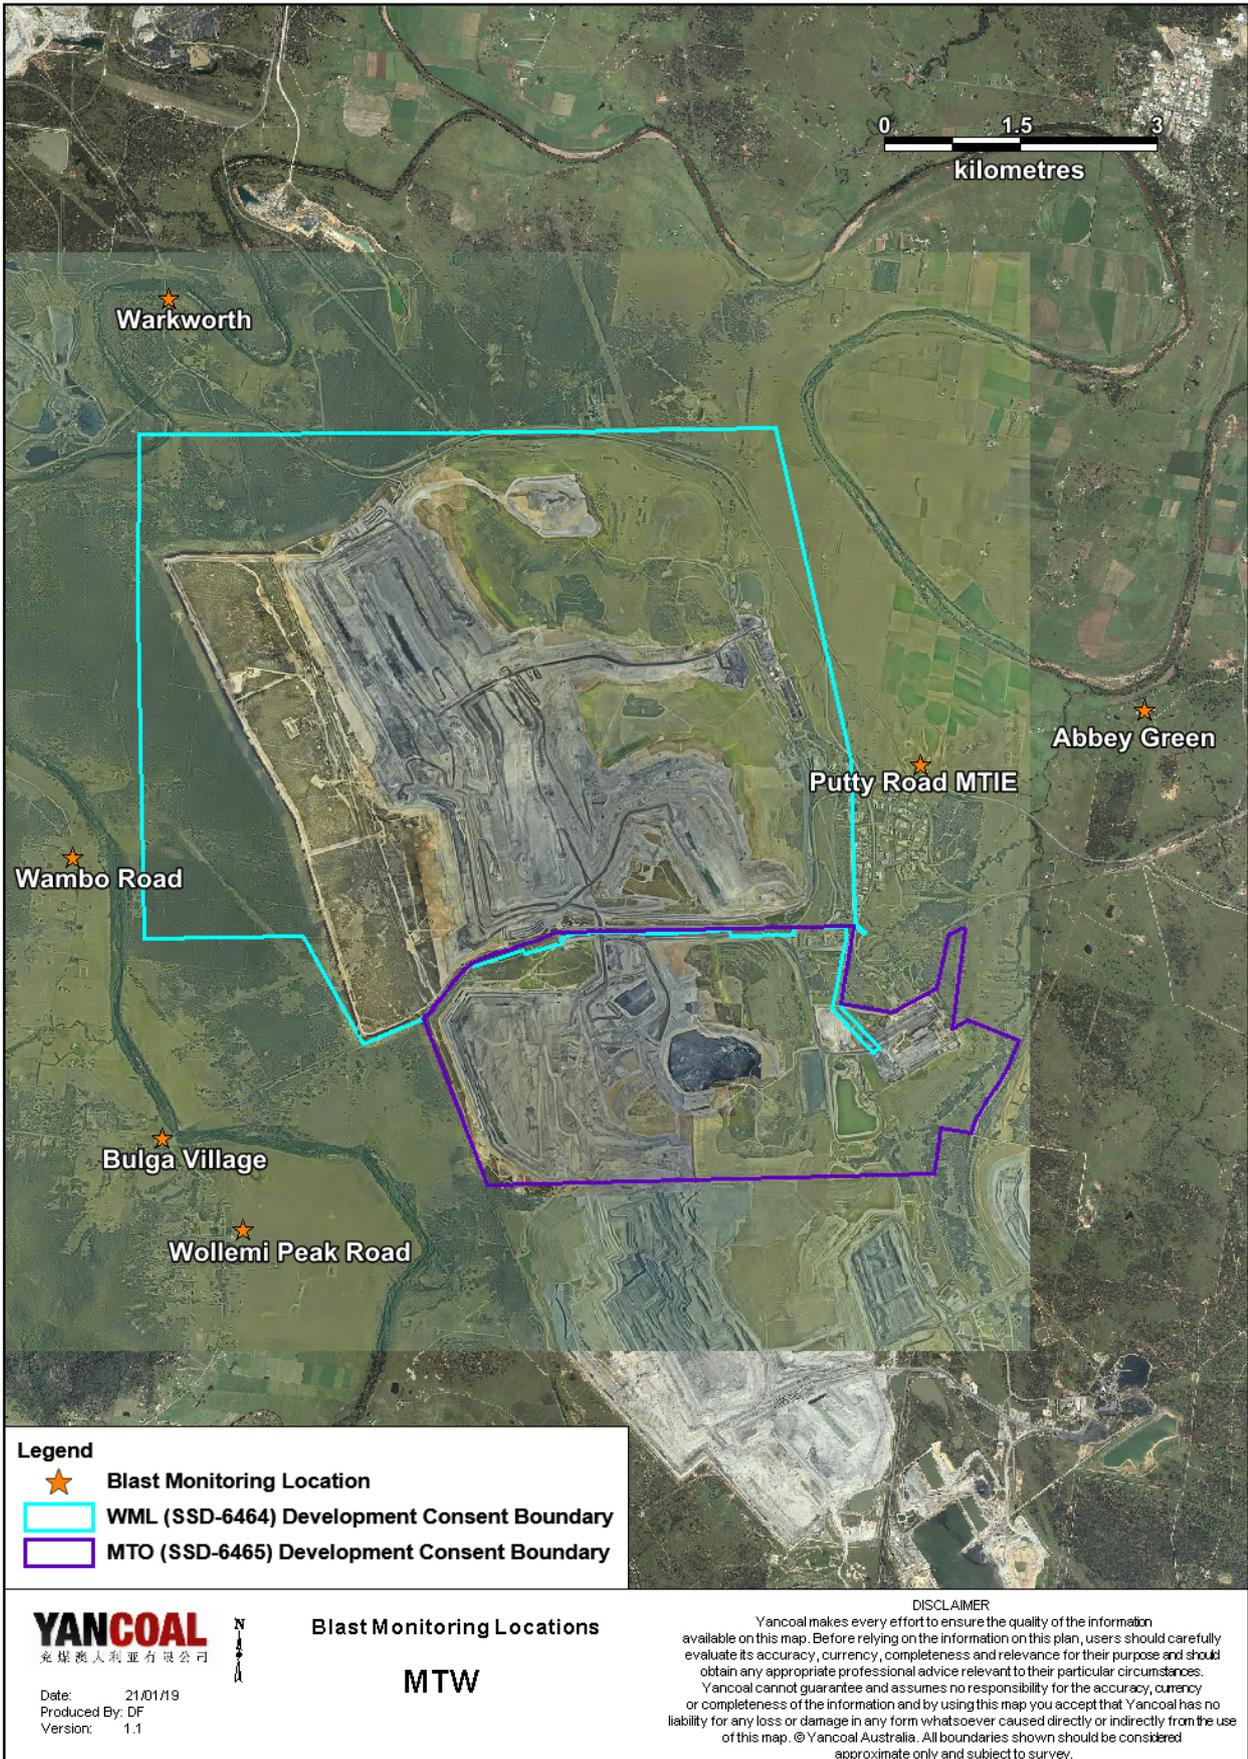
Figure 15: MTW Blast Monitoring Location Plan

MTW have a network of six blast monitoring units. These are located at nearby privately owned residences and function as regulatory compliance monitors.

The location of these monitors can be found in **Figure 15**.

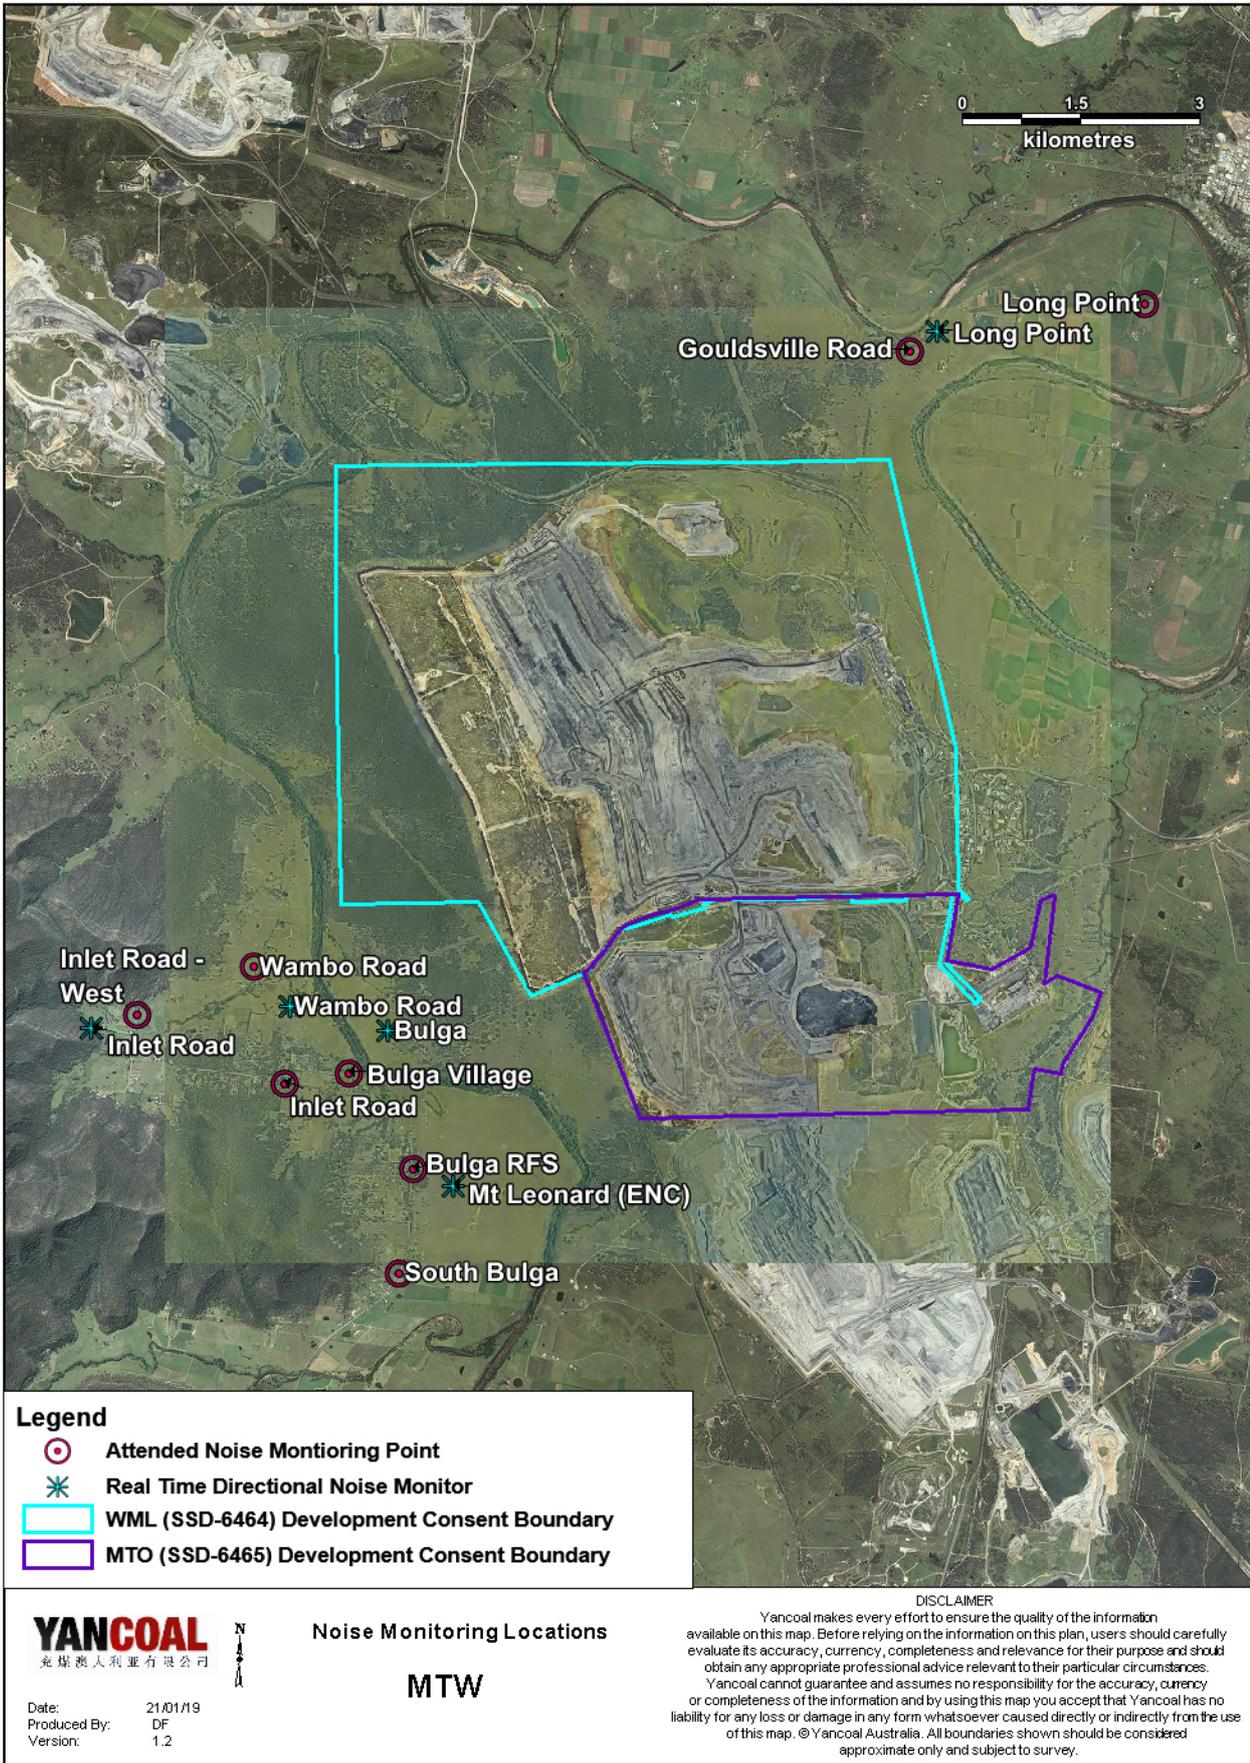
Figure 16: Noise Monitoring Location Plan

Routine attended noise monitoring is carried out in accordance with the MTW Noise Management Plan. A review against EIS predictions will be reported in the Annual Review. The purpose of the noise surveys is to quantify and describe the acoustic environment around the site and compare results with specified limits. Real time noise monitoring also occurs at five sites surrounding MTW. Noise monitoring locations are displayed in **Figure 16**.
