Stratford Coal CCC Meeting

Presentation –
Company Report &
Overview of Activities

November 2022

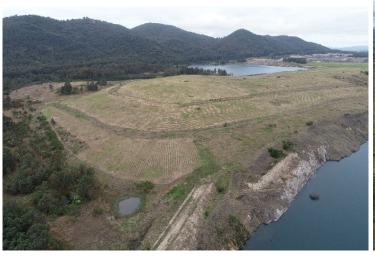
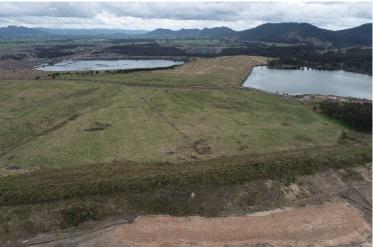
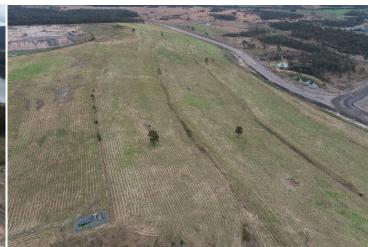
Photos: Rehabilitation Maintenance, 5 October 2022.

Management Area	Project	Status
Rehabilitated Waste Emplacements	 BRN backfilling and bulk- shaping Rehabilitation Maintenance 	 Mining in the BRN pit was finalised in June 2021 and minor backfilling has continued to progress in Q3 2022. Slashing of pasture rehab was completed in Q3 2022. Manual weed removal rescheduled to Q4 2022.
	 Native rehabilitation infill planting. 	 Due to above average persistent rainfall, infill planting with tubestock in existing rehabilitation areas has been postponed until November 2022. Planting areas will include BRN Rehabilitation area, Roseville West Rehabilitation area and Stratford Main Pit Rehabilitation area.
Monitoring	 Vegetation Monitoring - Ecosystem Function Analysis 	 Rehabilitation monitoring incorporating landscape function analysis and vegetation dynamics was completed in April 2022. The results will be included in the next Annual Review.
