# Monthly Environmental Monitoring Report

Yancoal Mt Thorley Warkworth

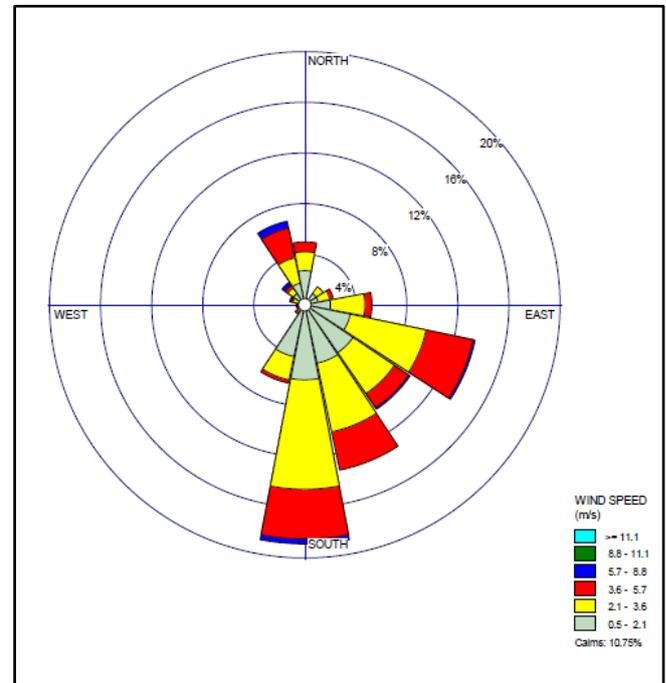
**Figure 3: Charlton Ridge Wind Rose – December 2021**

Winds from the south were dominant throughout the reporting period as shown in **Figure 2**.

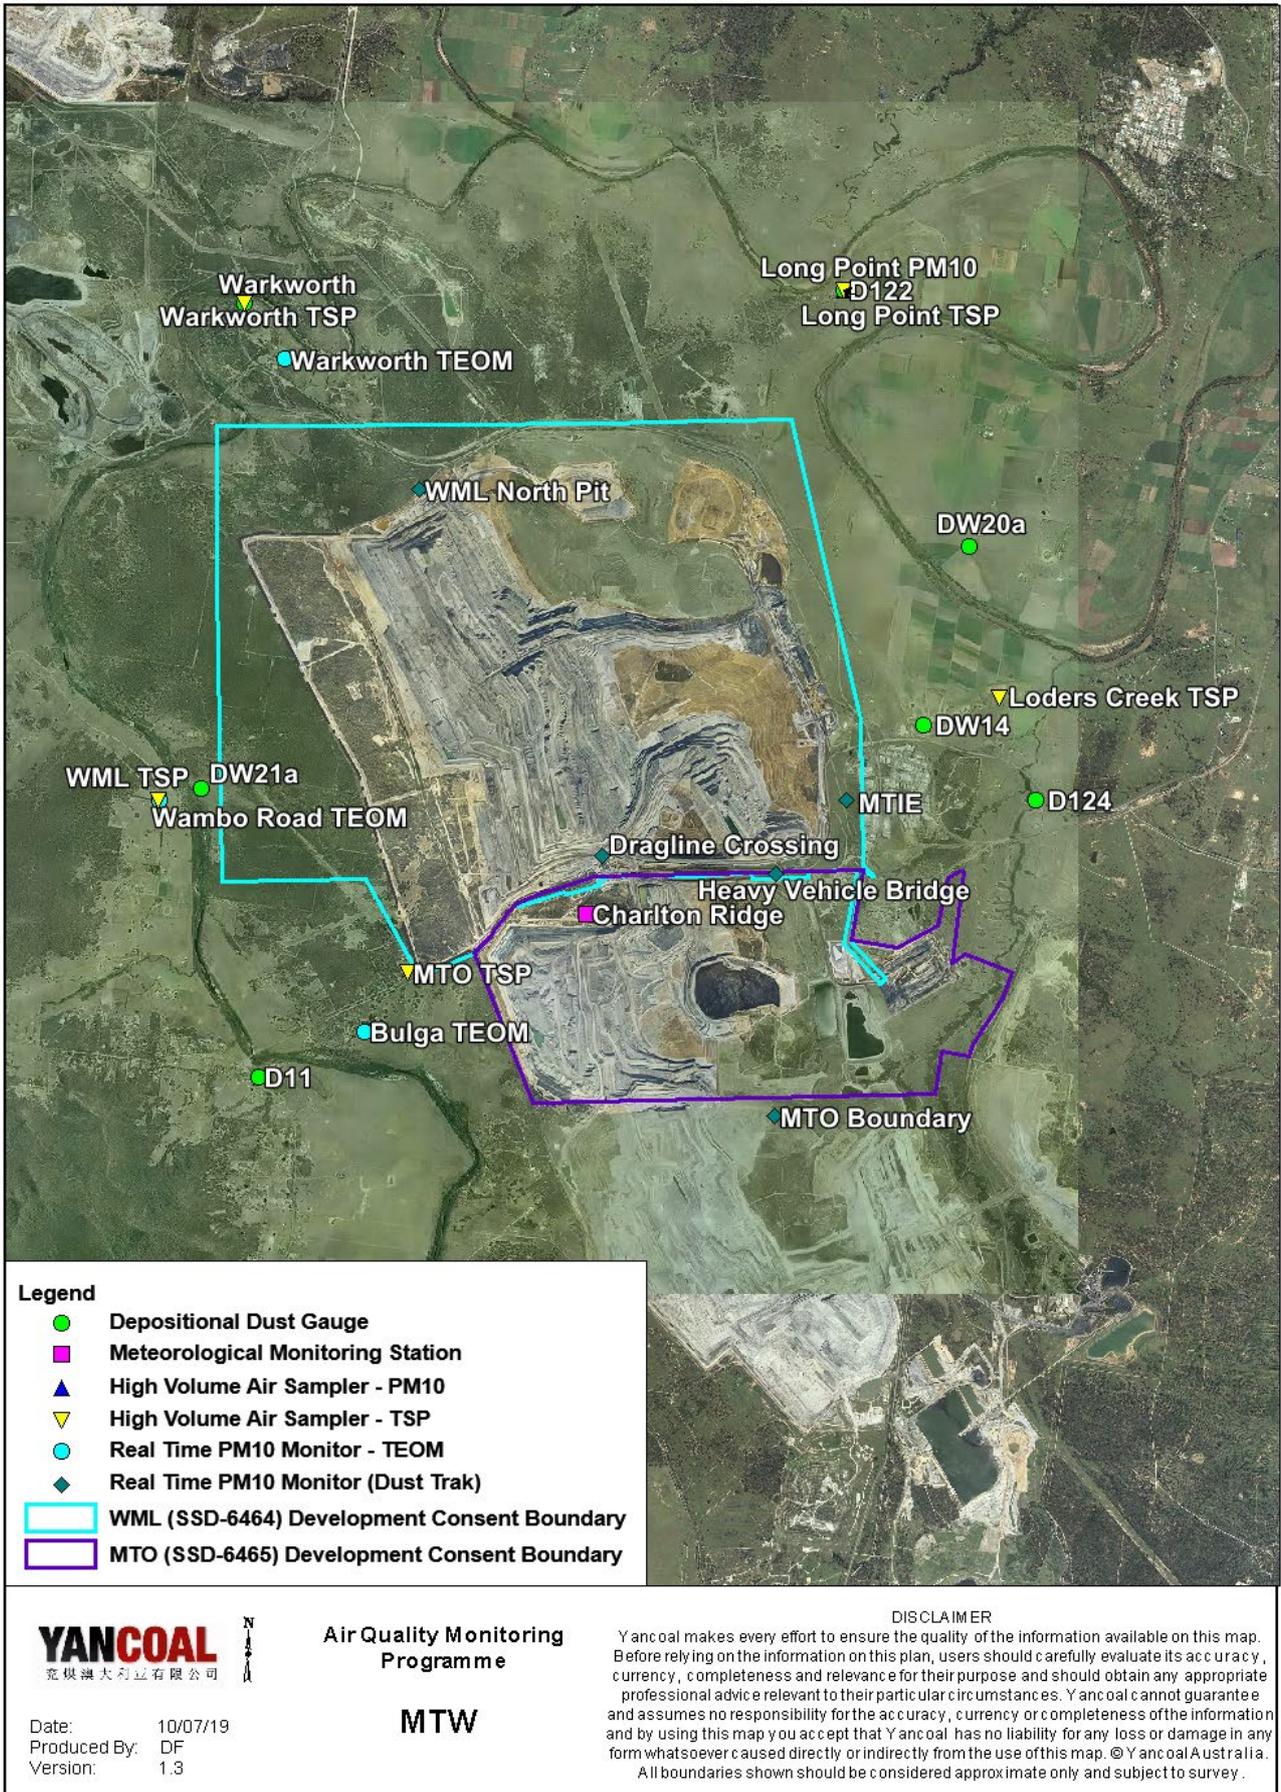
Figure 4: Air Quality Monitoring Locations

Meteorological data is collected at MTW's 'Charlton Ridge' meteorological station (refer to **Figure 3**).

Particulates (TSP) and Particulate Matter <10µm (PM<sub>10</sub>). The location of these monitors can be found in Figure 3. Each HVAS was run for 24 hours on a six-day cycle in accordance with EPA requirements.

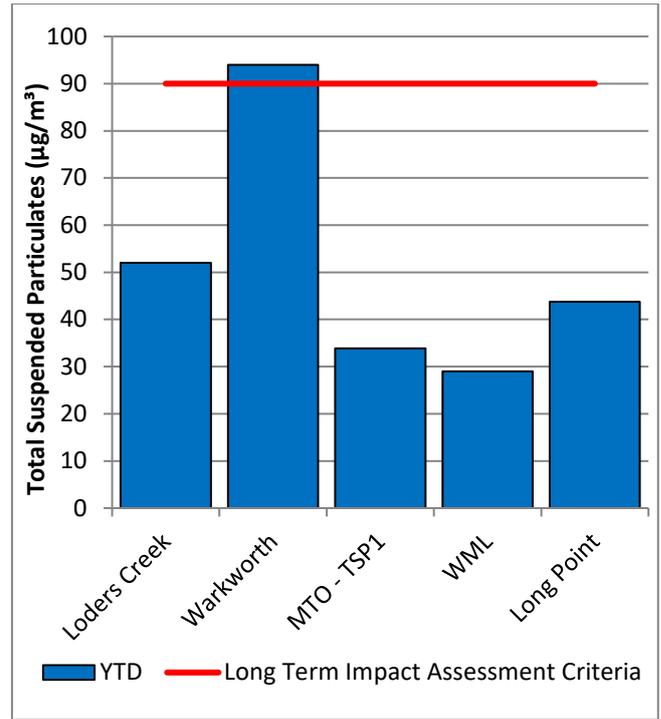
Figure 8: Annual Average Total Suspended Particulates – December 2021

Figure 7 shows the annual average TSP results compared against the long-term impact assessment criteria of 90µg/m<sup>3</sup>.

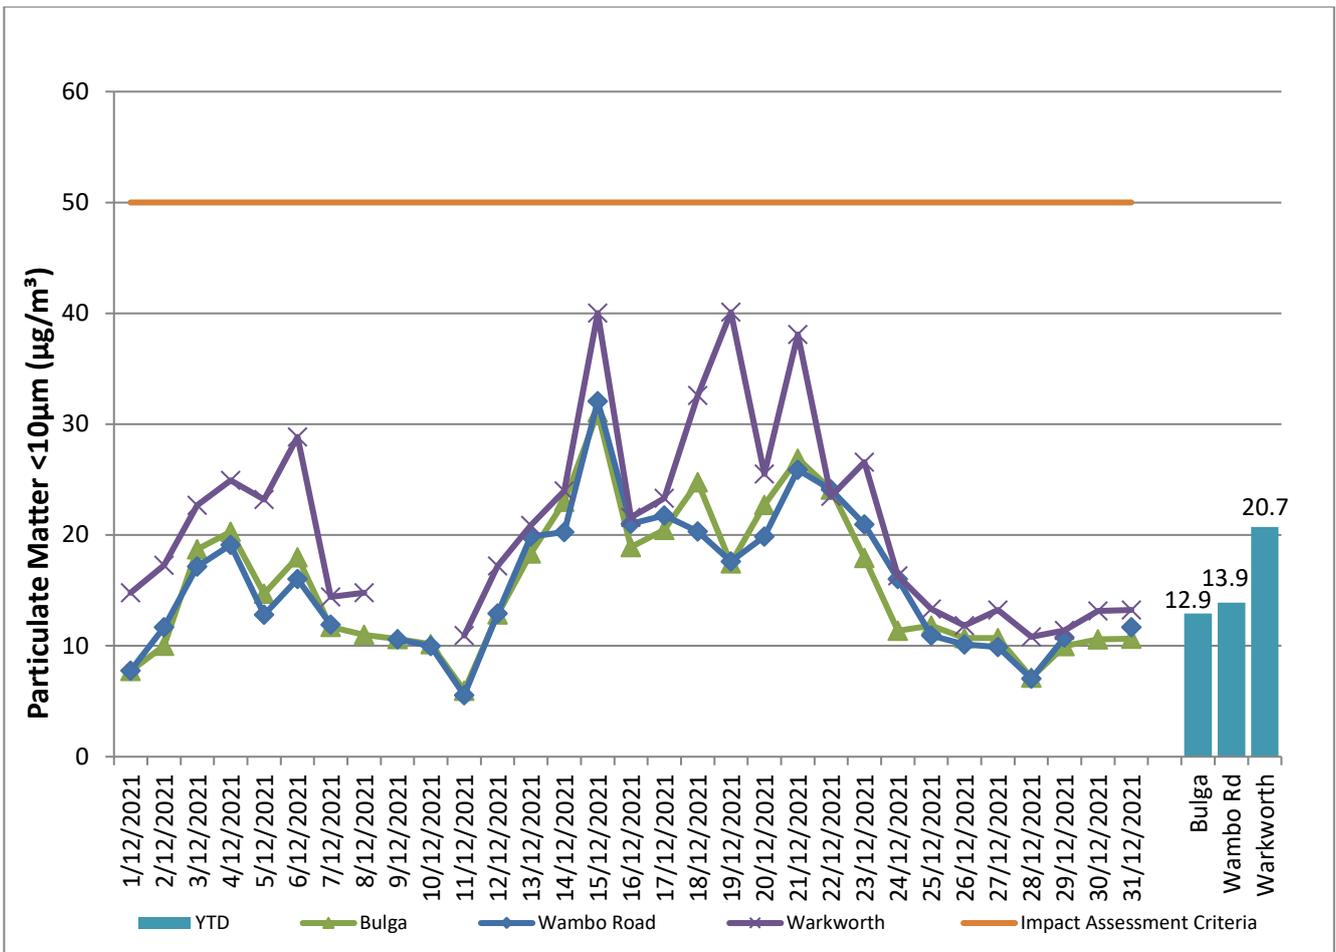
Figure 9: Real Time PM<sub>10</sub> 24hr average and Year-to-date average – December 2021

Results for real time dust sampling are shown in Figure 8, including the daily 24-hour average PM<sub>10</sub> result and the annual PM<sub>10</sub> average.

Data was not available on 9 and 10 December 2021 from the Warkworth TEOM and 8 and 30 December 2021 from the Wambo Road TEOM due to equipment or communications issues.

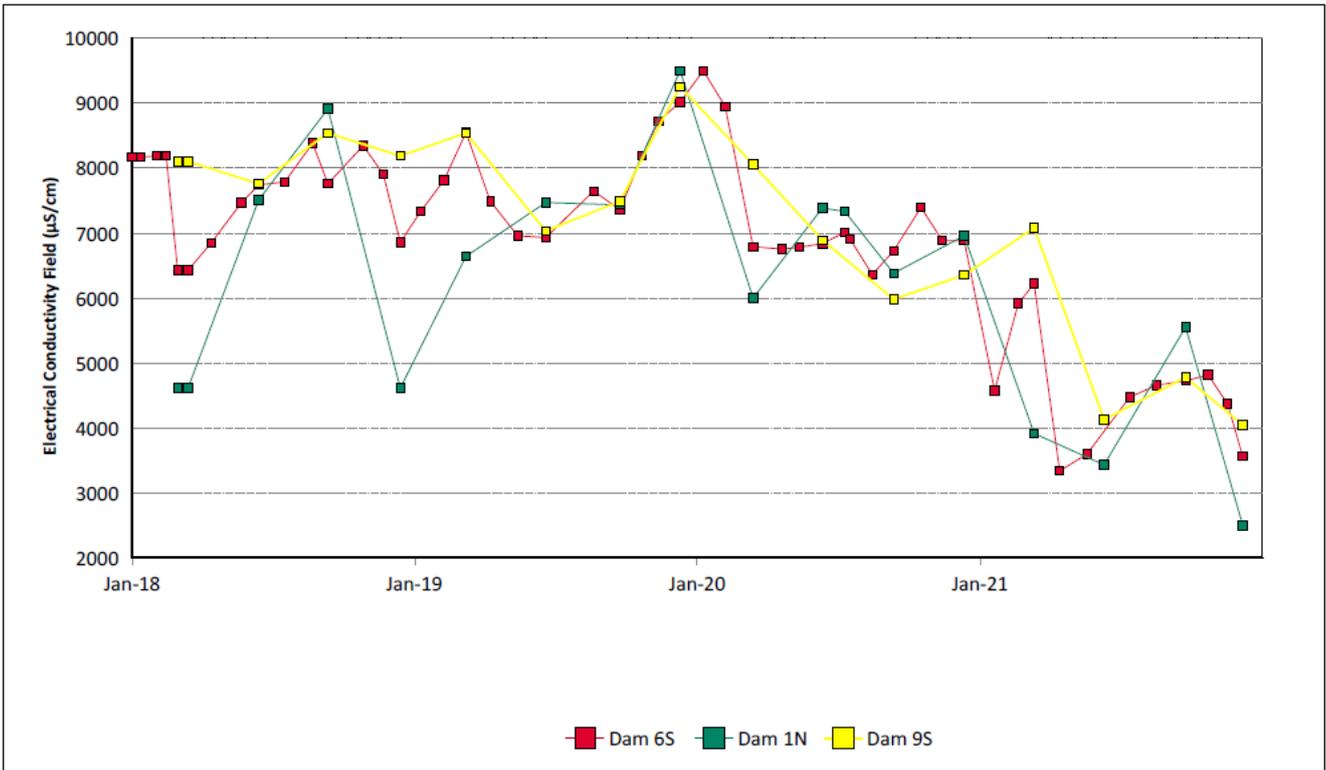
Figure 10: Site Dams Electrical Conductivity Trend – December 2021

**Figure 9** to **Figure 11** show the long-term surface water trend (2018 – current) within MTW mine dams. **Figure 12** to **Figure 14** show the long-term surface water trend (2018 - current) in surrounding watercourses.

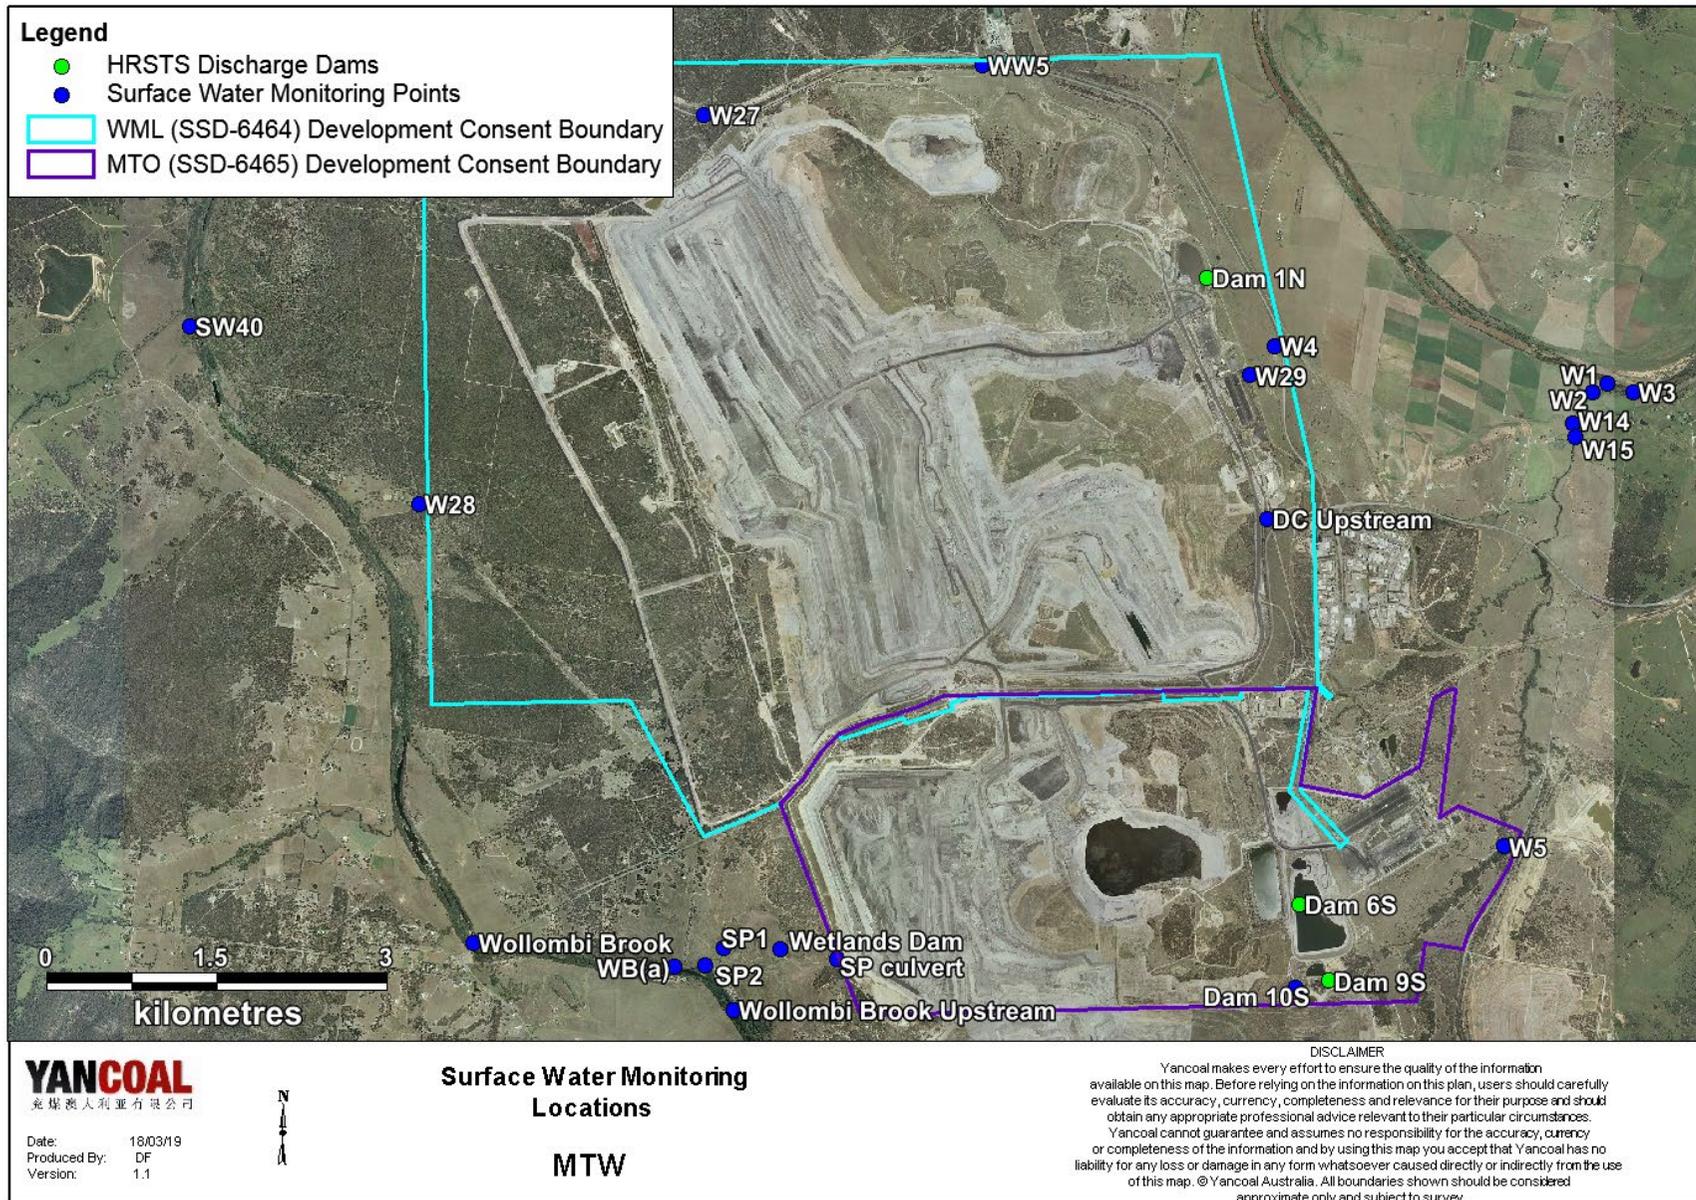
Figure 16: Surface Water Monitoring Location Plan

Monitoring is conducted at mine site dams and surrounding natural watercourses. The surface water monitoring locations are outlined in **Figure 15**.

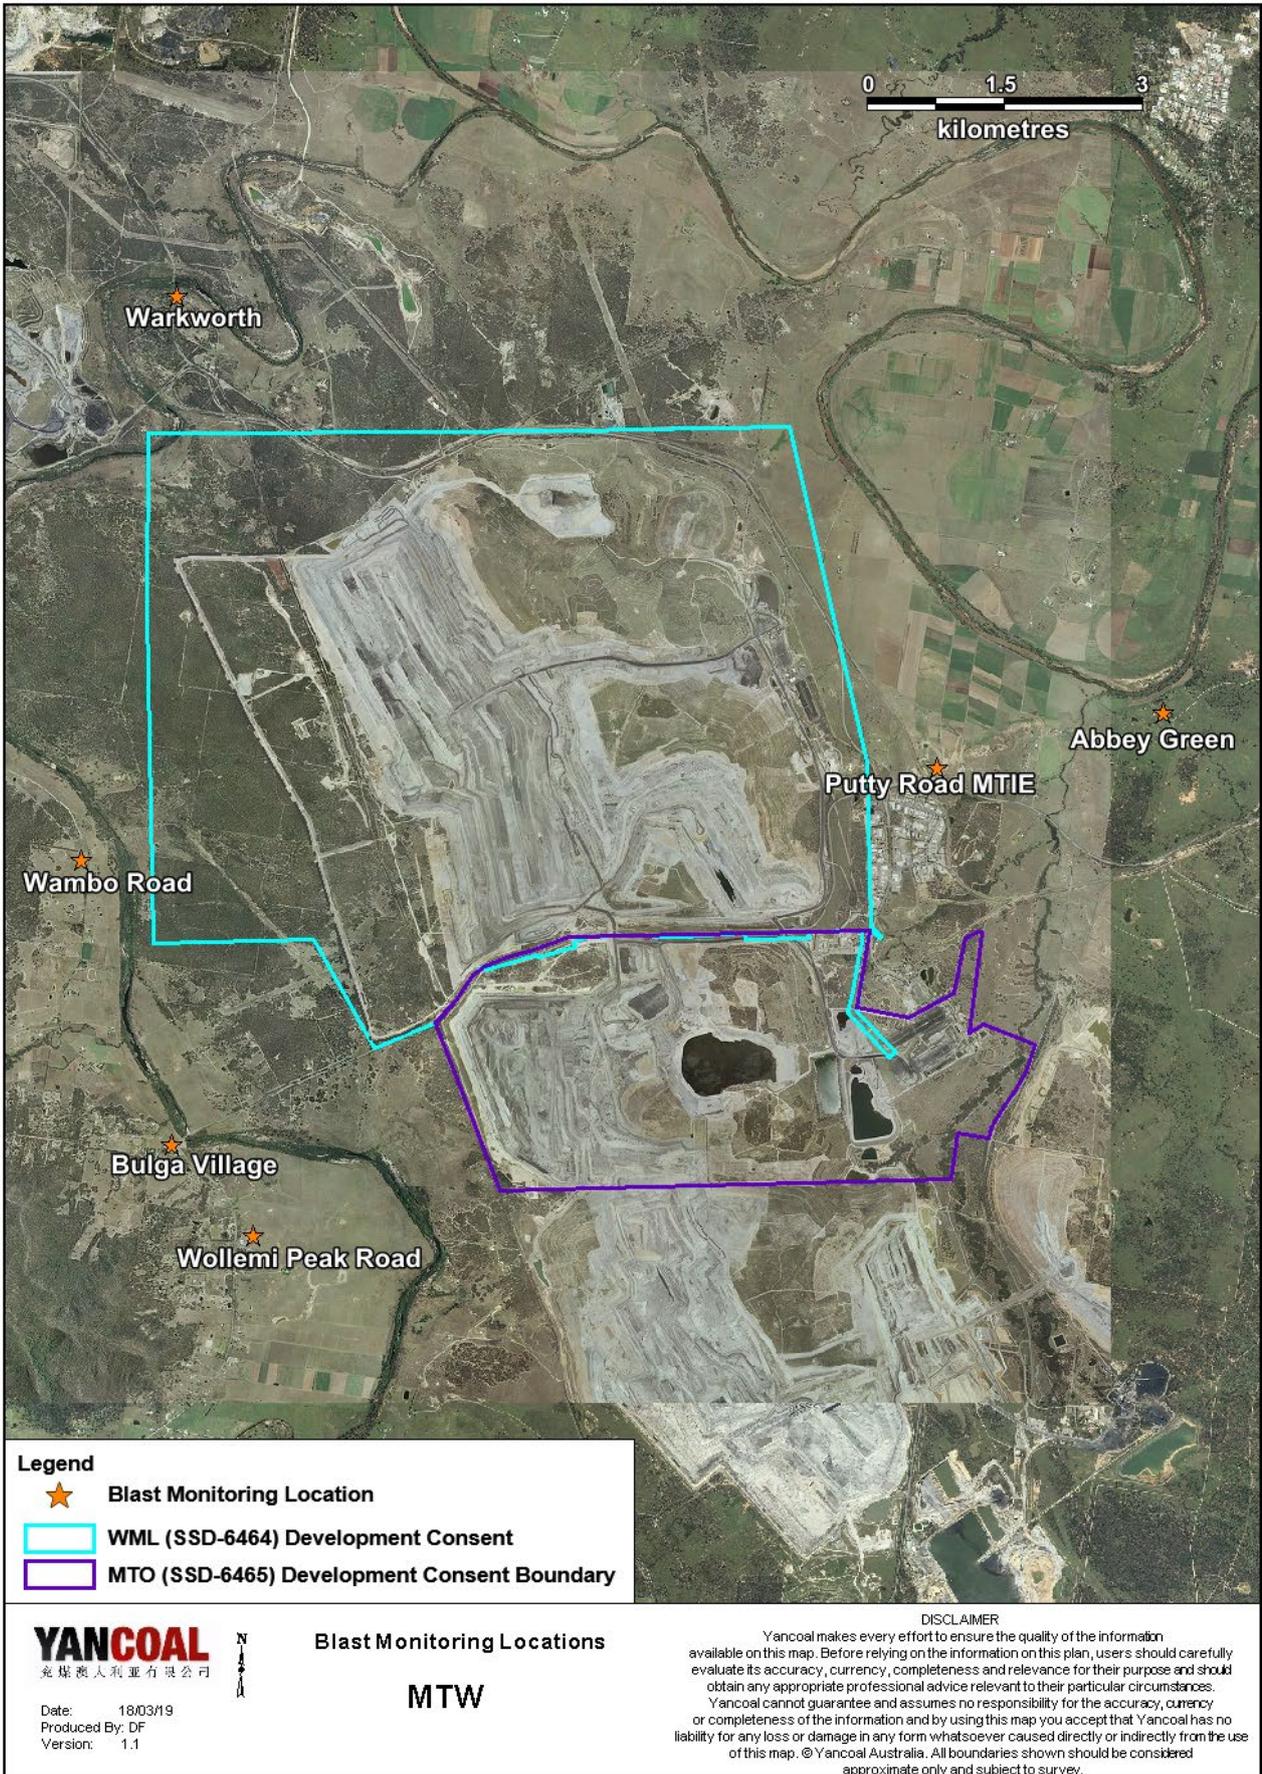
Figure 73: Blast and Vibration Monitoring Location Plan

The location of these monitors can be found in **Figure 72**.

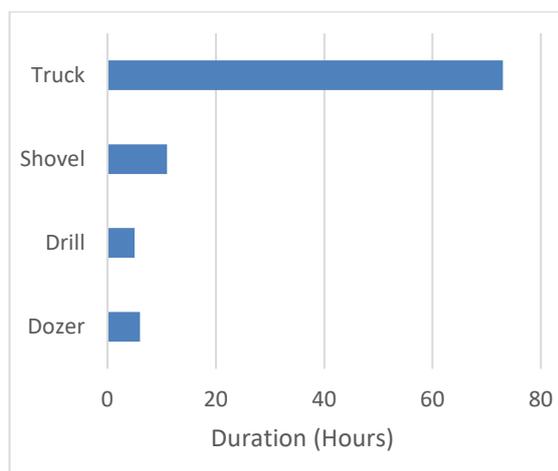
**Figure 75: Operational Downtime by Equipment Type – December 2021**

During December a total of 94 hours of equipment downtime was logged in response to environmental events such as dust, noise and adverse meteorological conditions. Operational downtime by equipment type is shown in **Figure 74**.
