### **Longwall 207B**

Lemington Road Monitoring and Maintenance Plan

August 2024

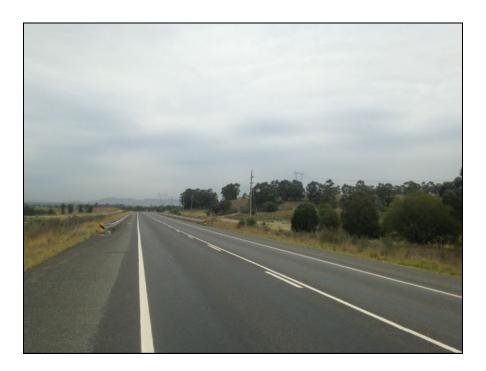
**Figure 6 Lemington Road looking South**

Lemington Road was diverted and reconstructed during and following mining of Longwalls 7B and 8 in the PG Seam as part of the Ravensworth North Open Cut Mine Project. **Figure 6** shows the road looking south from a position above Longwall 207B. Longwall 6B in the PG Seam subsequently mined below a small section of the new road causing low level subsidence above the corner of the panel and minor cracking along the edge of the road. During 2023, Longwall 206B, approximately 60m below Longwall 6B, was the first in the sequence of panels to be mined below Lemington Road in the ULLD Seam. No impacts to Lemington Road pavement were observed from the mining of Longwall 206B and the road remained in a safe and serviceable condition. On review of monitoring data, subsidence effects and subsidence impacts were less than forecast.
