Managed by Rio Tinto Coal Australia

Mount Thorley Warkworth Monthly Obtained Data Summary

Environment Protection Licence 1376

August 2017

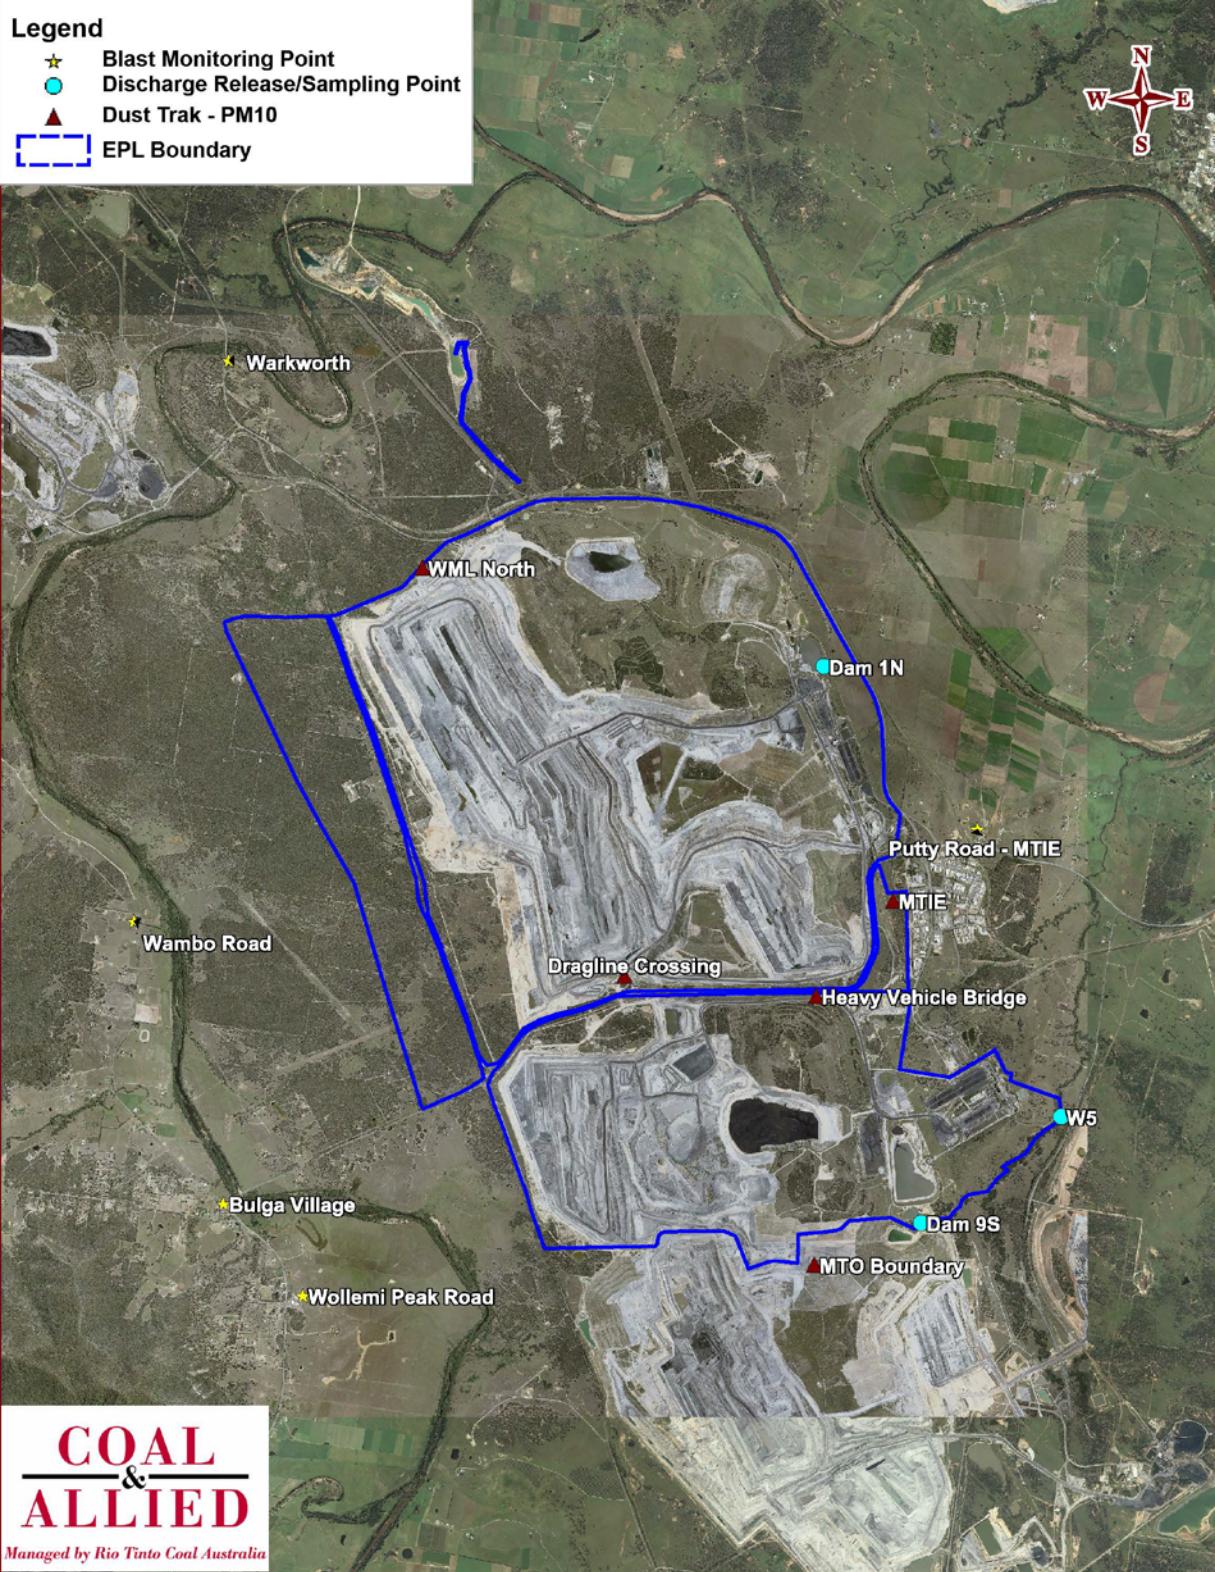
Figure 1 : Mount Thorley Warkworth Environmental Monitoring Locations

Environmental Monitoring Locations

To monitor regional air quality, MTW operates and maintains a network of 5 Particulate Matter <10µm (PM10) Monitors (DustTrak II) on mine owned land surrounding the mining operations. The location of these monitors can be found in Appendix A – MTW Monitoring Location Plan.

The location of these sampling points can be found in Appendix A – MTW Monitoring Locations Plan

The location of these monitors can be found in Appendix A – Mount Thorley Warkworth Environmental Monitoring Locations.
