Monthly Environmental Monitoring Report

Yancoal Mount Thorley Warkworth

August 2023

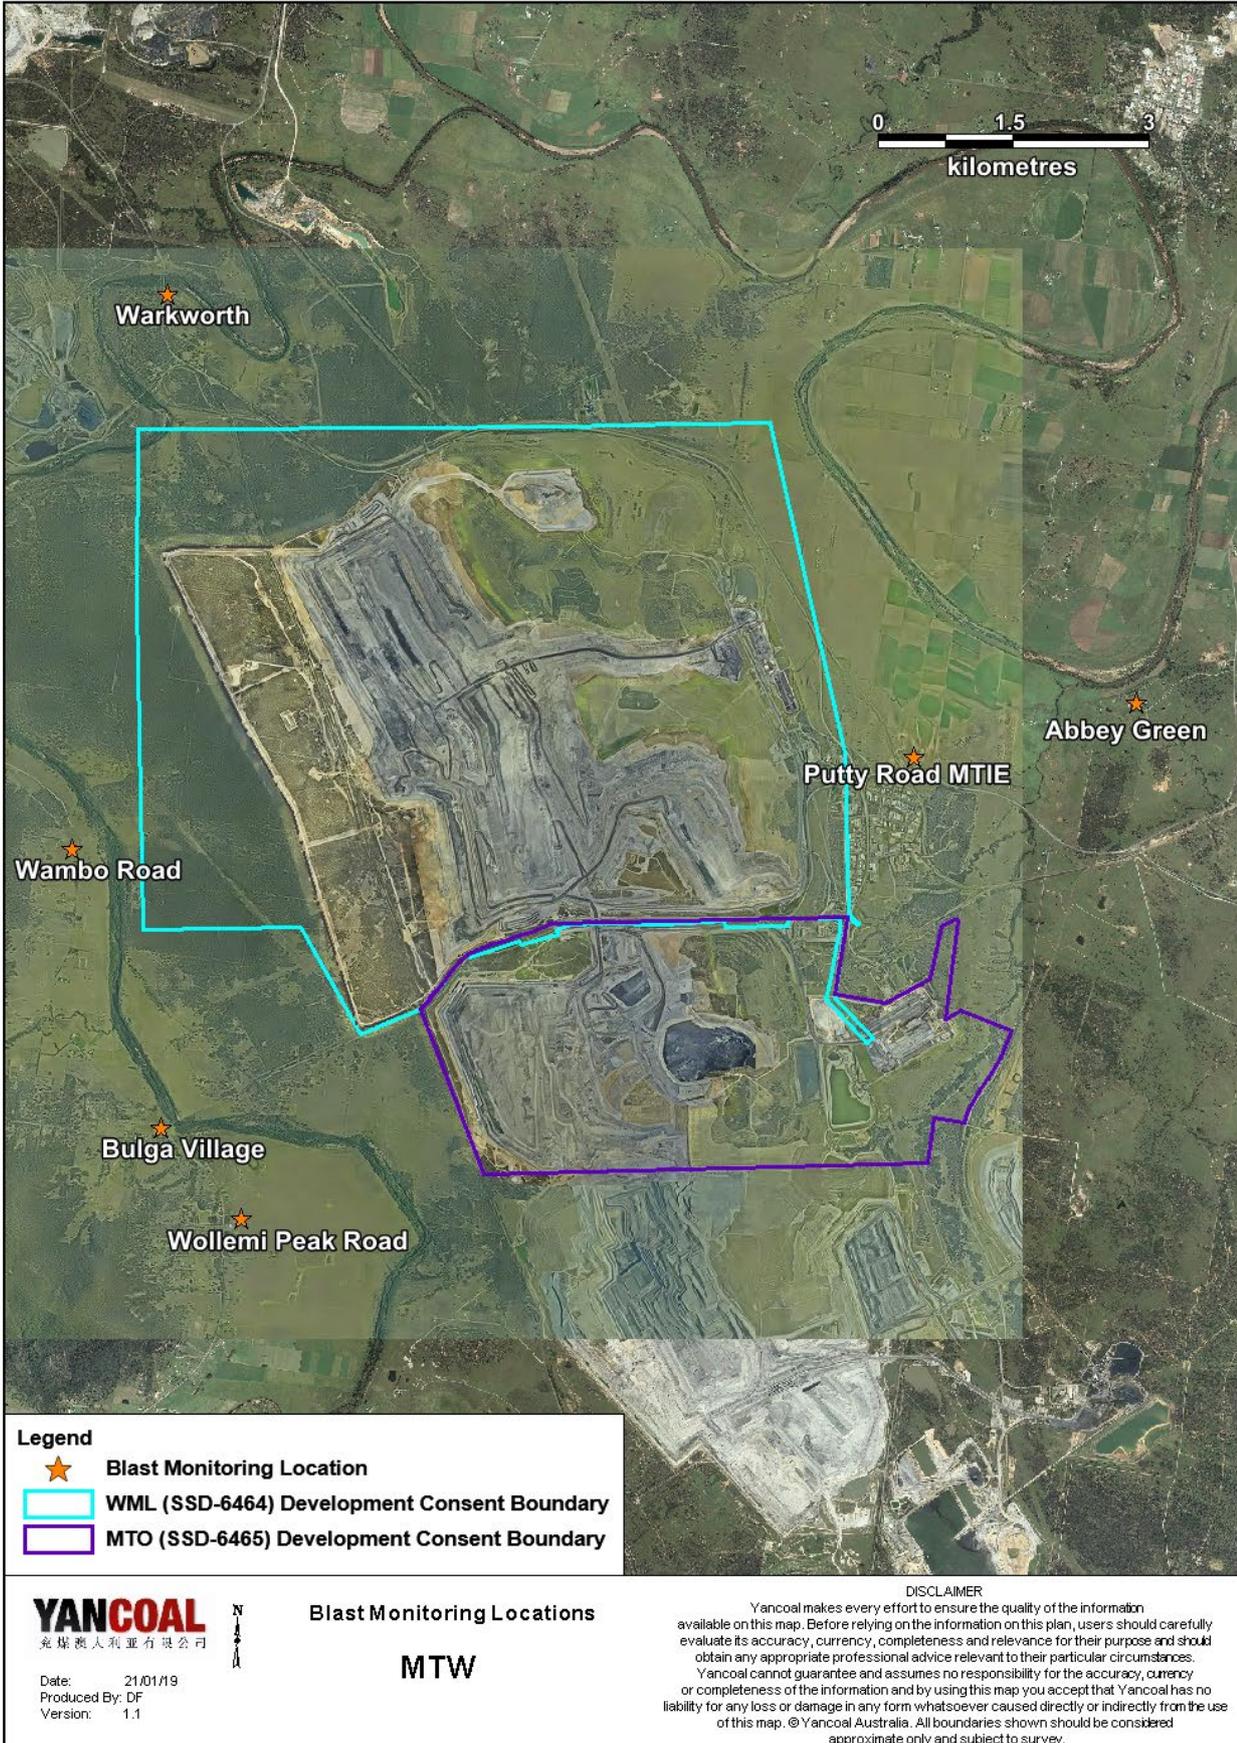
Figure 15: MTW Blast Monitoring Location Plan

MTW have a network of six blast monitoring units. These are located at nearby privately owned residences and function as regulatory compliance monitors.

The location of these monitors can be found in **Figure 15**.

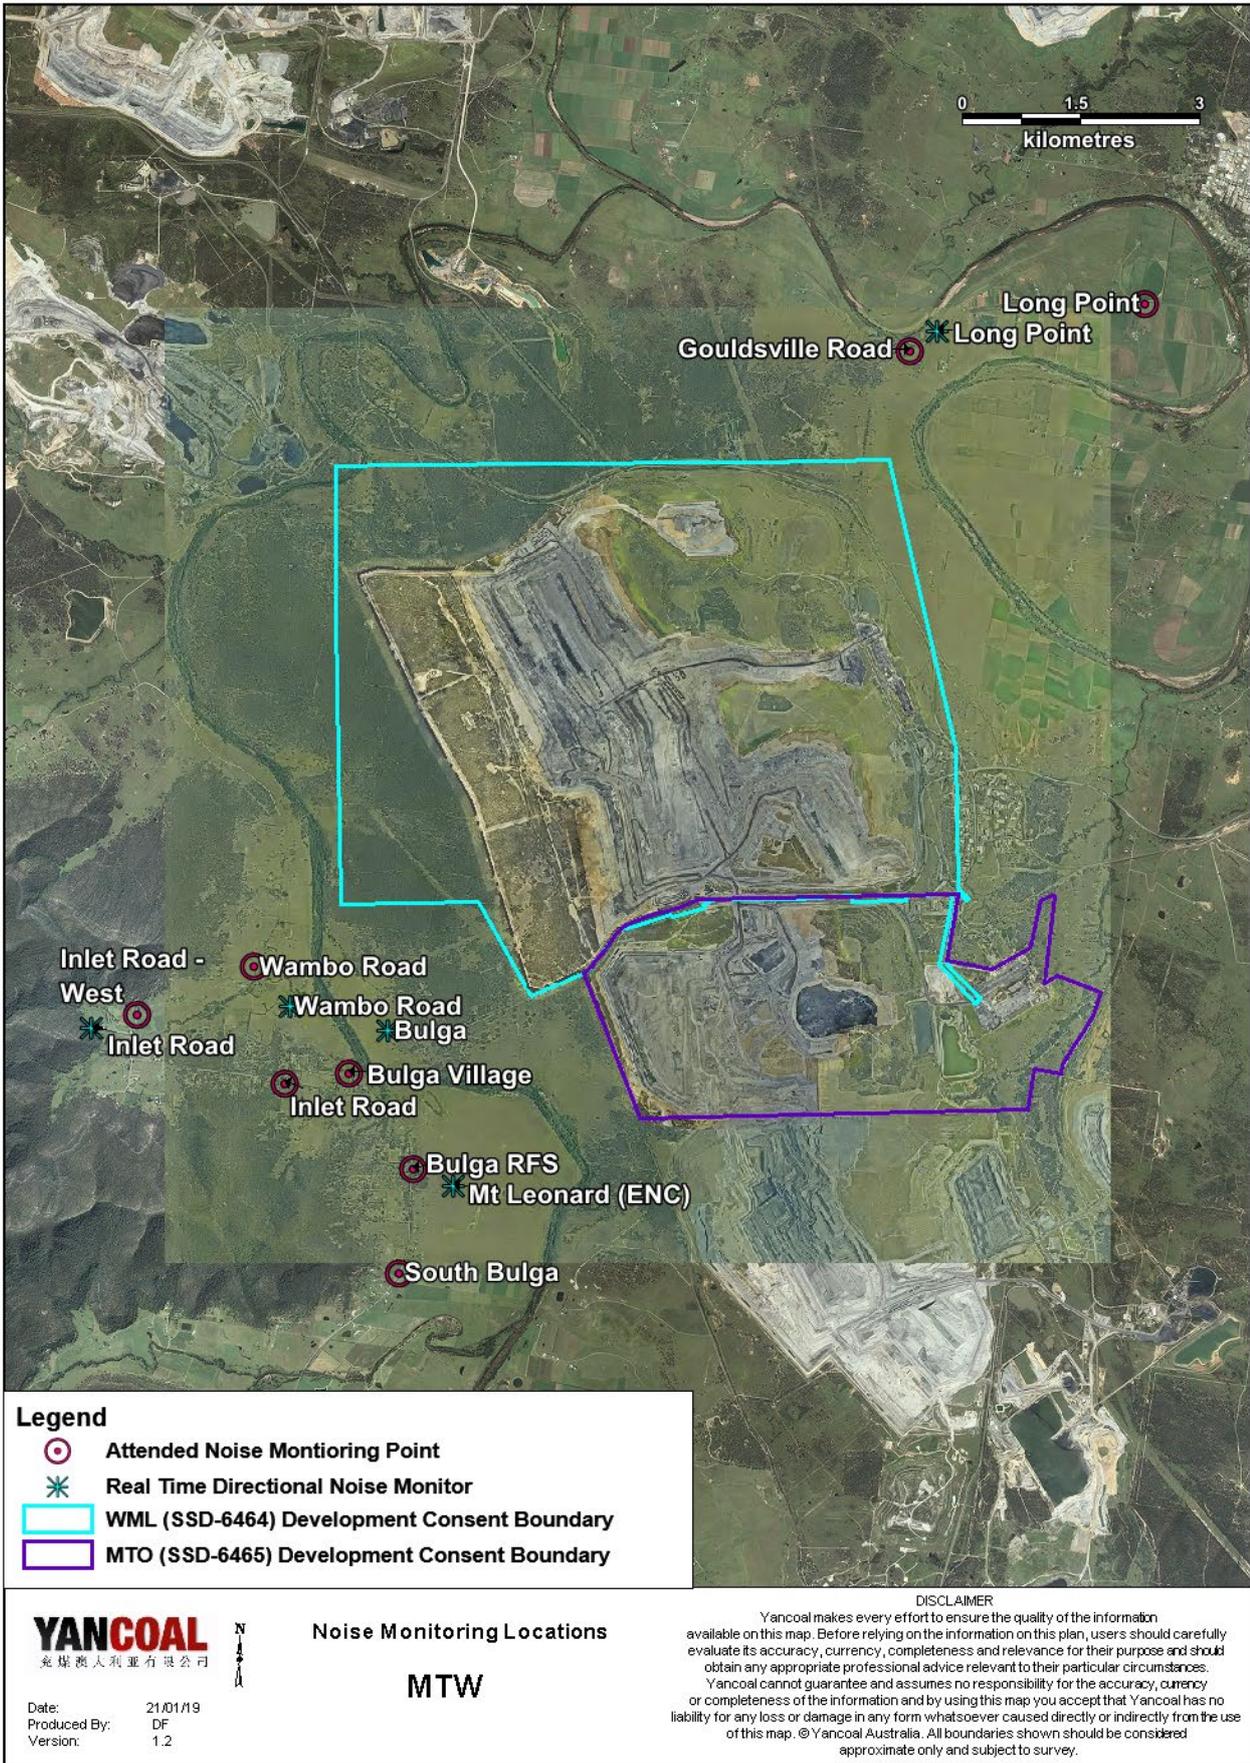
Figure 16: Noise Monitoring Location Plan

Routine attended noise monitoring is carried out in accordance with the MTW Noise Management Plan. A review against EIS predictions will be reported in the Annual Review. The purpose of the noise surveys is to quantify and describe the acoustic environment around the site and compare results with specified limits. Real time noise monitoring also occurs at five sites surrounding MTW. Noise monitoring locations are displayed in **Figure 16**.
